July 2024
F1002 A-B
NHTSA #24V-392 (School Bus)
NHTSA #24V-393 (Non-School Bus)
Transport Canada #2024-310 (Non-School Bus)
Transport Canada #2024-311 (School Bus)

Subject: Hub Snap Ring and Retainer Tabs

Models Affected: Specific model year 2025 Freightliner 108SD, 114SD, and Business Class M2; Freightliner Custom Chassis MC, MT45, MT45G, MT55, and MT55G Chassis, S2C 106, and S2RV 106 Cab & Chassis, XBS, XCM, XCP, XCR, and XCS Chassis; Thomas Built Buses SAF-T-LINER C2, and SAF-T-LINER EFX; Western Star 47X, 49X, and 57X vehicles manufactured February 2, 2024, through May 2, 2024.

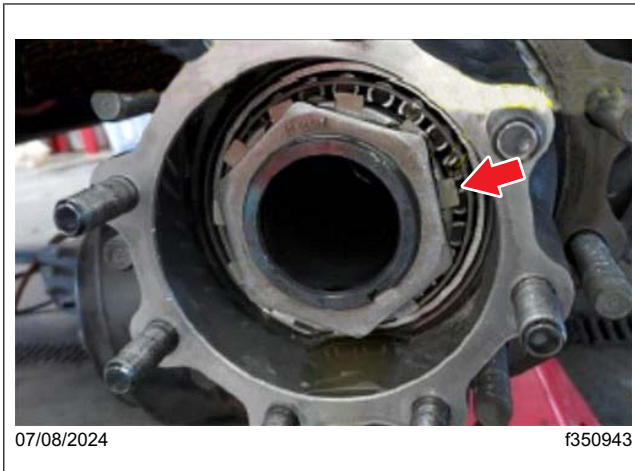
5. If so equipped, remove the tapered dowels and washers from the drive axle flange.
6. Remove the drive axle shaft.
7. Remove and discard the gasket.
8. Inspect the retainer tab to make sure that the tab is fully bent over on the nut. See [Fig. 2](#) and [Fig. 3](#).

Fig. 2, Incorrect – Lock Tab Not Bent

NO → Go to the **Inspection and Replacement of the Hub** procedure (on page 11).

1. Remove the hub and inspect all the components for wear.
2. If any component is worn, replace the hub. For instructions, see **Group 35** of the applicable workshop manual.
3. Clean a spot on the base label (Form WAR259) and attach a campaign completion sticker for F1002 (Form WAR260), indicating this work has been completed.

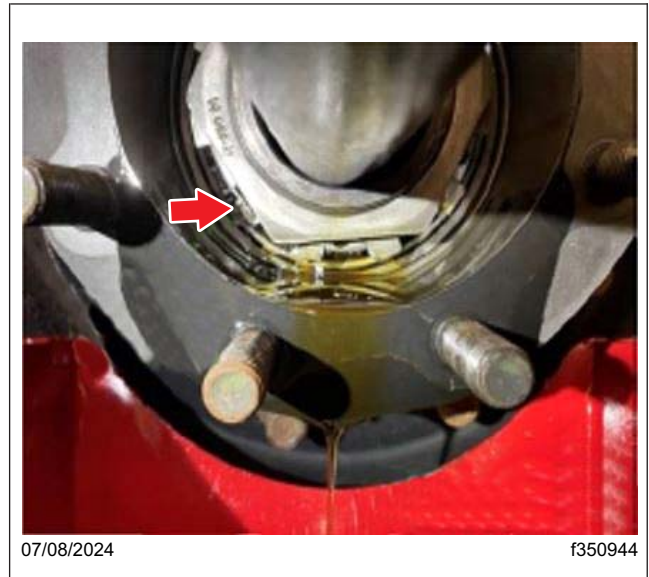
Fig. 3, Correct – Lock Tab Bent Over

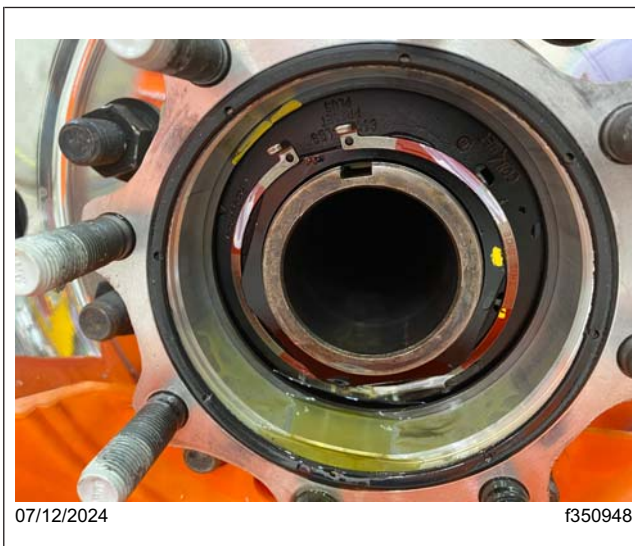
8. Inspect the locking snap ring to ensure the tab is fully inserted in the locking slots in the integrated spindle nut. **Figure 6** and **Fig. 7** shows an incorrectly installed and missing locking snap ring. **Figure 8** and **Fig. 9** shows correctly installed locking snap rings.

Fig. 6, Incorrectly Installed Locking Snap Ring

NO → Go to **Inspection and Replacement of the Hub** procedure (on page 11).

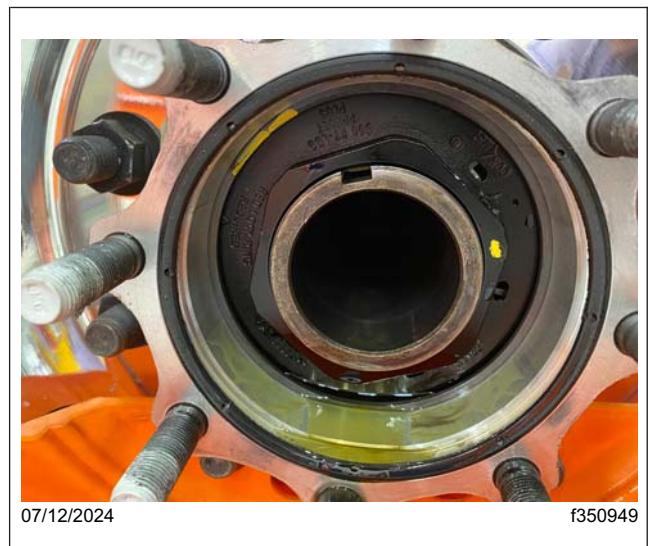
Fig. 7, Missing Locking Snap Ring

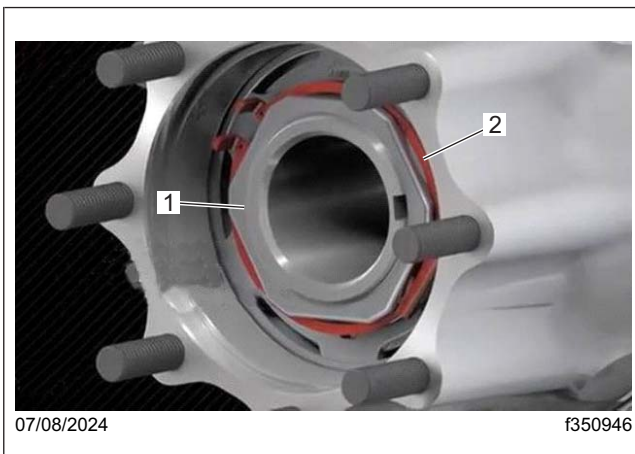
Fig. 8, Correctly Installed Locking Snap Ring

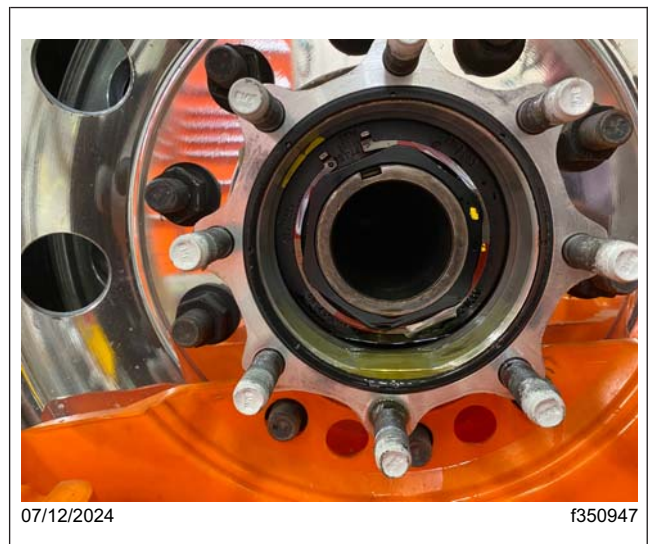
Fig. 9, Correctly Installed Locking Snap Ring
