# Recall Campaign Bulletin

Campaign No. 2024070005, July 2024

SUBJECT: **Model C-Class (206 platform)**  
**Model Year 2022 – 2023**

## **Check Pre-Fuse Box Wiring**

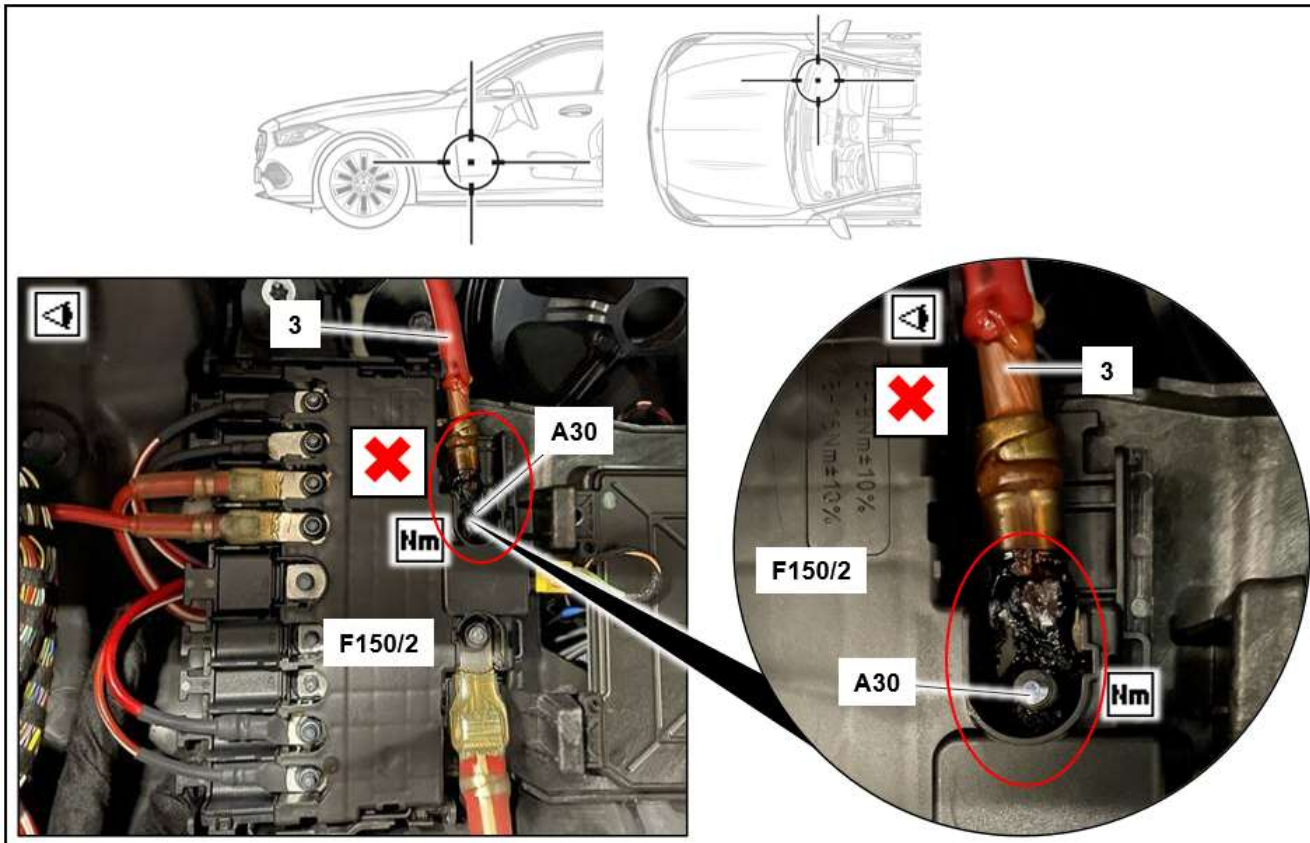
4. Inspect electrical connection (**Figure 2, A30**) of prefuse box **F150/2** visually for physical damage, such as arcing, scorch marks, melting and/or missing nut.
- If there is no damage to the electrical connection (**Figure 2, A30**), remove electric line (**Figure 2, 3**) at A30 connection and inspect the underside for damage. If there is no damage, re-install the electrical connection with nut (tightening torque of **16 Nm**) and **End Measure**.
  - If there is damage to the electrical connection (**Figure 2, A30**), carry out **Work Procedure**.  
**NOTE:** Capture photos of damaged electrical connection to be included in Warranty claim

Figure 2 (prefuse box with thermal damage, NOK)

**i** Replace damaged prefuse box (Figure 2, F150/2) and/or install missing nut on electrical connection (Figure 2, A30). For basic information, see AR54.15-P-1350WT.

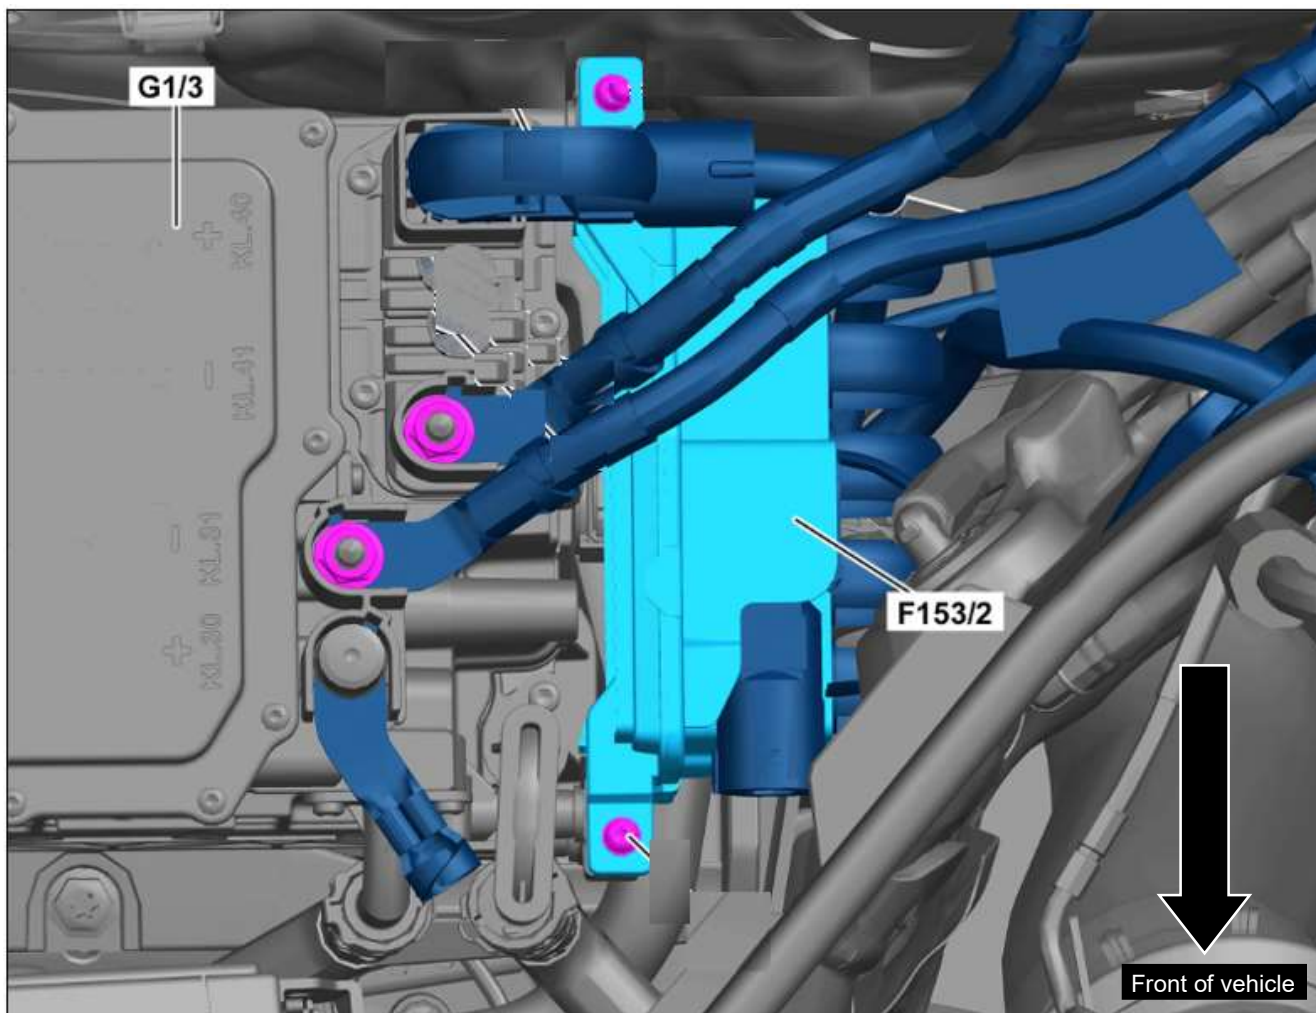
Figure 3 (passenger side of engine compartment)

To do this, disconnect 48 V on-board electrical system fuse box (Figure 3, F153/2) in engine compartment (see AR54.15-P-0011WT) and push the 48 V battery (Figure 3 and 4, G1/3) with coolant lines attached towards the front of the vehicle (Figure 4, direction of arrow).
