SERVICE PROCEDURE

24509
July, 2024

SUBJECT: SAFETY RECALL

Tie rod end ball studs on certain 2025 HV™ Series trucks built 05/02/2024 through 05/13/2024, LT® Series trucks built 04/30/2024 through 05/30/2024, MV™ Series trucks built 04/16/2024 through 06/04/2024, RH™ Series trucks built on 04/25/2024, and IC Bus® FE Chassis built 04/30/2024 through 05/03/2024 with Dana® Spicer® D-Series or E-Series steer axles.

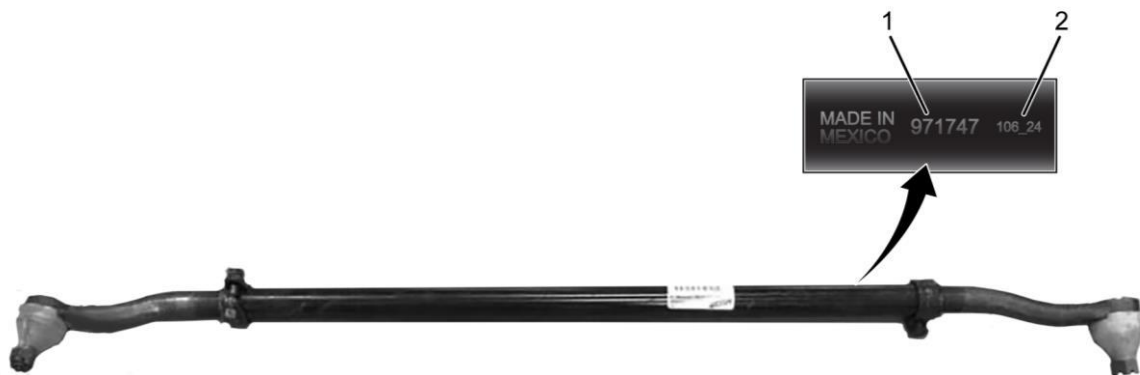
Figure 1. Julian Date Location

1. Part number
2. Julian date code

NOTE: Each tie rod cross tube has a Julian date code stamped as shown in Figure 1. If the date is not visible, remove paint from the area and cover the number with chalk for visibility.

4. On the front tie rod assembly, locate the part number (Figure 1, Item 1) and Julian date code (Figure 1, Item 2) stamped into tie rod cross tube.

5. Record the part number and Julian date code.
6. Refer to Table 3 for suspect part number / Julian date codes:
 - a. If component part number includes a suspect Julian date code, replace both tie rod ends. Proceed to Step 7.
 - b. If component part number does not include a suspect Julian date code, no further action is necessary. Proceed to Step 28.

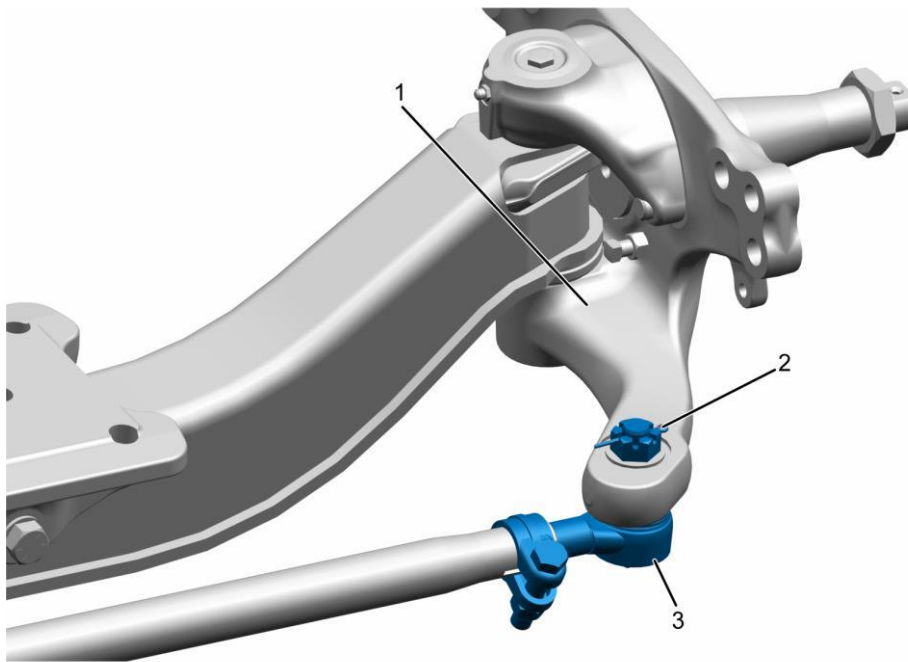
Figure 2. Tie Rod at Knuckle

1. Knuckle
2. Cotter pin and castle nut
3. Tie rod end

7. Turn front wheels to access tie rod end (Figure 2, Item 3).
8. Remove and discard the cotter pin and castle nut (Figure 2, Item 2).
9. Using appropriate tool, separate the tie rod end (Figure 2, Item 3) from knuckle (Figure 2, Item 1).

22. Using torque wrench, tighten castle nut to 120–160 lb-ft (163–217 N·m), ensuring cotter pin hole is properly aligned.
23. Install new cotter pin (Figure 2, Item 2) fully into castle nut / tie rod end. Bend back each prong of the cotter pin to secure.

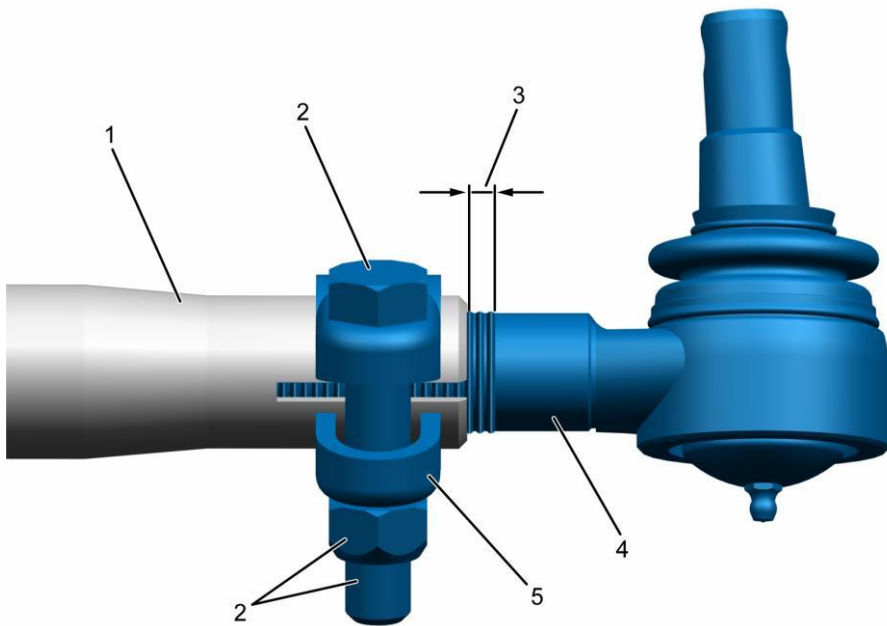
Figure 3. Tie Rod End

1. Cross tube
2. Bolt and nut assembly
3. Exposed threads
4. Tie rod end
5. Clamp

10. Count and record the number / length of exposed threads (Figure 3, Item 3) between the cross tube (Figure 3, Item 1) and tie rod end (Figure 3, Item 4) for reinstallation.
11. Loosen nut and bolt assembly (Figure 3, Item 2) on the clamp (Figure 3, Item 5). Discard nut.
12. Unscrew and remove tie rod end (Figure 3, Item 4) from cross tube (Figure 3, Item 1).
13. Destroy threads on suspect tie rod end and discard.
14. Position clamp (Figure 3, Item 5) over cross tube (Figure 3, Item 1). Loosely install bolt and new nut (Figure 3, Item 2) on clamp.
15. Install new tie rod end (Figure 3, Item 4) into cross tube (Figure 3, Item 1).

24. Using a torque wrench, tighten clamp bolt and nut assembly (Figure 3, Item 2) to 45–60 lb-ft (61–81 N·m).
25. Repeat Steps 7–24 for opposite side.

26. Perform toe-in adjustment procedure. Refer to appropriate technician manual for detailed instruction.
27. If tie rod clamp fasteners were loosened to adjust the toe-in measurement, then using a torque wrench, tighten clamp bolt and nut assembly (Figure 3, Item 2) to 45–60 lb-ft (61–81 N·m).
28. Remove wheel chocks.
