# ***SERVICE PROCEDURE***

24510  
July, 2024

**SUBJECT: SAFETY RECALL**  
**Tie rod end ball studs on certain 2025 IC Bus® CE school buses built 05/16/2024 through 5/28/2024 built with Dana® Spicer® D-Series or E-Series steer axles.**

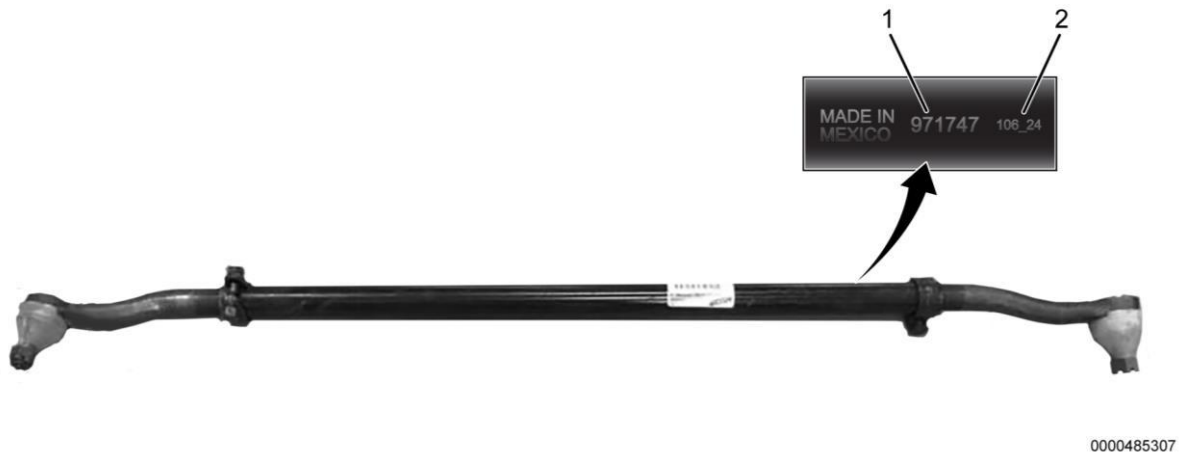
**Figure 1. Julian Date Location**

**NOTE:** Each tie rod cross tube has a Julian date code stamped as shown in Figure 1. If the date is not visible, remove paint from the area and cover the number with chalk for visibility.

4. On the front tie rod assembly, locate the part number (Figure 1, Item 1) and Julian date code (Figure 1, Item 2) stamped into tie rod cross tube.
5. Record the part number and Julian date code.

6. Refer to Table 3 for suspect part number / Julian date codes:
- a. If component part number includes a suspect Julian date code, replace both tie rod ends. Proceed to Step 7.
  - b. If component part number does not include a suspect Julian date code, no further action is necessary. Proceed to Step 28.

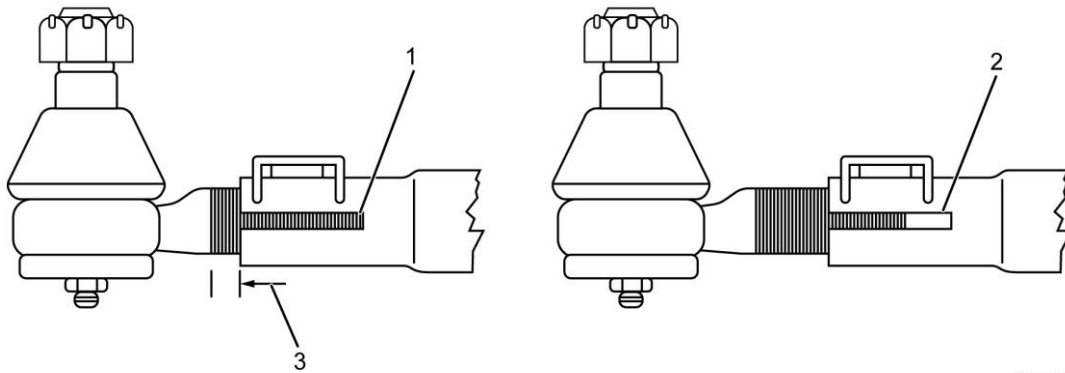
**Figure 4. Tie Rod End into Cross Tube**

**NOTE: Threaded portion of tie rod must be fully inserted into cross tube.**

16. Using cross tube split to inspect, ensure tie rod threads are fully inserted (Figure 4, Item 1). If any spacing between edge of cross tube and tie rod threads is visible (Figure 4, Item 2), the tie rod is NOT fully installed.
17. Using the prerecorded exposed threads (Figure 4, Item 3), ensure new tie rod end has the same number / length of exposed threads.
18. Ensure clamp (Figure 3, Item 5) is positioned over split located on cross tube.
19. Hand-tighten bolt and nut assembly (Figure 3, Item 2) on the clamp.
20. Position tie rod end (Figure 2, Item 3) into steering knuckle (Figure 2, Item 1).
21. Loosely install new castle nut (Figure 2, Item 2).
