September 2024  
F1006 AB  
NHTSA #24V-511

## Subject: ABA Brake Lamp Illumination

**Models Affected:** Specific model years 2023-2025 Freightliner Custom Chassis S2C, and S2RV 106 Cab and Chassis manufactured August 25, 2022 through February 8, 2024.

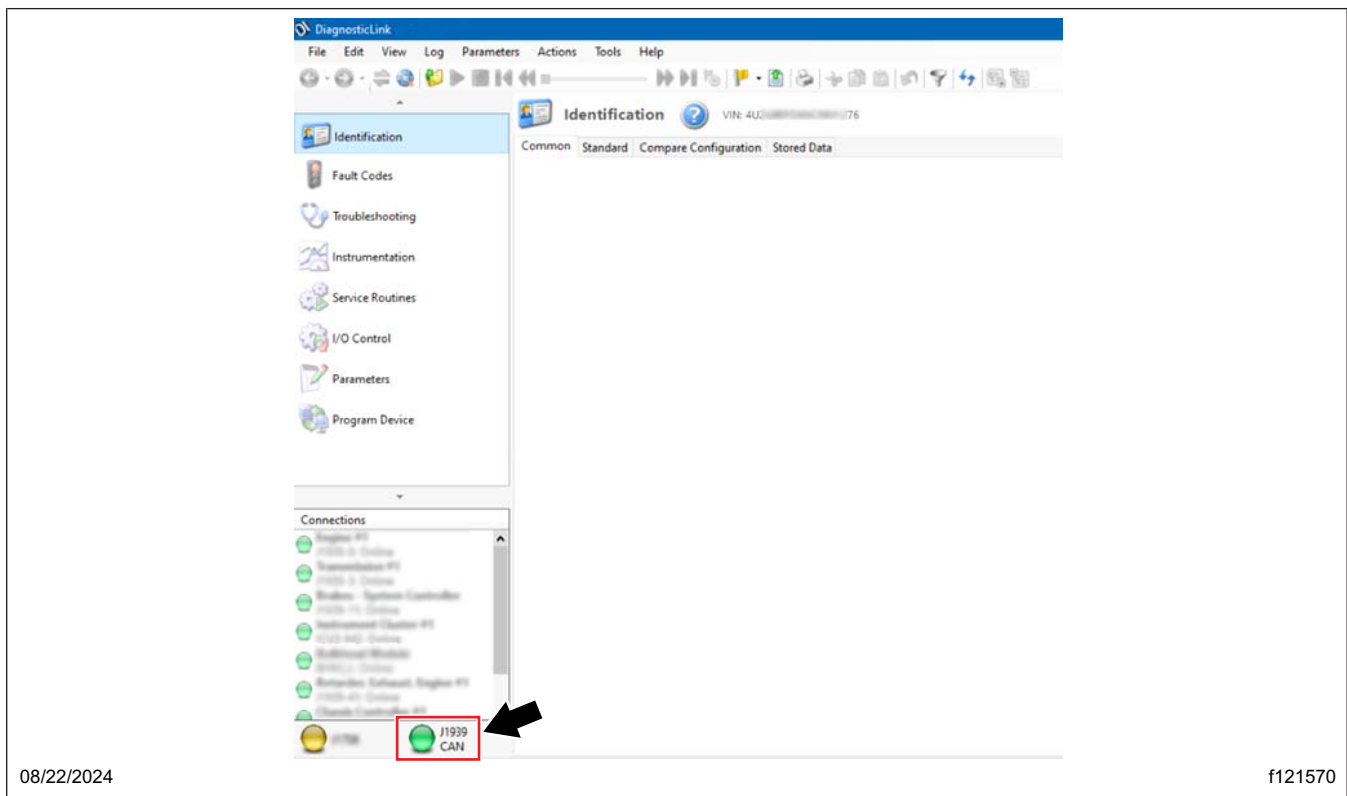
Fig. 1, J1939 Online

6. Turn the ignition key to the ON position.
7. Make sure the 'J1939' databus communicates with DiagnosticLink, and is visible in the 'Connections' panel at the bottom-left of the screen. See [Fig. 1](#).

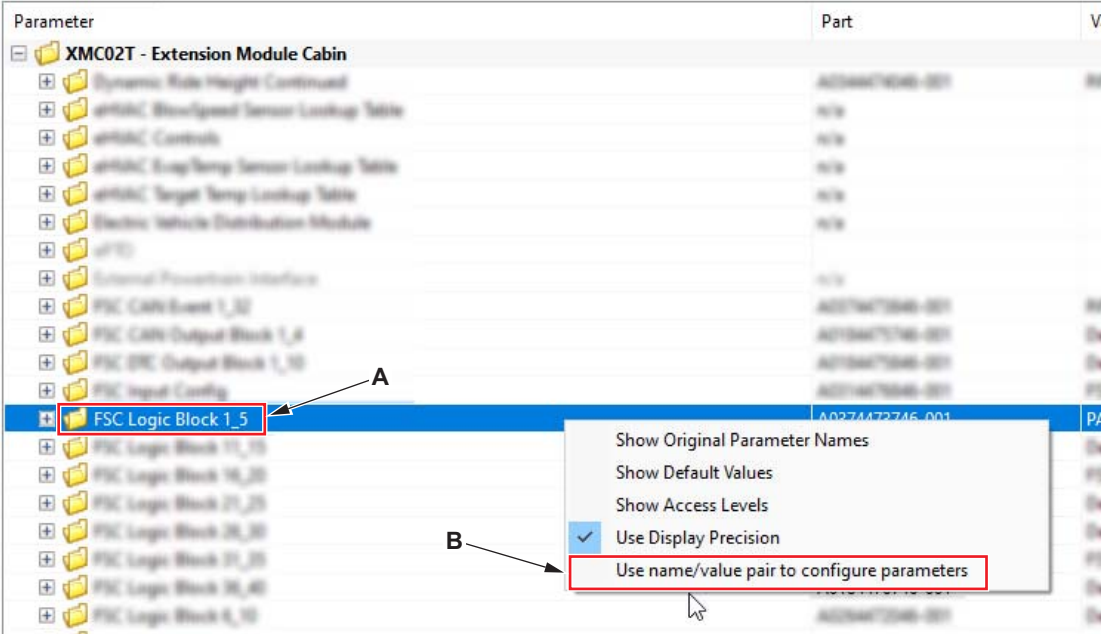
**Fig. 3, Making Sure the Option is Unchecked**

A. Right-click on any of the parameter sub-folders.  
B. Make sure the 'Use name/value pair to configure parameters' option is unchecked.

10. Right-click on any of the parameter sub-folders within the XMC02T folder, and make sure the 'Use name/value pair to configure parameters' option is unchecked. See [Fig. 3](#).

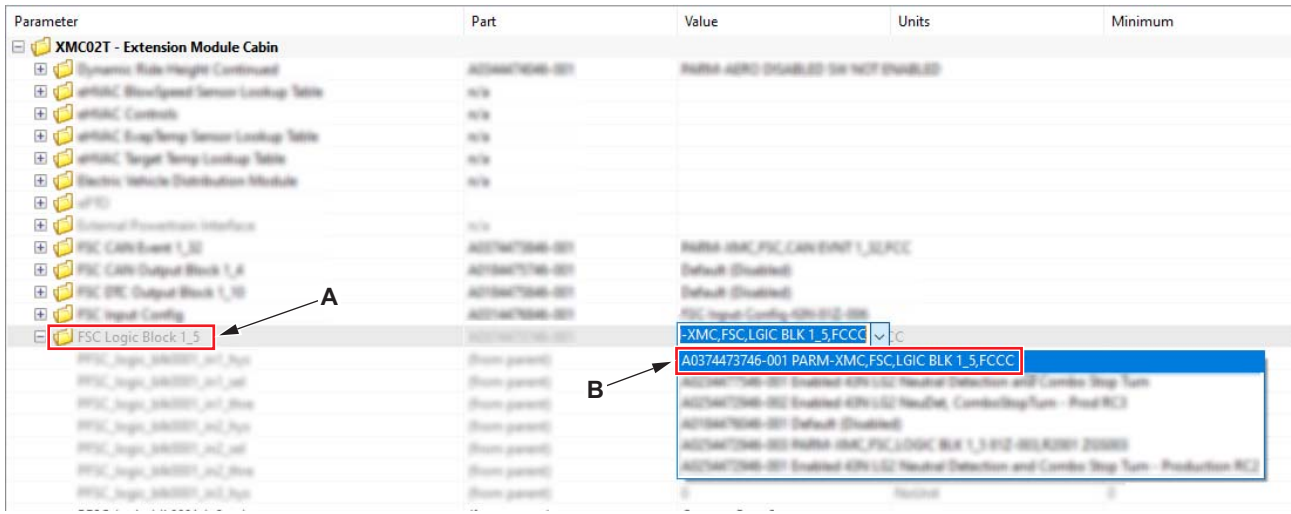
**Fig. 4, Setting the FSC Logic Block 1\_5 Parameter Value**

A. Select the 'FSC Logic Block 1\_5' parameter sub-folder.  
B. Set the parameter value to 'A0374473746-001 PARM-XMC,FSC,LGIC BLK 1\_5,FCCC.'

11. Select the 'FSC Logic Block 1\_5' parameter sub-folder, and set the parameter value to 'A0374473746-001 PARM-XMC,FSC,LGIC BLK 1\_5,FCCC.' See [Fig. 4](#).

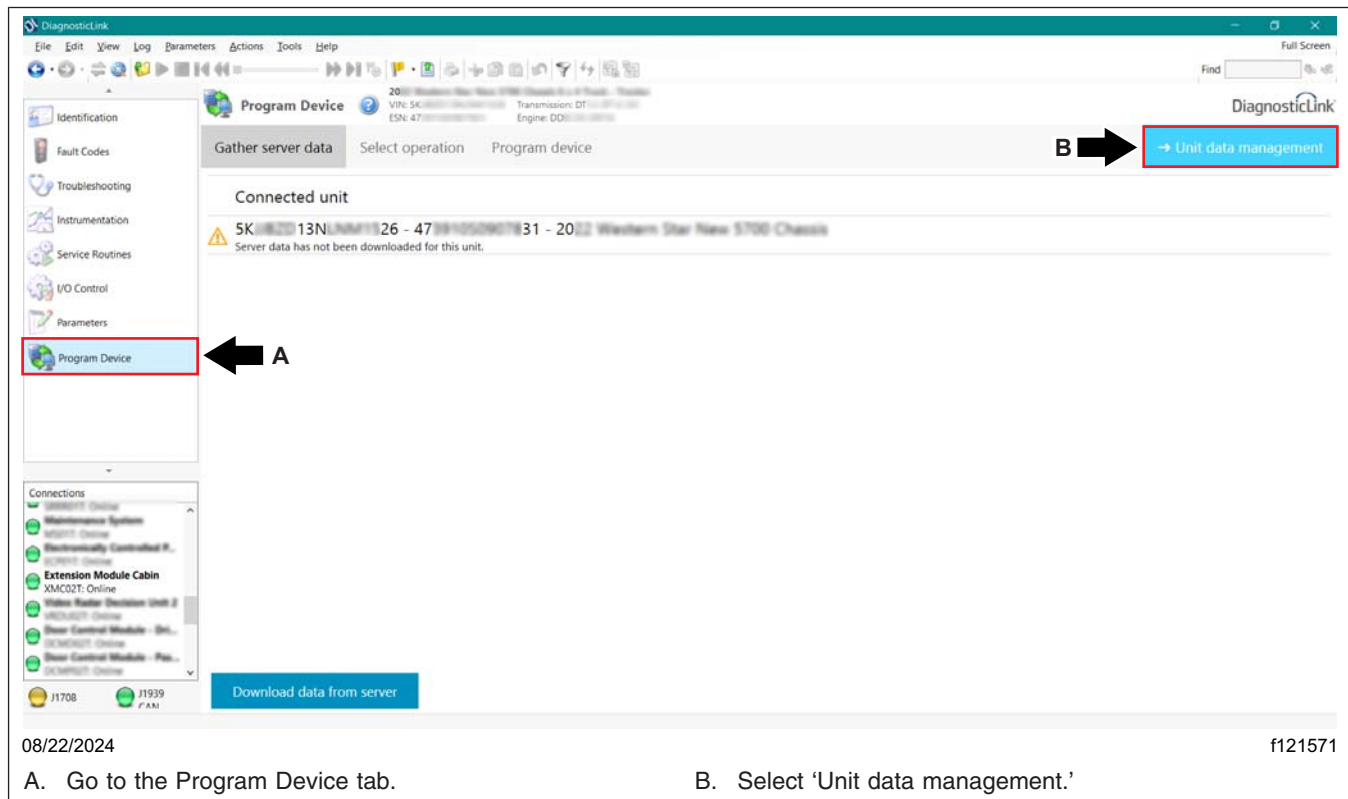
**Fig. 9, Selecting Unit Data Management**

A. Go to the Program Device tab. B. Select 'Unit data management.'

15. Once the parameter change is complete, go to the 'Program Device' tab. Select 'Unit data management' in the upper-right corner. See [Fig. 9](#).
