<p>TO: Mercedes-Benz Dealer Principals, General Managers, Sales Managers, Service Managers, Parts Managers</p>	<p>FROM: Anthony Washington, Senior Manager, Regulations and Certifications</p>
<p><b>Re: Launch Recall Campaign Notification</b> <b>Model: Sprinter</b> <b>Model Years: 2023-2024</b> <b>Replace Spring U-Bolts</b></p>	<p>DATE: August, 2024</p>

**IMPORTANT RECALL CAMPAIGN INFORMATION**

<b>Campaign No. :</b>	<b>Campaign Desc. :</b>	<b>Replace Spring U-Bolts</b>
<b>2024070014</b>	<b>VS3FEDERB</b>	
<p>This is to notify you of a <b>Recall Campaign</b> to Replace the Spring U-Bolts on approximately <b>1,214</b> MY 2023-2024 Sprinter Vans. The recall campaign will be visible on the <a href="http://www.safercar.gov">www.safercar.gov</a> website and may generate questions from customers. All affected VINs will be flagged as "<b>OPEN</b>" in VMI and cannot be sold until remedied.</p>		
<b>Background</b>		
<b>Issue</b>	<p>Mercedes-Benz AG ("MBAG"), the manufacturer of Mercedes-Benz Sprinter vehicles, has determined that on certain Sprinter (907 platform) vehicles, the material properties of the spring U-bolts might not meet current specifications. The rear axle spring U-bolts may no

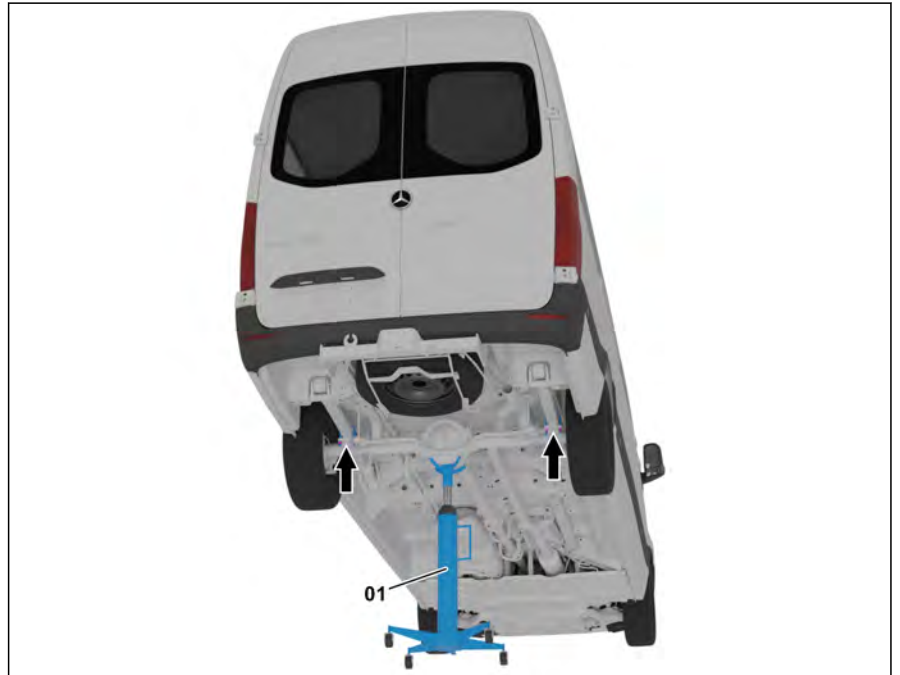
D32.20-A025-76

**Shown on vehicle except code CB2 (Air suspension comfort suspension)**

3	Support rear axle using telescopic jack (01).	⚠ Never exceed permissible working angle of installed propeller shaft when rear axle is released. Damage may occur otherwise.	
4	Replace rear spring U-bolt (1) on left side of vehicle.	<b>i</b> For this purpose, remove nuts (2). Dispose of spring U-bolt (1) and nuts (2) properly. <b>Nm</b> Nut, spring U-bolt for rear axle spring to rear axle	BA32.20-Z-1005-03KOA
5	Replace front spring U-bolt (1) on left side of vehicle.	<b>i</b> For this purpose, remove nuts (2). Dispose of spring U-bolt (1) and nuts (2) properly. <b>Nm</b> Nut, spring U-bolt for rear axle spring to rear axle	BA32.20-Z-1005-03KOA
6	Replace rear spring U-bolt (1) on right side of vehicle.	<b>i</b> For this purpose, remove nuts (2). Dispose of spring U-bolt (1) and nuts (2) properly. <b>Nm</b> Nut, spring U-bolt for rear axle spring to rear axle	BA32.20-Z-1005-03KOA
7	Replace front spring U-bolts (1) on right side of vehicle.	<b>i</b> For this purpose, remove nuts (2). Dispose of spring U-bolt (1) and nuts (2) properly. <b>Nm</b> Nut, spring U-bolt for rear axle spring to rear axle	BA32.20-Z-1005-03KOA

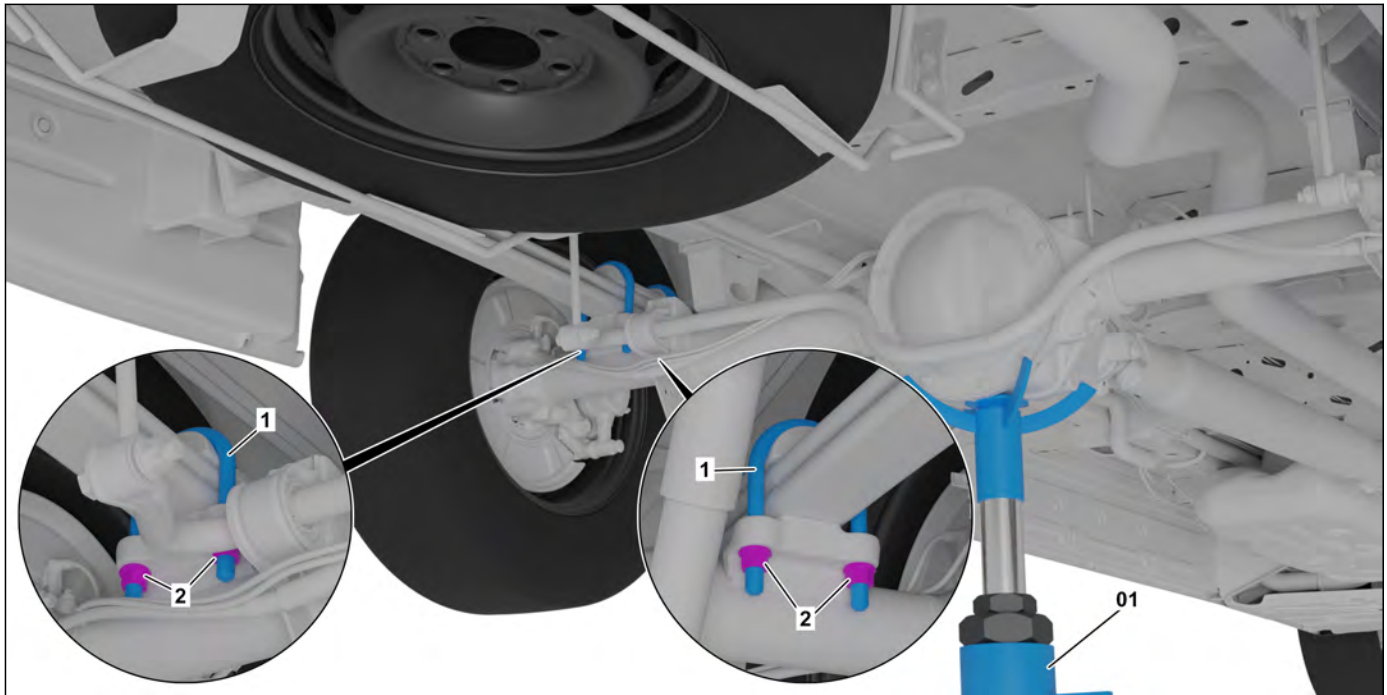
D32.20-A026-79

**Shown on left side of vehicle except code CB2 (Air suspension comfort suspension)**
