**TAXA LLC
Customer Service Department
428 Industrial Ln
Birmingham, AL 35211**

**TO: Taxa LLC Dealers
SUBJECT: NHTSA Recall: 24V-579**

NHTSA Recall # 24V579

Inspection & Repair Instructions

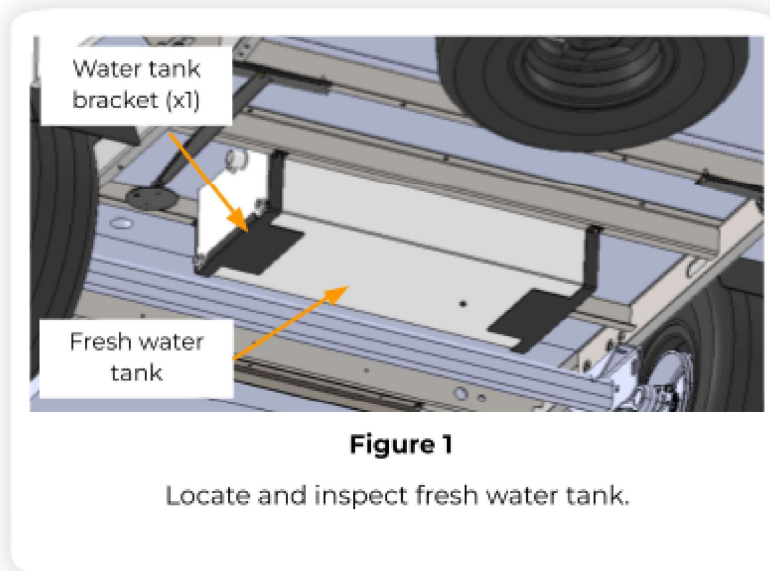
Locate the fresh water tank and inspect it. Refer to Figure 1.

- a. Is the water tank deformed or damaged in any way?
- b. Are all fittings and hose connections secure?

NOTE: If any damage is found, document the issue and provide photos to TAXA Outdoors. Contact TAXA Outdoors customer service for further instructions on repairing damaged water tanks. If no damage is present, proceed to the repair procedure.

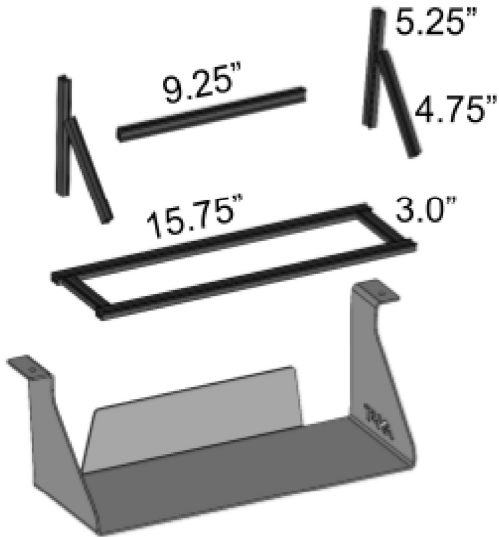
Figure 2

Cut and install gaskets to bracket.
The assembly is symmetrical.

Collect the gasket material and cut to the lengths shown in figure 2. Install them on the interior of the bracket. Match the placements shown in figure 3.

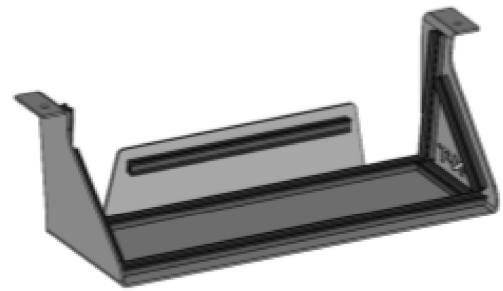
Figure 3

Replacement bracket (MT-04-1005) with
gaskets installed

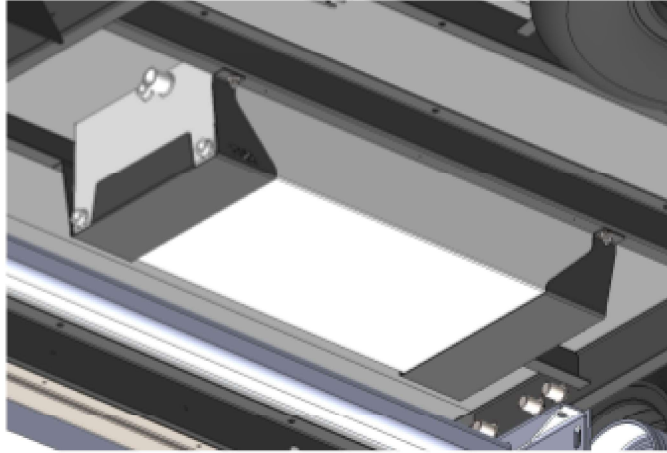
Figure 4

Replacement brackets installed.

Reinstall the brackets using the washers from step 5. Secure with the bolts (HW-H01) and locking nuts (HW-C13) provided by TAXA Outdoors. Ensure the bolt threads are facing downward. Torque the bolts to 63.3 in-lbs. See Figure 4.
