TO: Mercedes-Benz Dealer Principals, General Managers, Sales Managers, Service Managers, Parts Managers	FROM: Gregory Gunther, Senior Manager, Vehicle Compliance and Analysis, Engineering Services
RE: Recall Campaign Launch Notification Replace Integral Carrier MY24 GLC (254)	DATE: October 4, 2024

Campaign No. 2024090013, October 2024

SUBJECT: **Model GLC (254 platform)**
Model Year 2024

Replace Front Axle Integral Carrier

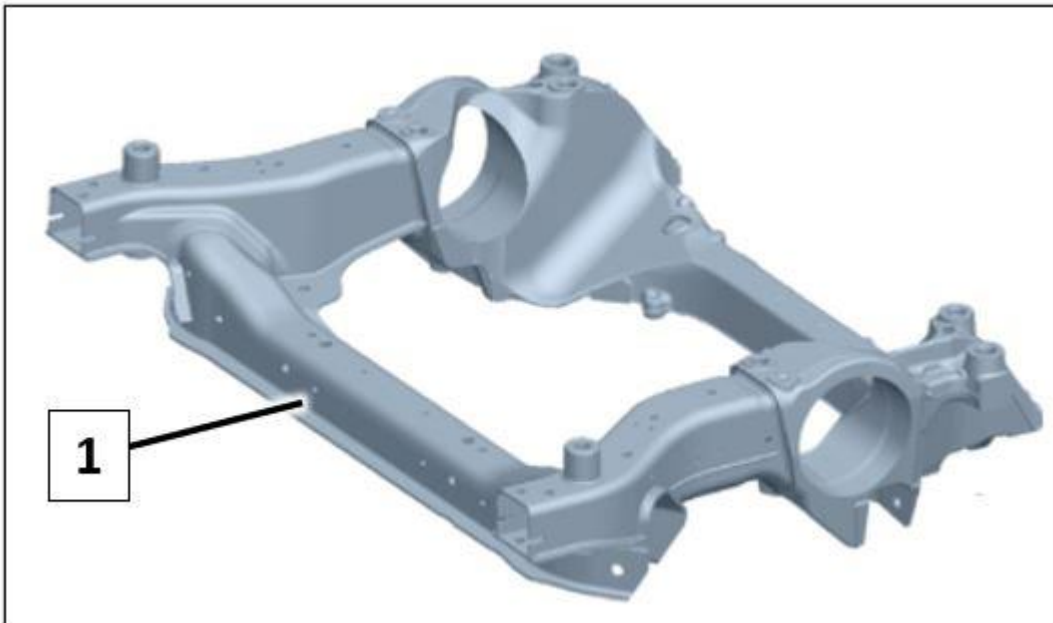
Figure 1

Mercedes-Benz AG, the manufacturer of Mercedes-Benz vehicles, has determined that on certain MY 2024 GLC (254 platform) vehicles, the integral carrier welds might not meet current production specifications. In this case, the durability of the integral carrier might be affected over the vehicle's lifetime. As a result, the controllability of the vehicle might be affected, which could increase the risk of a crash. An authorized Mercedes-Benz dealer will replace the integral carrier on the potentially affected vehicles.

1. Replace front axle integral carrier (Figure 1, 1).

**Do not** use a pneumatic wrench to **release or screw-in** threaded connections (self-tapping) on front axle carrier. There is a risk of thread damage!

Clean threads on body-in-white with compressed air and inspect for any thread damage/chipping.
 -

Before threading in new bolts, check that the front axle carrier is in contact with the body-in-white and the hole patterns are aligned properly!
 -

Thread new screws **by hand** with 3 to 4 thread turns before using a **manual** tool (e.g. ratchet) for tightening.
 -

Tighten screws with the specified torque outlined in WIS.
2. Perform wheel alignment measurement.
 -
