Recall Campaign Bulletin

Campaign No. 2024100006, October 2024

SUBJECT: **Model GLE (167 platform)**
Model Year 2021 – 2022

Check Acceleration Sensor Wiring Harness Routing

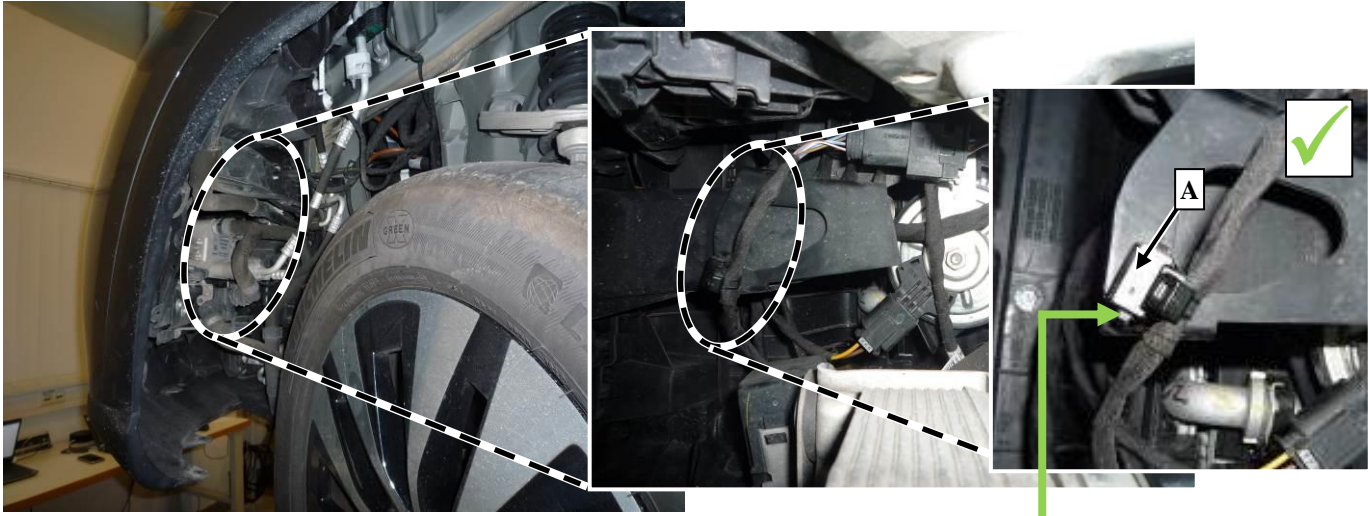
Figure 2

2. Check the wiring harness bracket (**Figure 2, A**) for the frontal acceleration sensor to ensure it is assembled correctly.

i Correct assembly position: (**Figure 2, A**).
 Incorrect assembly position: (**Figure 3, B**).

- a. Wiring harness bracket **correctly** (**Figure 2, A**) installed: **End measure**.
- b. Wiring harness bracket **incorrectly** (**Figure 3, B**) installed: Perform **Work Procedure**.

1. Remove front bumper.
i For basic data, see AR88.20-P-2000ME.
2. Fit wiring harness bracket correctly as shown (**Figure 2, A**).
i Wiring harness bracket is attached to the existing tab (**Figure 3, A**).
3. Assemble in reverse order.
