**USA
RECALL CAMPAIGN**

REF. NO. C24100088

**CHECK THE TORQUE OF THE SCREWS
(BOLTS) AND THE INSTALLATION OF THE
RELATIVE SUPPORT PLATES OF THE
DRIVESHAFTS (AXLE) TO THE GEARBOX**

MODEL YEARS 2023 - 2024

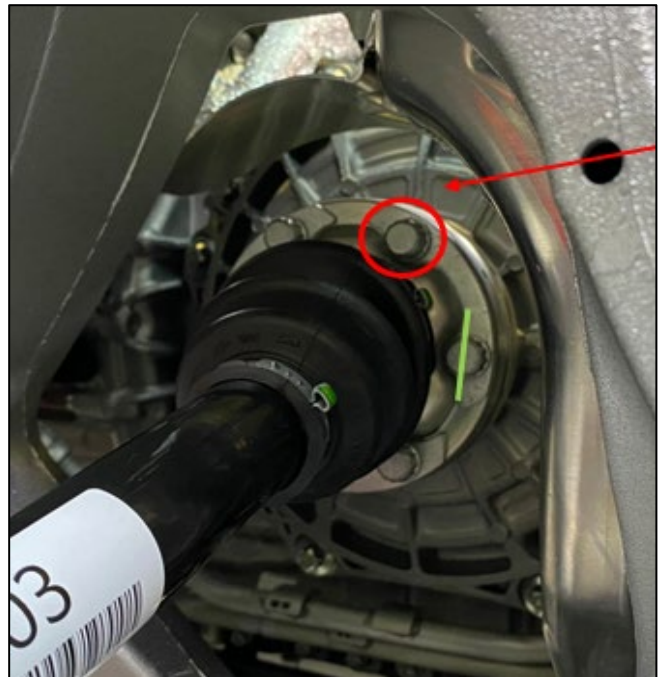
- Place the vehicle on a hoist with a locked gearbox (park lock active) to avoid rotation of the wheels.
- Mark with a marker (green in the picture) the alignment of the screws (bolts) on the plate to highlight a possible rotation after the check.
- After disassembling the wheels, check the screws (bolts) in the picture (6 on the right driveshaft (axle) and 6 on the left driveshaft (axle)) with a **torque wrench set to 30 Nm** (expected to see an immediate lock of the wrench).
- Check the screws (bolts) again with **the torque wrench set at 78 Nm** (expected to see a minimum rotation due to minimal torque loss).

- After the check, measure the rotation of the mark on the screw (bolt) compared to the plate.
- Please record the data from the torque wrench used and the date of the last torque wrench calibration.
- If during the first check at **30 Nm** a rotation of the screws (bolts) is noticed, **it means that the component has not been assembled correctly and may be damaged.**
In this case, open a ROL relating to the damaged components and wait for instructions.
- If during the second check at **78 Nm** a rotation of the screws (bolts) is noticed (**but no rotation at 30 Nm**), it is allowed to **tighten the screws (bolts) to the correct torque. No replacement is needed.**
