Remedy available for  
 2024 (WL) Jeep Grand Cherokee/Grand Cherokee L

**SAFETY RECALL**  
NORTH AMERICA  
**Speedometer Lag**

Reference: B8B / NHTSA 24V-872

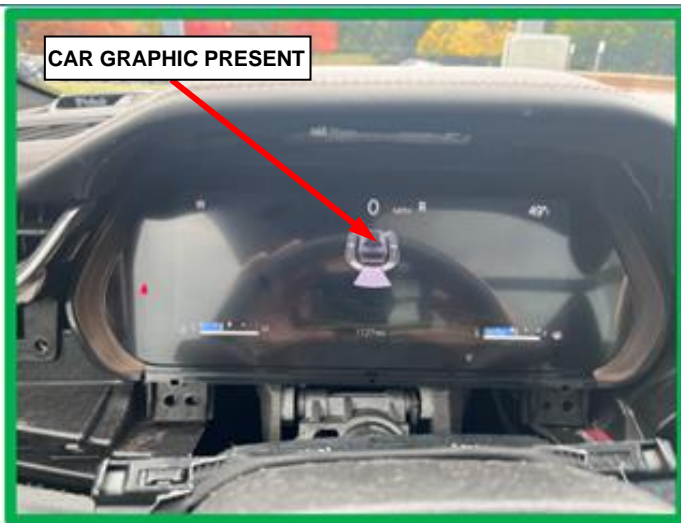
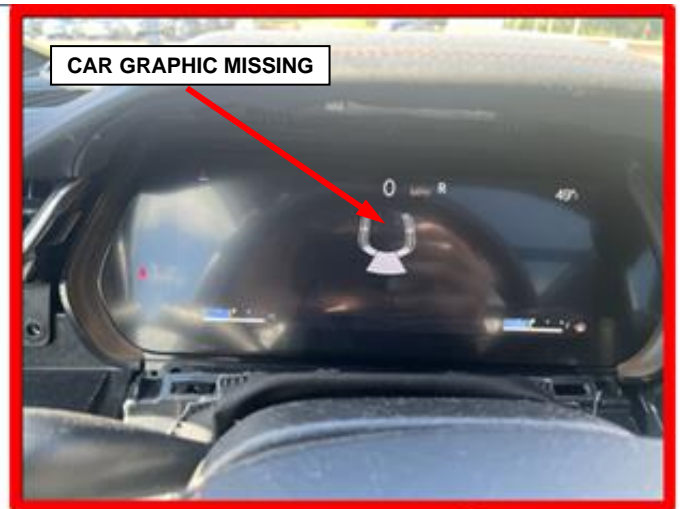
**Figure 1 – Check for Car Graphic (with sales code XH3)**

- 
4. Does the car graphic appear (Figure 1 and 2)?
    - YES>>> This vehicle has passed the inspection and may be returned to the customer. Claim the inspect LOP to close the recall.
    - NO >>> Proceed to Step 5.
  5. Reload the software to the IPC. See B, IPC Update.
