| RE: <b>Recall Campaign Launch Notification</b><br><b>Check Sliding Roof Bonding</b><br><b>MY 01-11 C-Class, CLK-Class, E-Class and CLS-Class (203, 209, 211, and 219 platform)</b> | DATE: December 20, 2024 |

Campaign No. 2024120002, December 2024

## **Check Sliding Roof Bonding**

Models: 203, 209, 211, 219 with code 413 (PANORAMIC SLIDING SUNROOF – GLASS ROOF)

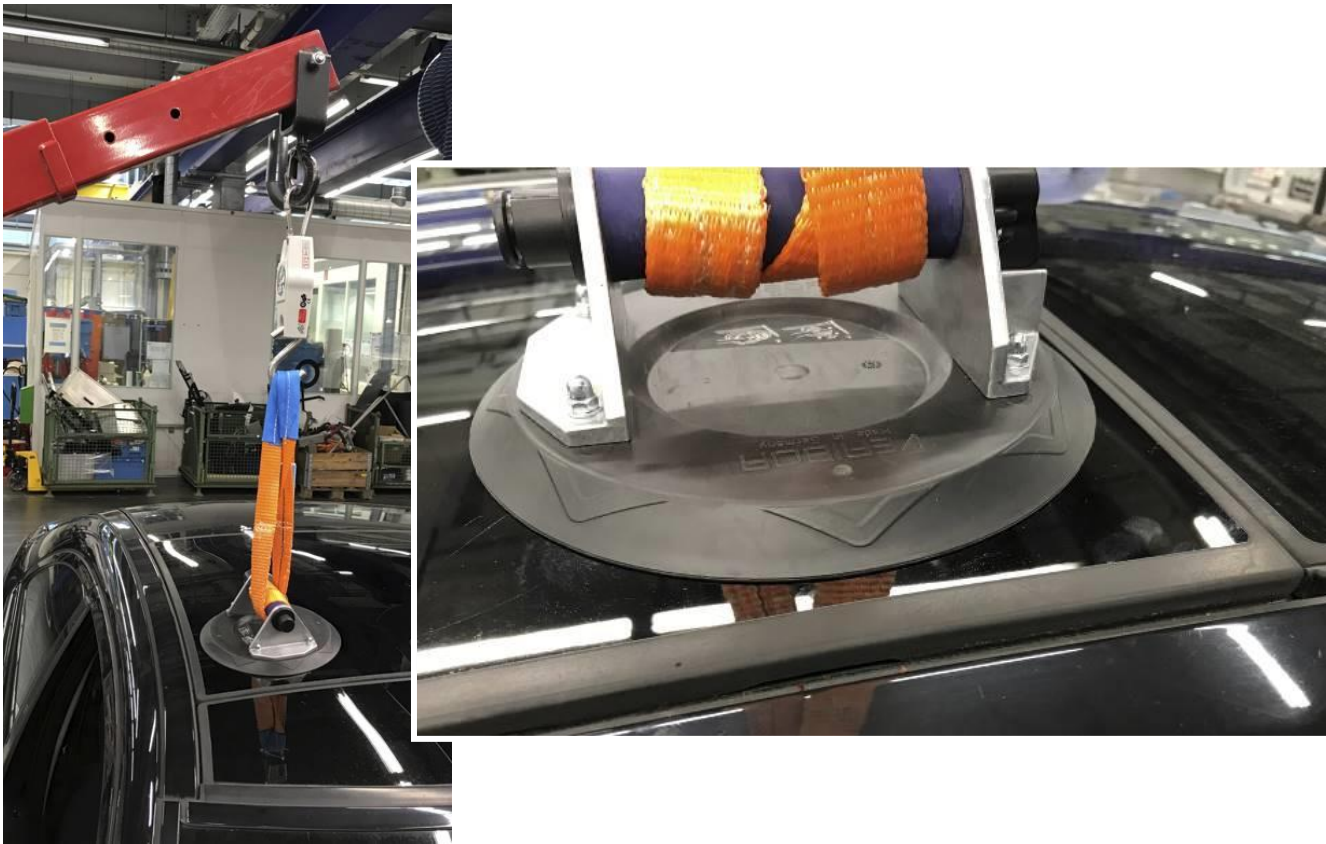
Figure 1

**i** Special caution must be exercised during the check.
  3. Position suction cup tool (**Figure 1**) and pull as **vertically** as possible (tolerance of  $\pm 10$  degrees) using lifting tool.

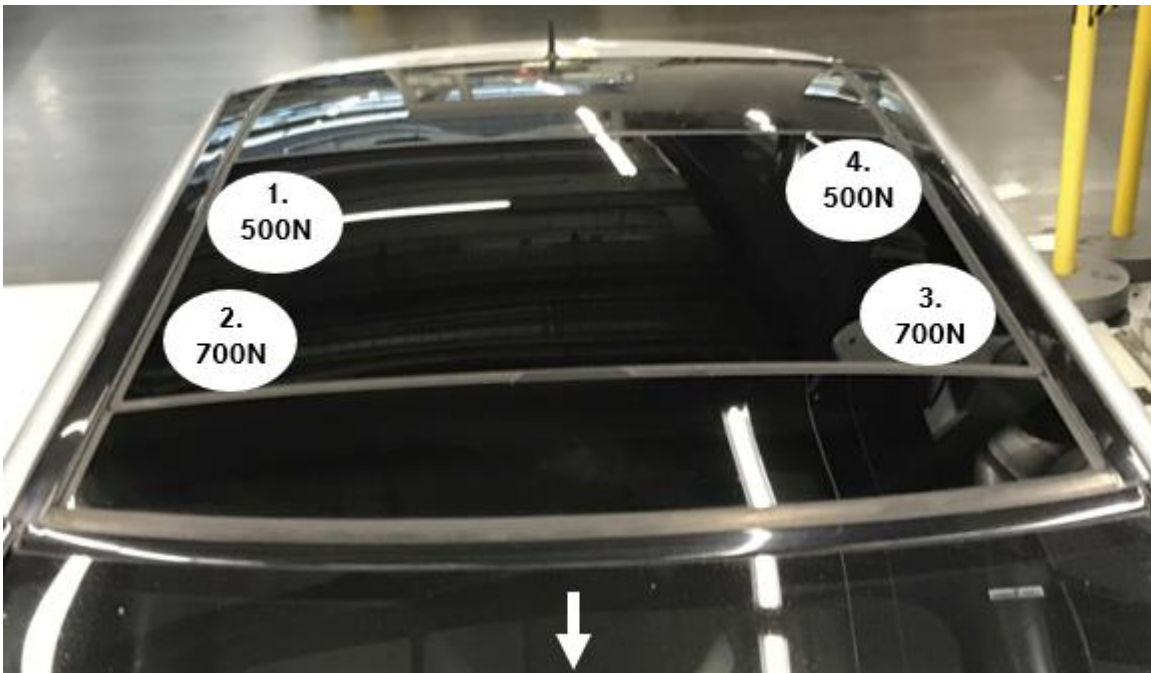
**i** The hanging scale **must always** be adjusted per the Operator's Manual before use.  
Specified force **500N/700N (Figure 2)**.

**i** Position suction cup tool at 4 positions in the sequence **1, 2, 3, 4: (Figure 2)**.

Figure 2 (test sequence 1, 2, 3, 4 – arrow indicates front of vehicle)

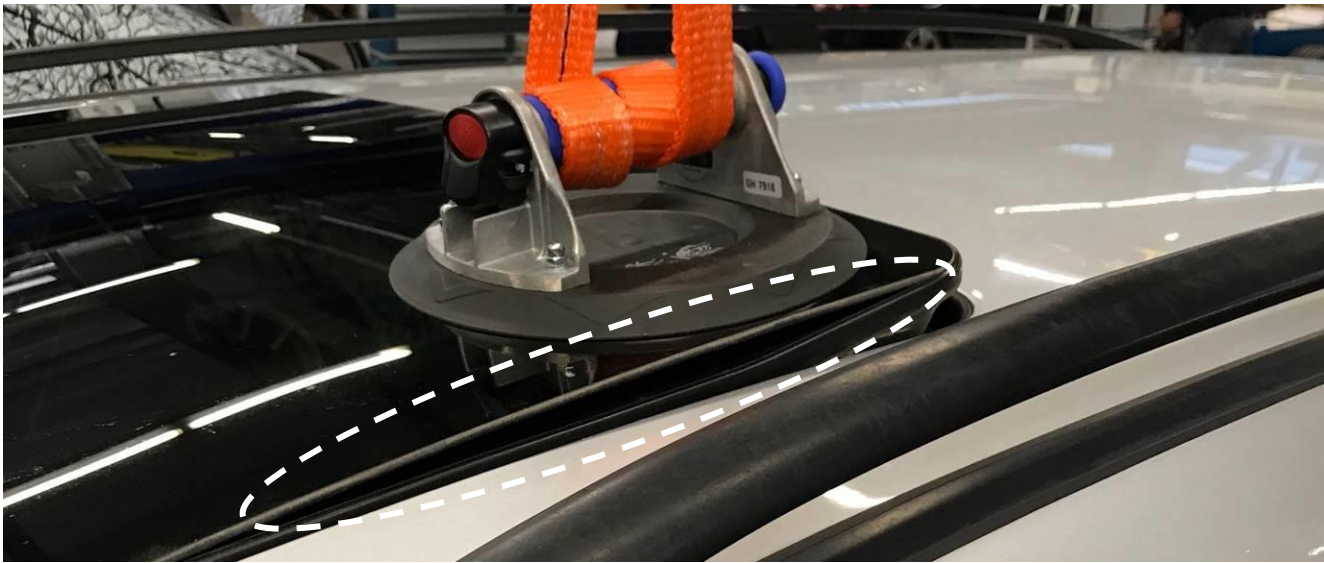
**i** If the panoramic sliding sunroof panel is detached from the padding of the sliding sunroof/tilting roof frame at one of the test points (**Figure 3**), the sliding sunroof panel must be replaced.

Figure 3, not OK (shown on a sliding sunroof/tilting roof)

1. Replace panoramic sliding sunroof panel (AR77.21-P-0500PB).
