TO: Mercedes-Benz Dealer Principals, General Managers, Sales Managers, Service Managers, Parts Managers	FROM: Gregory Gunther, Senior Manager, Vehicle Compliance and Analysis, Engineering Services
RE: <b>Recall Campaign Launch Notification</b> <b>Check Sliding Roof Bonding</b> <b>MY 01-11 C-Class, CLK-Class, E-Class and CLS-Class (203, 209, 211, and 219 platform)</b>	DATE: December 20, 2024

Campaign No. 2024120001, December 2024

SUBJECT: **Model C-Class, CLK, E-Class, and CLS (203, 209, 211, and 219 platform)  
Model Year 2001 – 2011**

## **Check Sliding Roof Bonding**

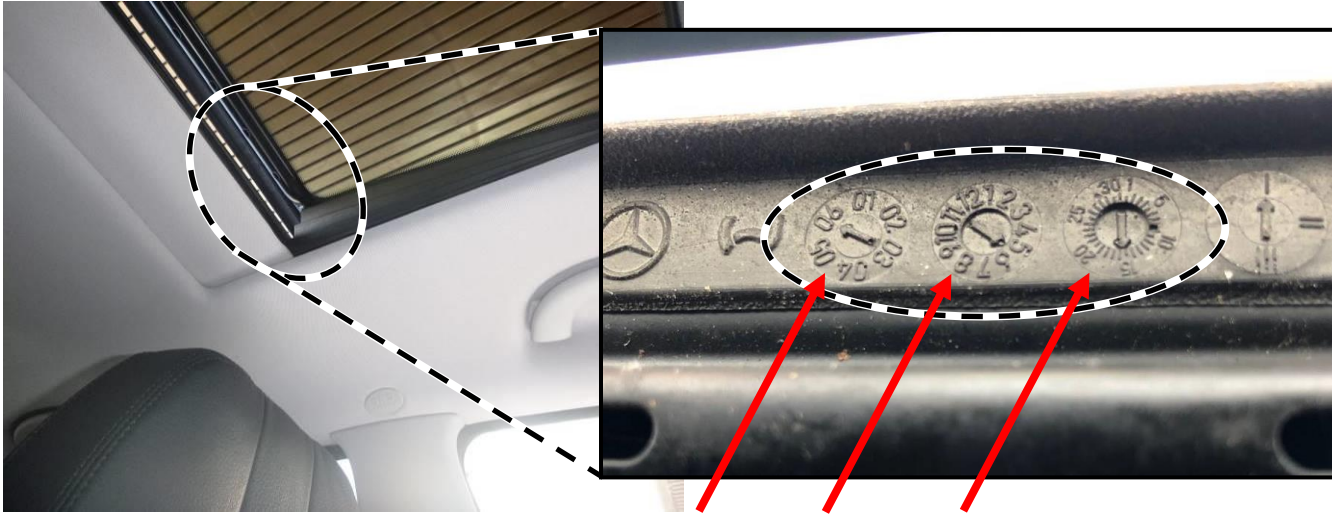
1. Move sliding sunroof to tilt position and check production date (**Figure 1**).

**i** The production date **must** be on or after 11/25/2005 or on or before 10/31/2007.

**i** If the production date is **not** at the location shown (**Figure 1**), the vehicle is **not** affected.

**Figure 1** (The production date in the sample picture is (06<sup>th</sup> year / 5<sup>th</sup> month / 15<sup>th</sup> day); 05/15/2006)

- a. Production date on or between **11/25/2005** and **10/31/2007**: Perform **Check/Test Procedure B**.
- b. Production date **not** on or between **11/25/2005** and **10/31/2007**: **End measure**.
- c. **No** production date present at location shown (**Figure 1**): **End measure**.

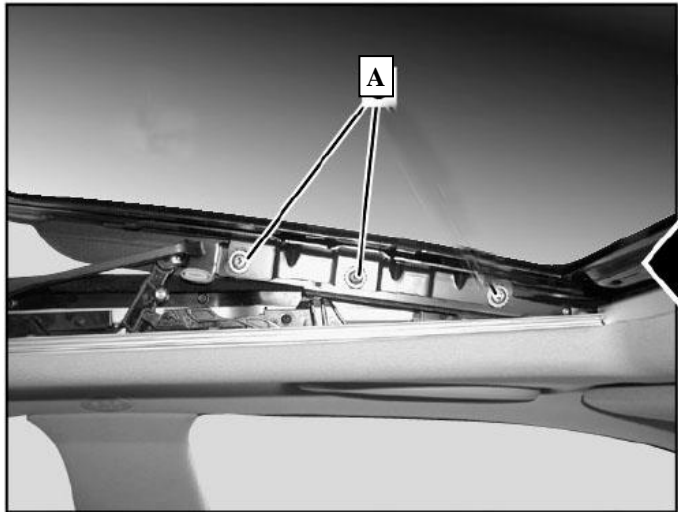
**Figure 2**

**i** If the sliding sunroof is **not** functioning, loosen the two rear sliding sunroof panel screws (**Figure 2, A**), lift the sliding sunroof manually and then read off the production date.

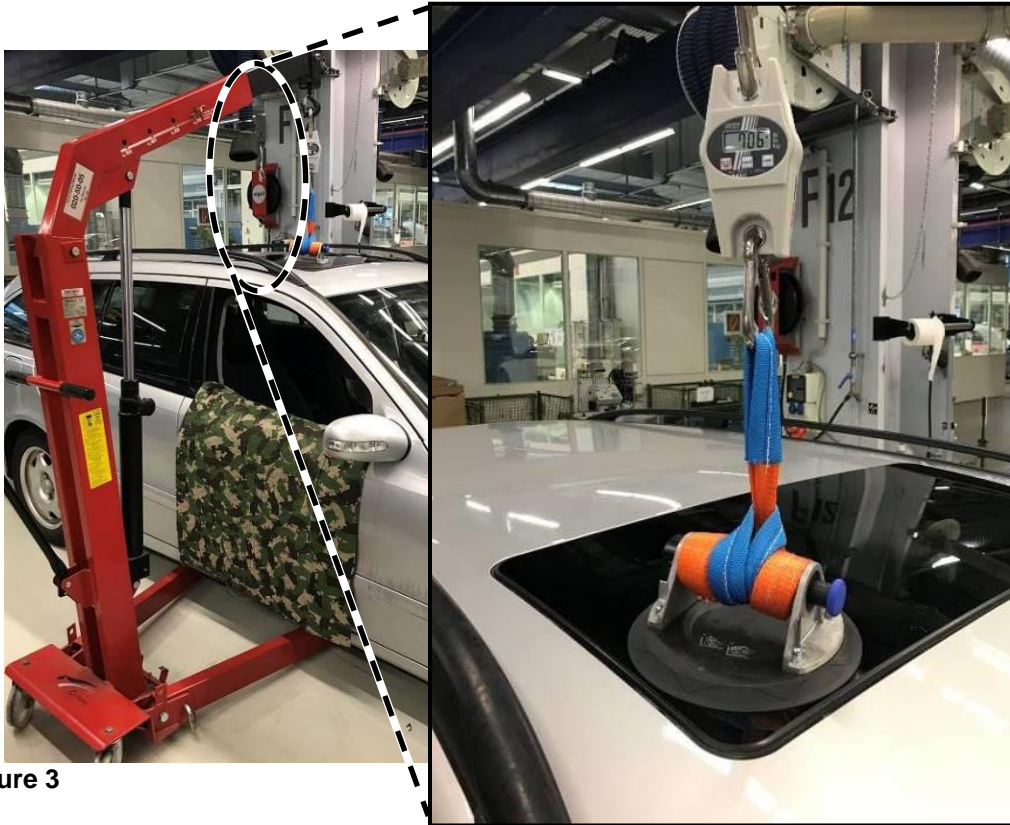
Figure 3

**i** Special caution must be exercised during the check.
  3. Position suction cup tool (**Figure 3**) and pull as **vertically** as possible (tolerance of  $\pm 10$  degrees) using lifting tool.

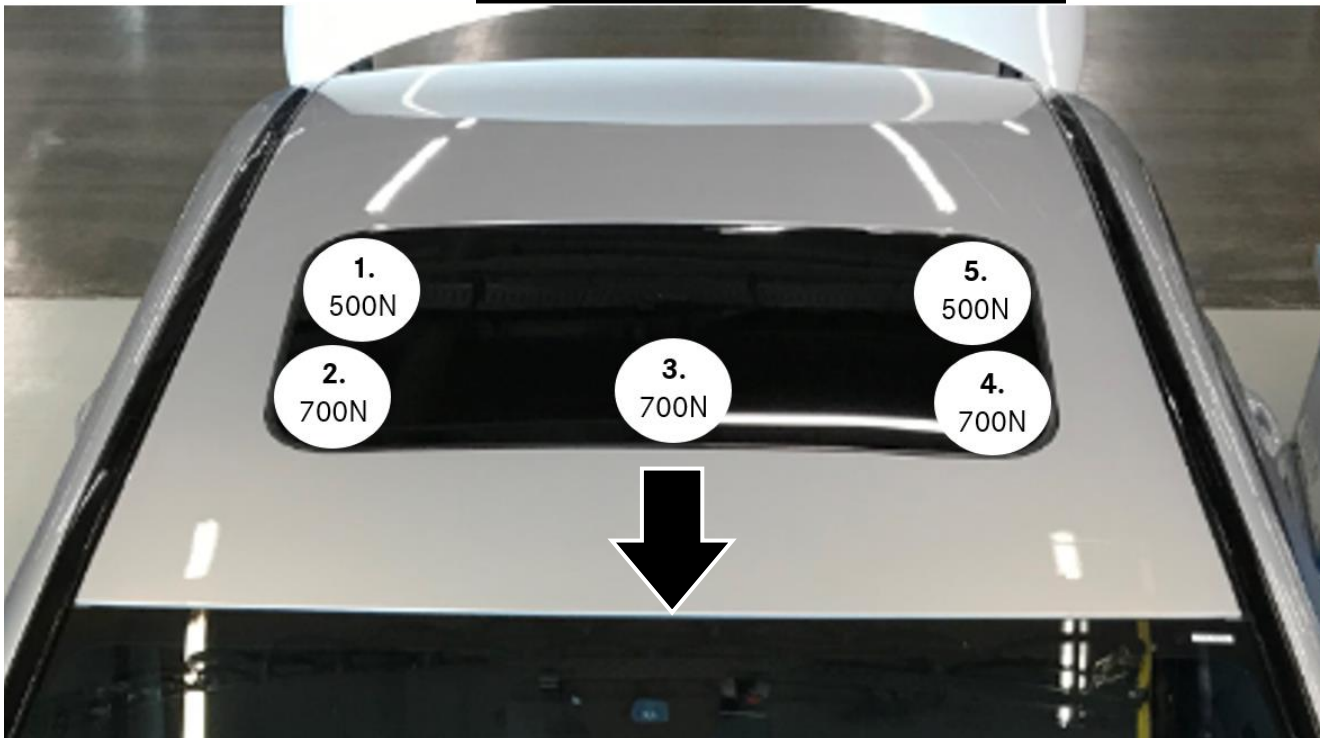
**i** The hanging scale **must always** be adjusted per the Operator's Manual before use.  
**i** Specified force **500N/700N (Figure 4)**.  
**NOTE: Do not convert the specified force!** This **must** be measured in Newtons (N) or there is potential for damage.

**i** Position suction cup tool at 5 positions in the sequence **1, 2, 3, 4, 5: (Figure 4)**.  
**i** The specified force must be monitored during the first minute and adjusted if necessary (tolerance  $\pm 10$  N). The specified force must not be exceeded. Pull as vertically as possible (tolerance  $\pm 10$  degrees) with the specified force for each location. There **must not** be a person inside the vehicle during the check, and the vehicle **must not** be touched when possible.

Figure 4 (test sequence 1, 2, 3, 4, 5 – arrow indicates front of vehicle)

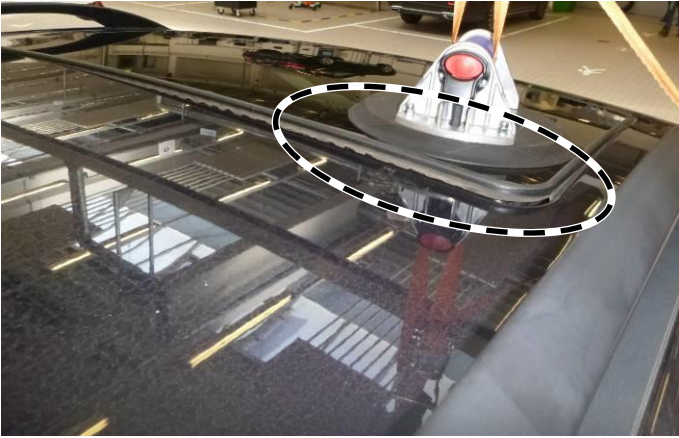
**i** The sliding sunroof panel is lifted out of the roof frame noticeably at the rear test positions 1 and 5 (**Figure 5**).

**Figure 5** (Sliding panel is lifted out of the frame at rear test position 1 and 5 – OK)

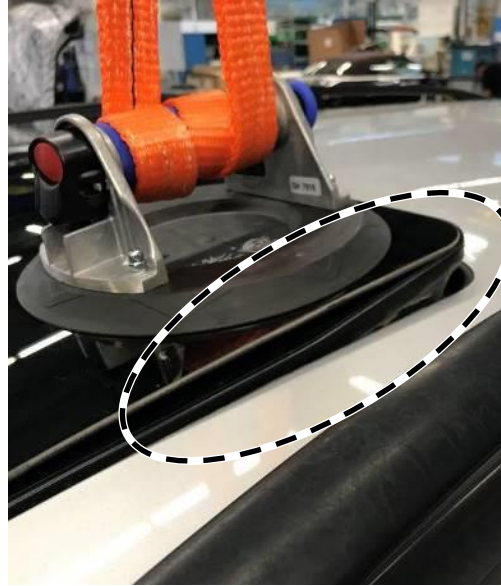
**i** If the sliding sunroof panel detaches from the padding of the tilting/sliding sunroof frame at one of the test positions (see example **Figure 6**), the sliding sunroof panel must be replaced.

**Figure 6** (*not* OK)

- a. If the sliding roof panel detaches from the padding: Carry out **Work Procedure**.
- b. If the sliding roof panel does **not** detach from the padding: **End measure**.

1. Replace sliding sunroof.

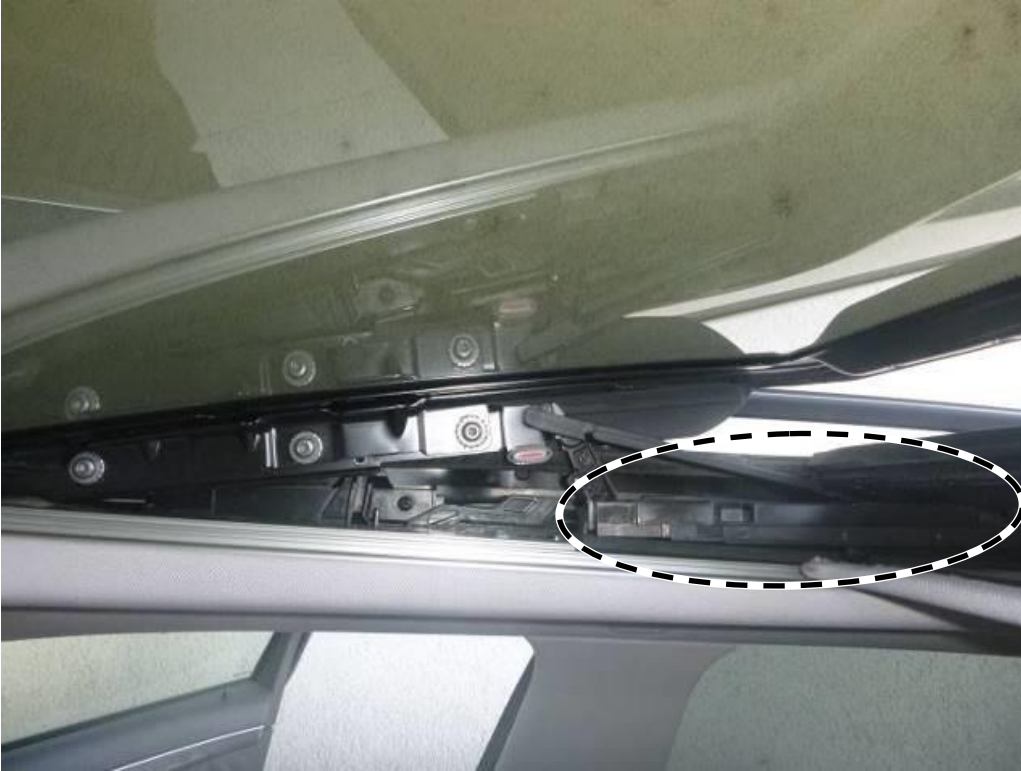
**Figure 7**

**i** The accordion boot **does not need to be removed** completely. It is sufficient to slide it back (**Figure 7**).
