| RE: <b>Recall Campaign Launch Notification</b><br><b>Check Sliding Roof Bonding</b><br><b>MY 01-11 C-Class, CLK-Class, E-Class and CLS-Class (203, 209, 211, and 219 platform)</b> | DATE: December 20, 2024 |

# Recall Campaign Bulletin

Campaign No. 2024120003, December 2024

## **Check Sliding Roof Bonding**

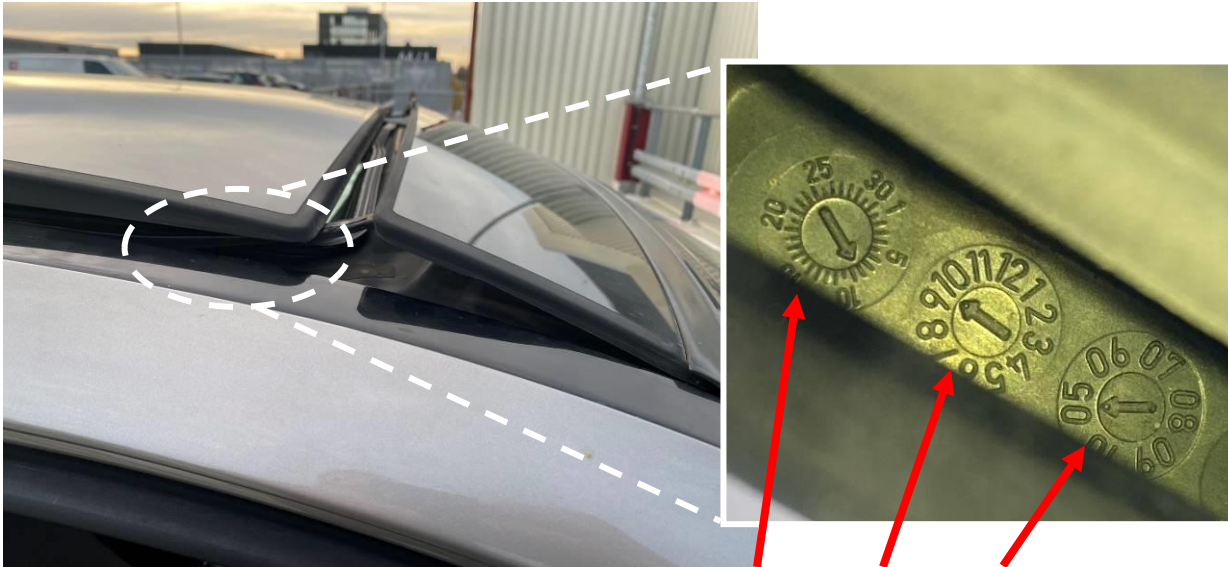
1. **Open** panoramic sliding sunroof **approx. 3 cm** and check manufacturing date (**Figure 1**).

**Figure 1** (The manufacturing date in the sample picture is (8<sup>th</sup> day / 10<sup>th</sup> month / 05<sup>th</sup> year) 10/08/2005)

- a. Manufacturing date is **on or after 06/30/2005**: Carry out **Check/Test Procedure B**.
- b. Manufacturing date is **on or before 06/29/2005**: **End measure**.

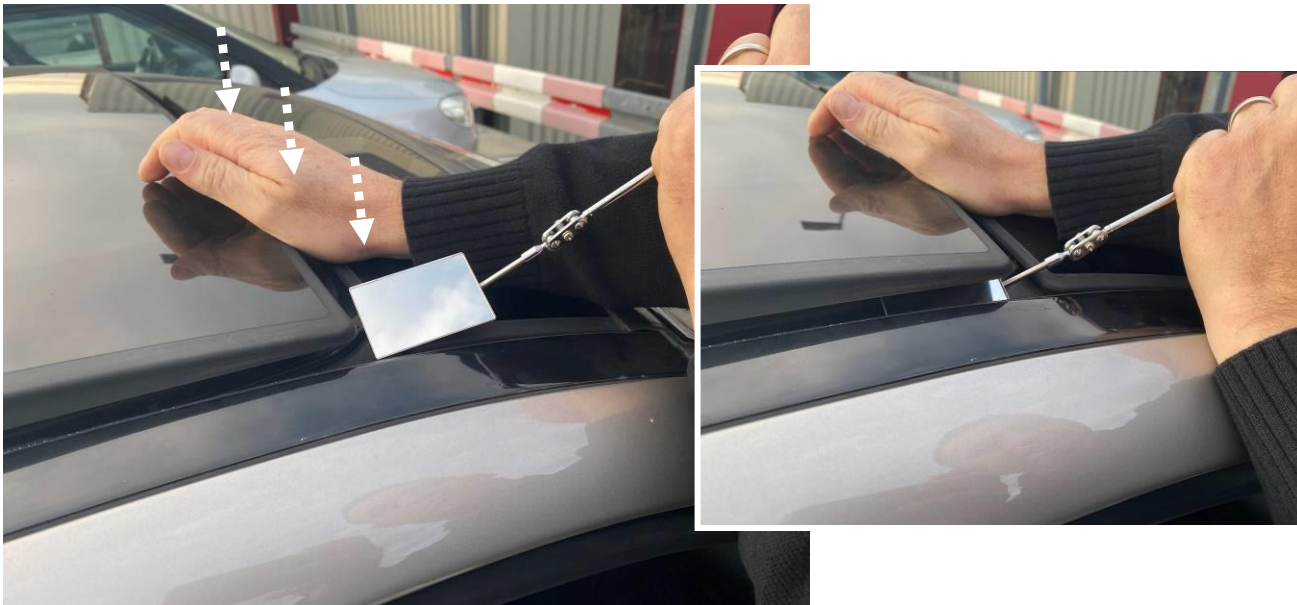
**Figure 2**

- i** Carry out check with a mirror as shown in Figure 2.
- i** To position the mirror, the wind deflector must be pushed downward by hand.
- i** Vehicles with a registration date that does **not** match with the manufacturing date of the panoramic sliding sunroof can also be affected.

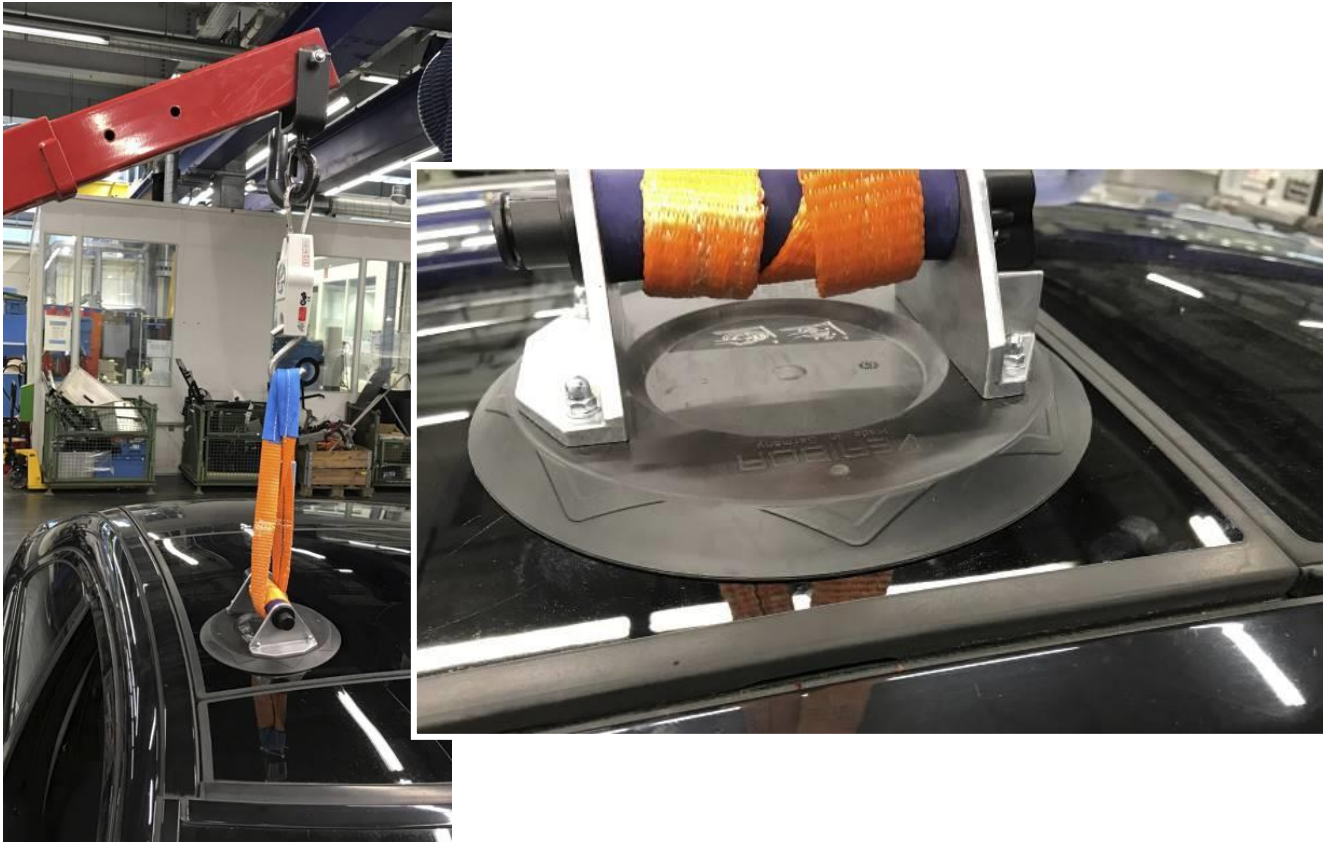
**Figure 3**

**i** Special caution must be exercised during the check.
  3. Position suction cup tool (**Figure 3**) and pull as **vertically** as possible (tolerance of  $\pm 10$  degrees) using lifting tool.
