TO: Mercedes-Benz Dealer Principals, General Managers, Sales Managers, Service Managers, Parts Managers	FROM: Gregory Gunther, Senior Manager, Vehicle Compliance and Analysis, Engineering Services
RE: Recall Campaign Launch Notification Replace Mounting Brackets in Roof MY23 EQS (296 platform)	DATE: January 24, 2025

Campaign No. 2025010005, January 2025

SUBJECT: **Model EQS (296 platform)**
Model Year 2023

Replace Mounting Brackets in Roof

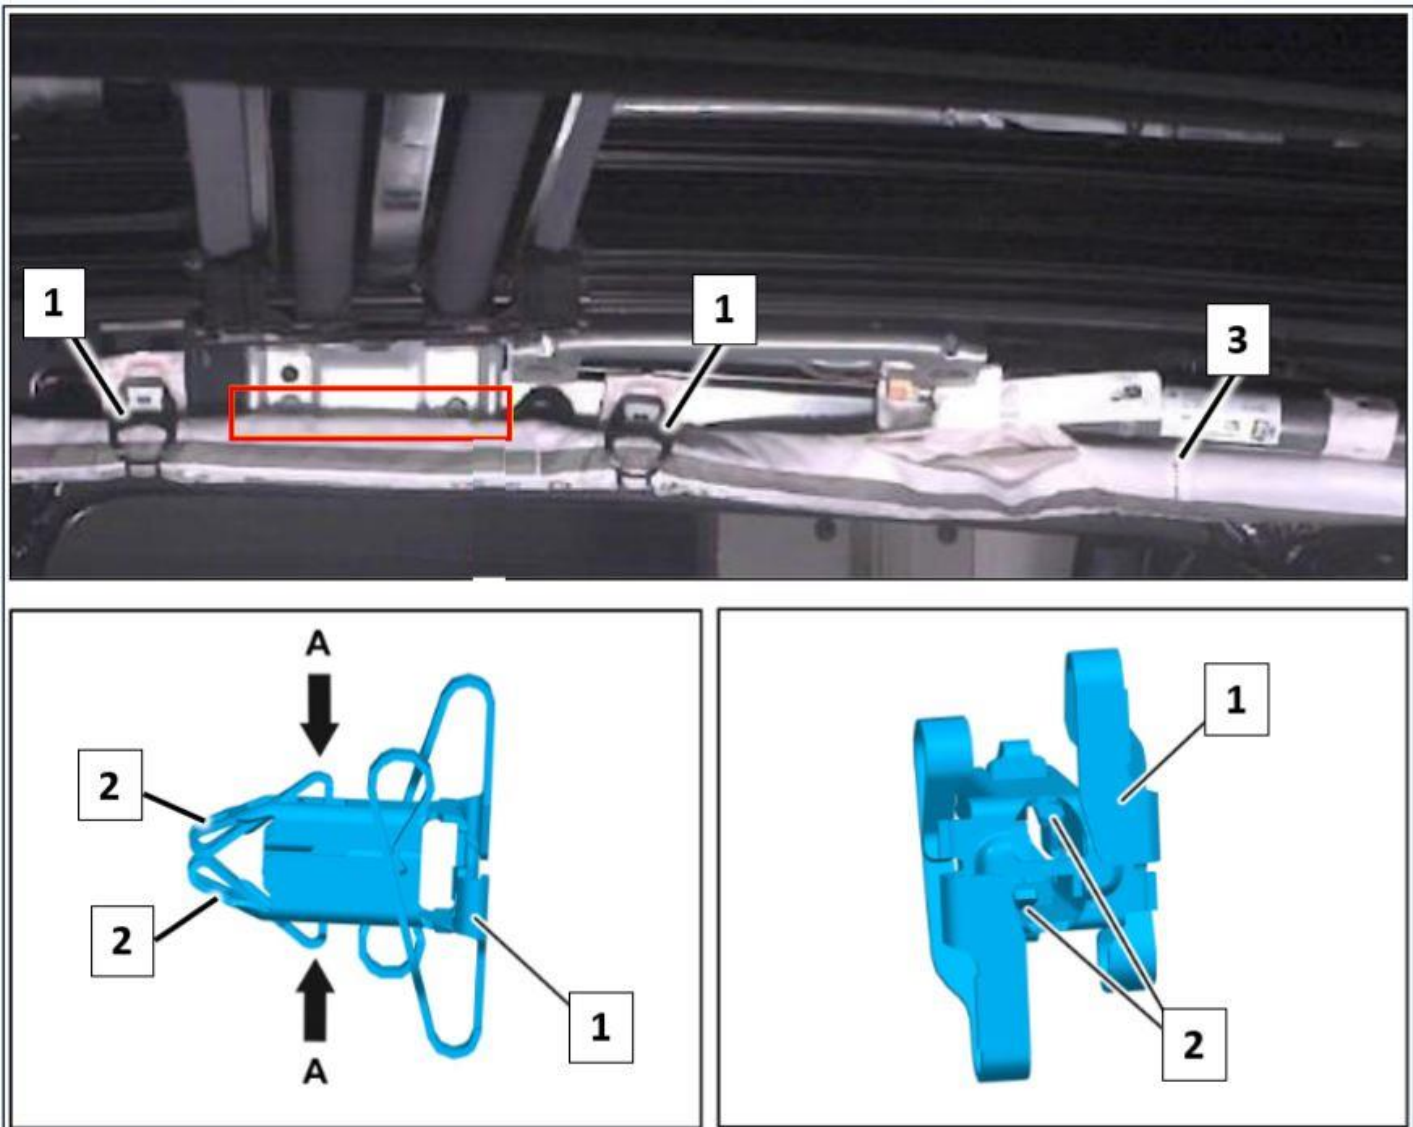
Figure 1

1. Adjust driver and front passenger seat to fully reclined position.
2. Remove headliner and place on the seat backrests.
i For basic information, see AR68.30-P-4300EQS.
3. Loosen the clips (**Figure 1, 1**) on the left and right window airbag (**Figure 1, 3**).
i To do so, press together tabs (**Figure 1, 2 & A**) using suitable needle nose pliers, and remove clips (**Figure 1, 1**).
NOTE: A relatively large amount of force will be required to remove the clips (**Figure 1, 1**).

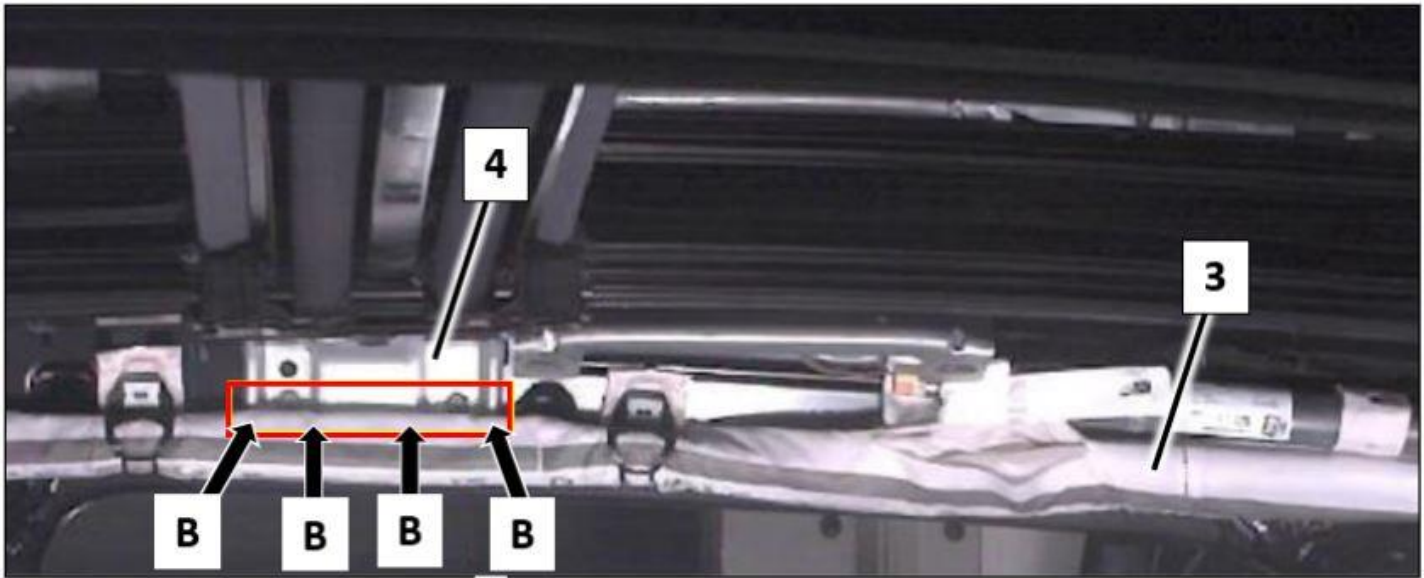
Figure 2

4. Check contact surface of the window airbag sleeve on the left and right window airbags (**Figure 2, 3**) for damage.
i Check lower area of mounting bracket edge (**Figure 2 and 3, B**) for damage.

- a. If window airbag sleeve (**Figure 2 and 3, 3**) is **not damaged**, only perform **Work Procedure A**.
- b. If window airbag sleeve (**Figure 2 and 3, 3**) is **damaged**, perform **Work Procedure A and B**.

6. Replace damaged window airbag(s) (**Figure 1 and 2, 3**).
