Storyteller Overland, LLC
Customer Service Department
428 Industrial Lane
Birmingham, AL 35211

TO: Storyteller Overland, LLC Dealers
Subject: NHTSA Recall: 24V-966

NHTSA Recall 24V-966 Secondary Alternator Recall

Rev02032025

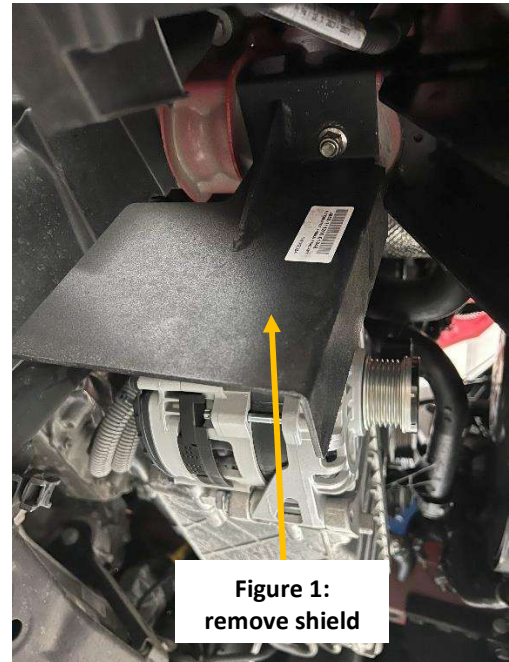
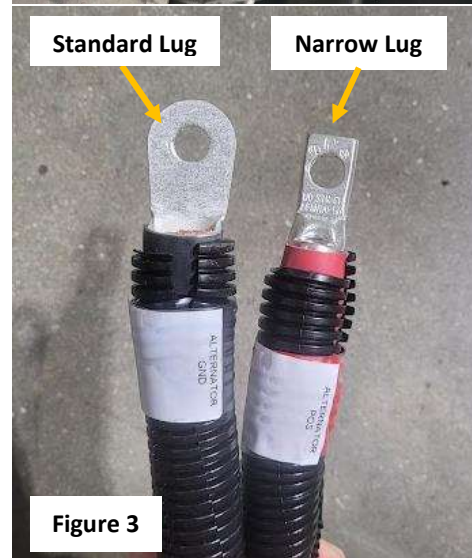
- b) If both leads are different sizes, such as those shown in figure 3, proceed to Electrical Cabinet Modification step 5 before removing the alternator. Ensure the original positive cable lug is the narrow lug style (roughly 0.5" wide) shown on the right side in figure 3.
