VOLUNTARY RECALL CAMPAIGN

Classification: EL24-017	Reference: NTB24-064	Date: December 19, 2024
-----------------------------	-------------------------	----------------------------

VOLUNTARY SAFETY RECALL CAMPAIGN 2025 KICKS; BCM CONFIGURATION

CAMPAIGN ID #: PMA42
APPLIED VEHICLES: 2025 Kicks (P16)

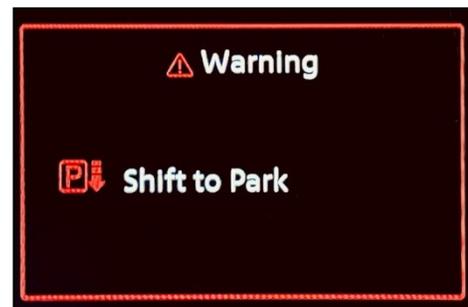
5. Release the brake pedal and turn the ignition OFF by depressing the push button start/stop switch one (1) time.
 - Verify the warning message shown in Figure 4 is displayed along with an audible warning chime.

- If the warning message shown in Figure 4 IS displayed, the vehicle passes inspection.
 - Shift the transmission to Park and proceed to **CLAIMS INFORMATION** on the last page.
- If the warning message shown in Figure 4 is NOT displayed, the vehicle fails the inspection.
 - Shift the transmission to Park and continue to step 6 on page 4.

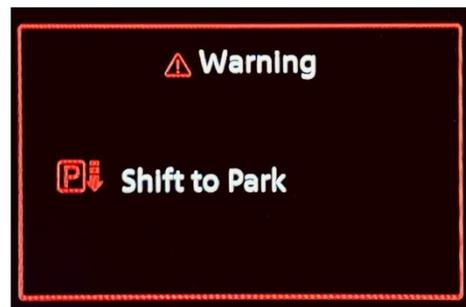
26. Release the brake pedal and turn the ignition OFF by depressing the push button start/stop switch one (1) time.
- Verify the warning message shown in Figure 18 is displayed along with an audible warning chime.

- If the warning message shown in Figure 18 IS displayed, the vehicle passes inspection.
 - Shift the transmission to Park and proceed to **CLAIMS INFORMATION** on the last page.
- If the warning message shown in Figure 18 is NOT displayed, the vehicle fails the inspection.
 - Shift the transmission to Park and return to step 6 on page 4 to configure the BCM.
