IMPORTANT SAFETY RECALL

NHTSA Recall No. 24V-042

SN724

SUBJECT: Rotation Bearing Bolts

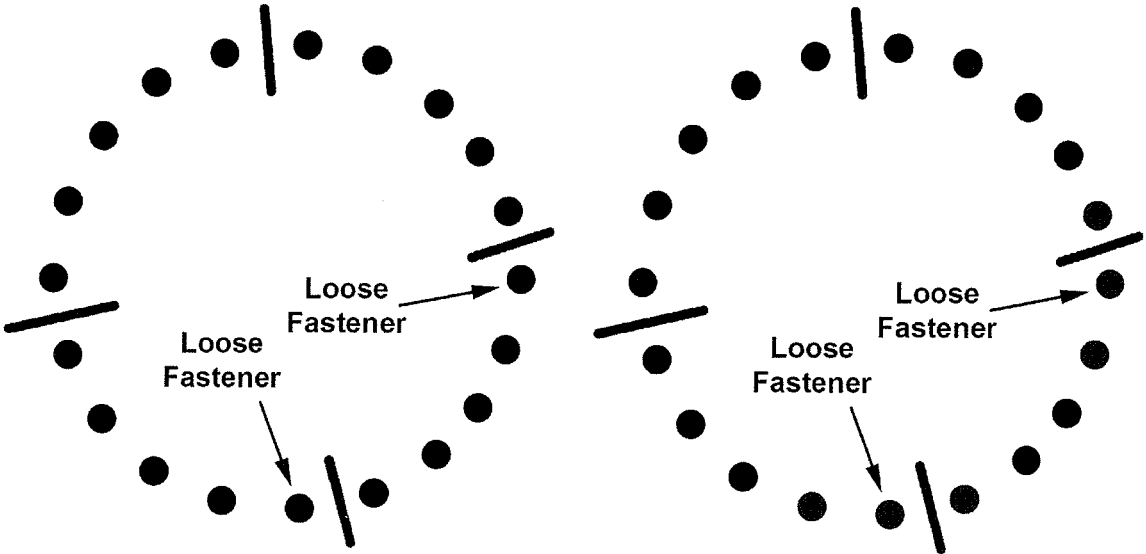
Loose fasteners are in different quadrants, replace each fastener and the fastener on both sides.

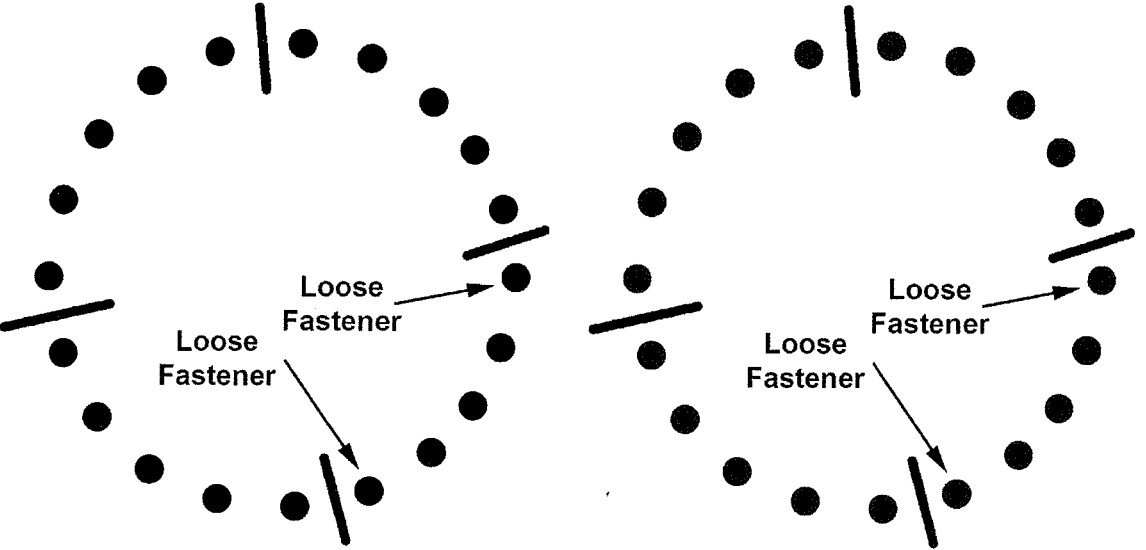
Both loose fasteners are in the same quadrant. Replace all fasteners in the ring.
