SUBJECT: SAFETY RECALL OF 2022~2024 Mercedes Benz TOURRIDER COACHES

Ref.: **NHTSA recall reference #: 24V-141**
Braun recall reference #: 24E-017
DCNA Bulletin # TI 86.10T24282A

TITLE: Tourrider USA - Override flap of lift opens before end position

Recall Notice Service Bulletin 407587 Rev. A

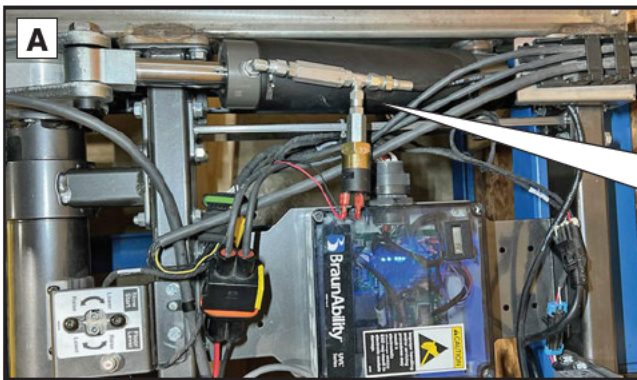
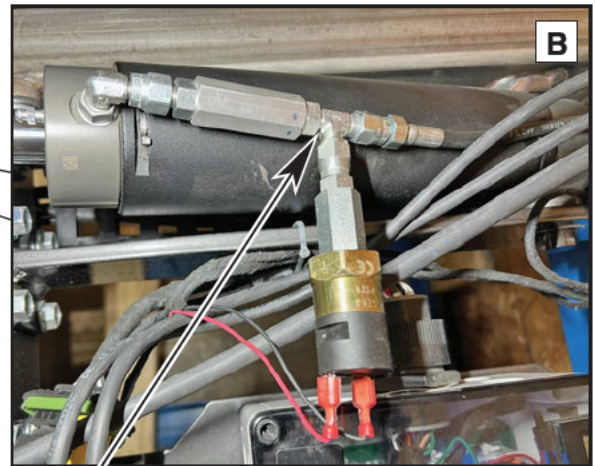
Tee Fitting

Current Configuration

2. Inspect location of pressure switch tee fitting. See Photos A through C.

3. If tee fitting is at location shown in Photo C, no further action is required.
If tee fitting is at location shown in Photo B, the pressure switch relocation procedure must be performed.

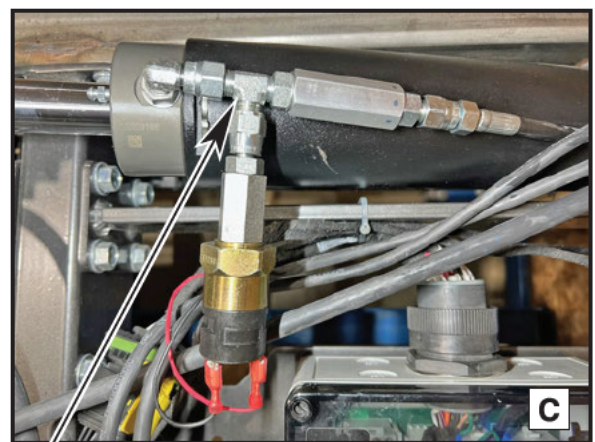
Tee Fitting

New Configuration

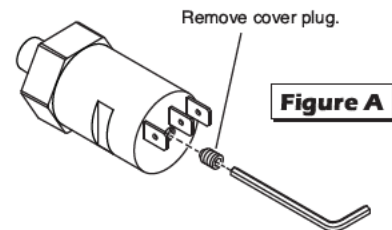
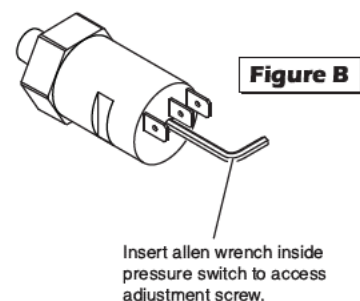
Ground Sense Pressure Switch: The Stow pressure switch is factory set and should not need adjustment. However, adjustment may be necessary if the actuator does not automatically lower the outer barrier once the platform is at ground level.

1. Verify outer barrier actuator functionality before adjusting the platform fold pressure.
2. Using hand pendant, platform to ground level.
3. Remove the cover plug on pressure switch with 2 mm Allen wrench as shown in Figure A
4. Insert 2 mm Allen into pressure switch to access the pressure adjustment screw inside. See Figure B.
5. Press and hold Down hand pendant switch and turn adjustment screw counterclockwise until actuator fully lowers the outer barrier.
6. Using hand pendant, raise platform and then lower back to ground level. Verify outer barrier deployment occurs after platform contacts the ground.
7. Replace cover plug on pressure switch.
