**SUBJECT: SAFETY RECALL OF 2022~2024 MB TOURRIDER COACHES**

Ref.: **NHTSA recall reference #: 24V-151**  
**DCNA Bulletin # TI 83.10T24281A**

**TI No.: 83.10T24281A**

**TITLE:** **Tourrider USA - Replacing the operating levers of the emergency exit hatches**

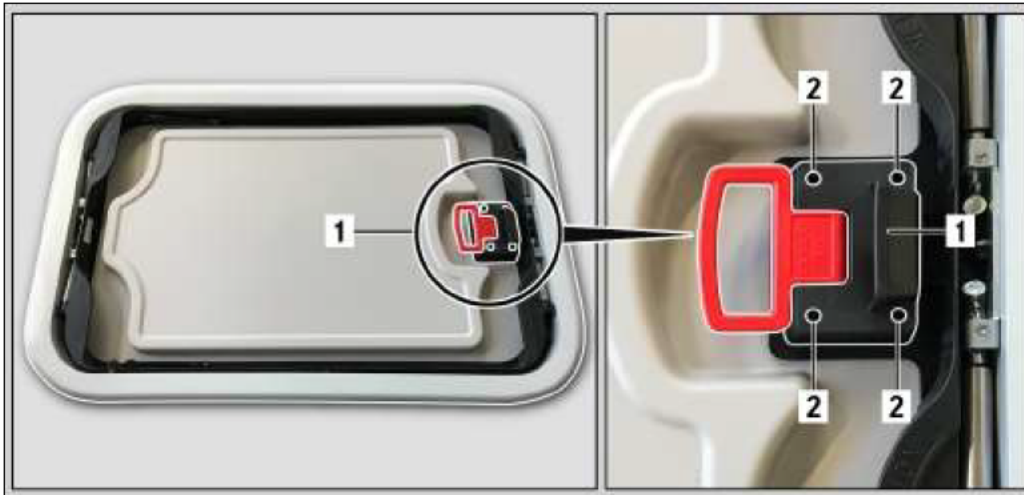
M83.10-A019-80

The operating levers of the emergency exit hatches could break.

Inadequate material strength of the operating levers.

1. Remove screws **(2)**.
2. Remove operating lever **(1)**.
3. Fit the new operating lever and fasten in place.

2 Nm

4. Open and close the emergency exit hatch 2-3 times to ensure trouble-free operation.
