## IMPORTANT SAFETY RECALL

**NHTSA Recall Number:** 24V439

**Altec Identifier:** CSN-3161

## Chassis Marker Lighting Harness Replacement on Freightliner M2 Plus Chassis

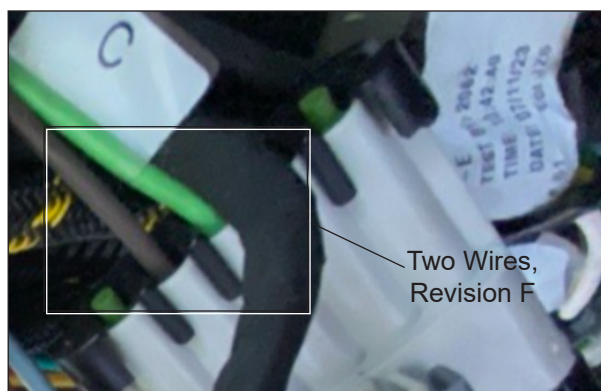
**Figure 1 — Chassis Marker Lighting Harness Revision Level**

1. Read and understand all steps of the instructions before beginning the procedure. Wear appropriate personal protective equipment (PPE) following your employer's requirements.
2. Position the unit on a level surface, apply the parking brake, and turn off the engine. Remove the key from the ignition, and secure it following your employer's vehicle lockout/tagout procedure. Chock the wheels.
3. Locate the chassis marker lighting harness, part number 990063691, at the tailshelf of the vehicle. Determine the number of wires terminated into the C plug (refer to Figure 1).
  - Two wires - harness is revision F or later. Proceed to step 4.
  - A single wire - harness is revision E or earlier. Proceed to step 5.

4. No repair is required.
  - a. Put the unit back into service.
  - b. Complete the Inspection Sheet at the end of this notice, and return it to Altec.
  - c. If the inspection was performed by Altec, mark this notice as complete on the Service Request.
  - d. Do not complete the remaining step in this notice.
5. Repair is required.
  - a. If your unit does not meet the Continued Operation Criteria on page 3, remove the unit from service.
  - b. Arrange for the installation of the Harness Replacement Kit, part number 991780978 and revision F or later, using one of the methods below.
    - Contact Altec Service to schedule the installation of the kit.
    - Contact Altec Parts to order the kit, and schedule for your own technician or your third party provider to install the kit
  - c. Install the kit upon receipt.
  - d. Put the unit back into service.
