IMPORTANT SAFETY RECALL

NHTSA Recall No. 24V-740

SN732

SUBJECT: Jib Extension Cylinder Rod Weld

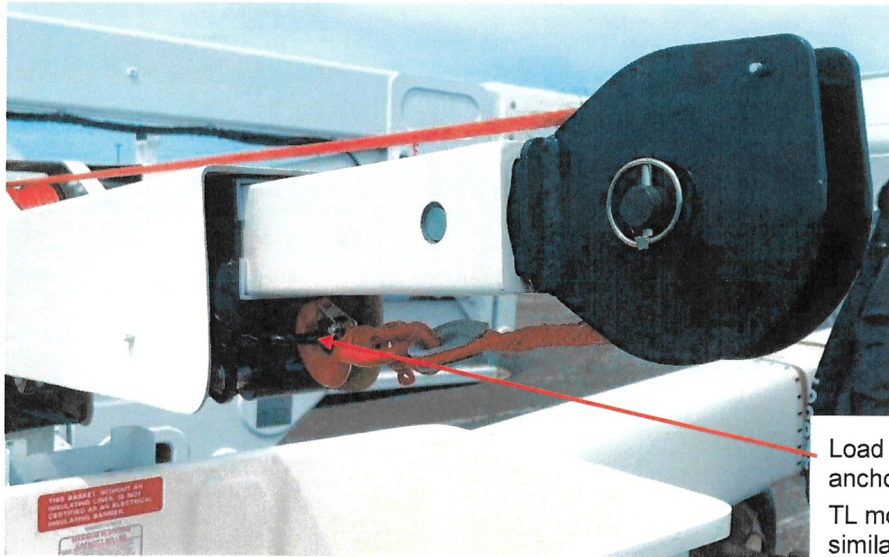
Figure 1. Load Line Hook Secured to Anchor on Main Jib Boom

1. Always follow the inspection and maintenance requirements as specified in the manuals.
2. Ensure the jib extend hydraulic cylinder is at or above horizontal when loaded.
3. Secure the load line hook when stowing the machine as shown in Figure 1 below.

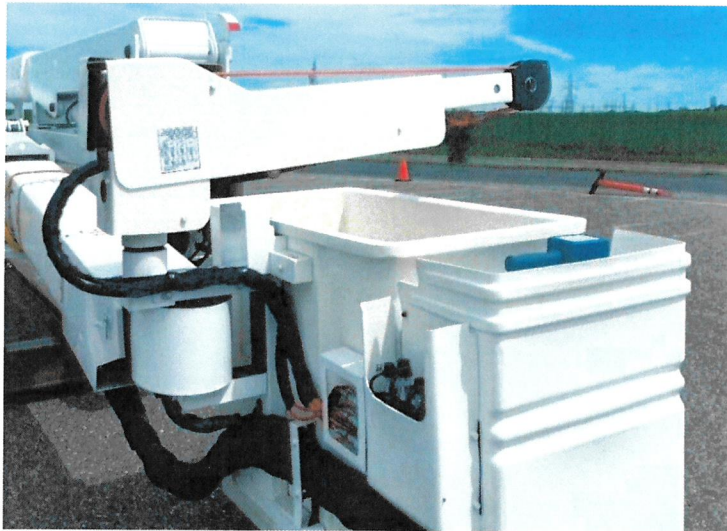
Excluded are dual basket machines where the jib is between the baskets, Figure 3, and single 2-man baskets with side mount jibs, Figure 4.

Figure 2. Included – Certain Top Mount Jib Assemblies

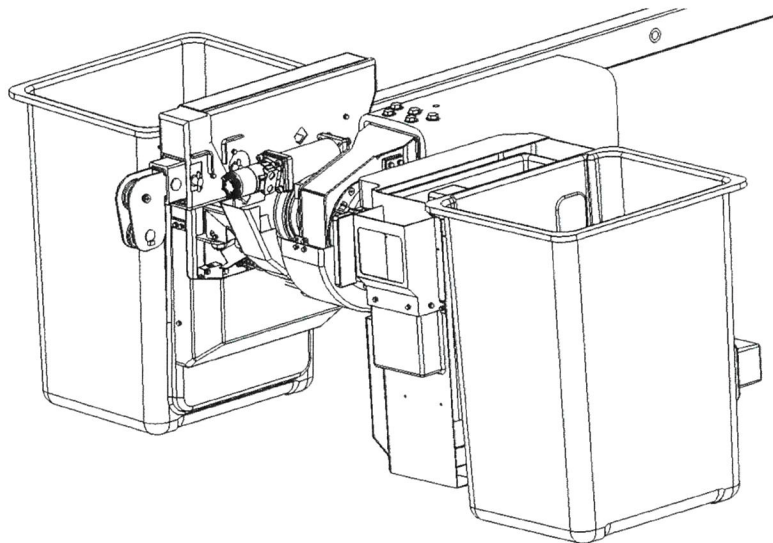
Figure 3. Excluded – Dual Basket with Side Mount Jib Assembly

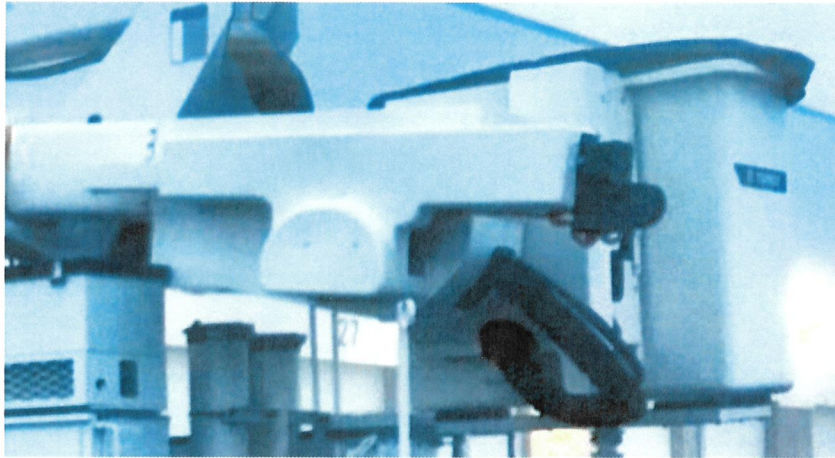
Figure 4. Excluded – Single 2-Man Basket with Side Mount Jib Assembly

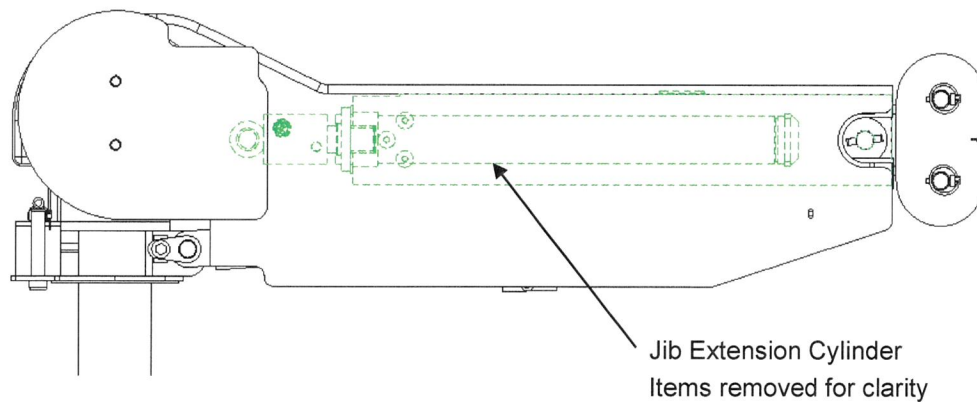
Figure 5. Location of Jib Extension Cylinder

3. Locate the jib extension hydraulic cylinder, using Figure 5 below as reference.

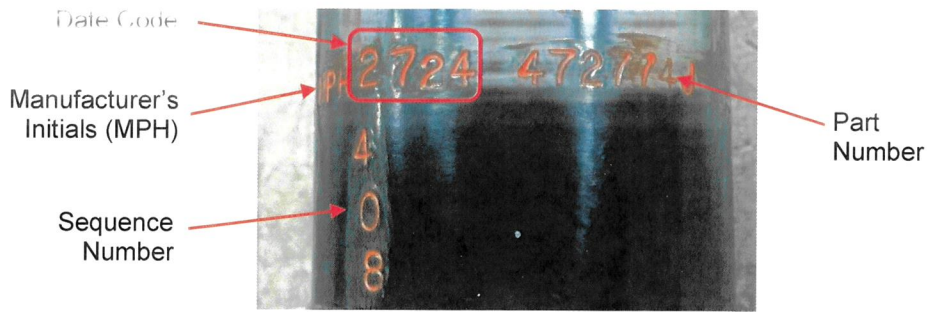
Date Code and Sequence Number

Figure 6. Example Hydraulic Cylinder Date Code

6. Any MPH hydraulic cylinder with part number 472774 and date codes and sequence numbers shown in the table below stamped in the case is subject to the recall and will need the hydraulic cylinder replaced.

Date Code	Sequence Number
3523	271 through 290
4523	76 through 95
4523	226
4523	230 through 231
4723	137
5023	51 through 70
5223	260

4. Remove covers as needed and remove the jib extend hydraulic cylinder following the instructions in the Maintenance Manual of your machine.
5. Using Figure 6, inspect the part number and date code on the hydraulic cylinder. The first two numbers in the date code are the week the cylinder was manufactured. The second two numbers are the year the cylinder was manufactured. The example below was manufactured week 27 in 2024. Sequence number 408 represents this was the 408th cylinder manufactured in week 27 in 2024.
