SAFETY RELATED RECALL

Global Recall Action  
Number: H520

| Subject:<br><br><b>Oil Filter Housing Crack</b> | Publication No.: H520 |
| | Model: F-PACE (X761) |

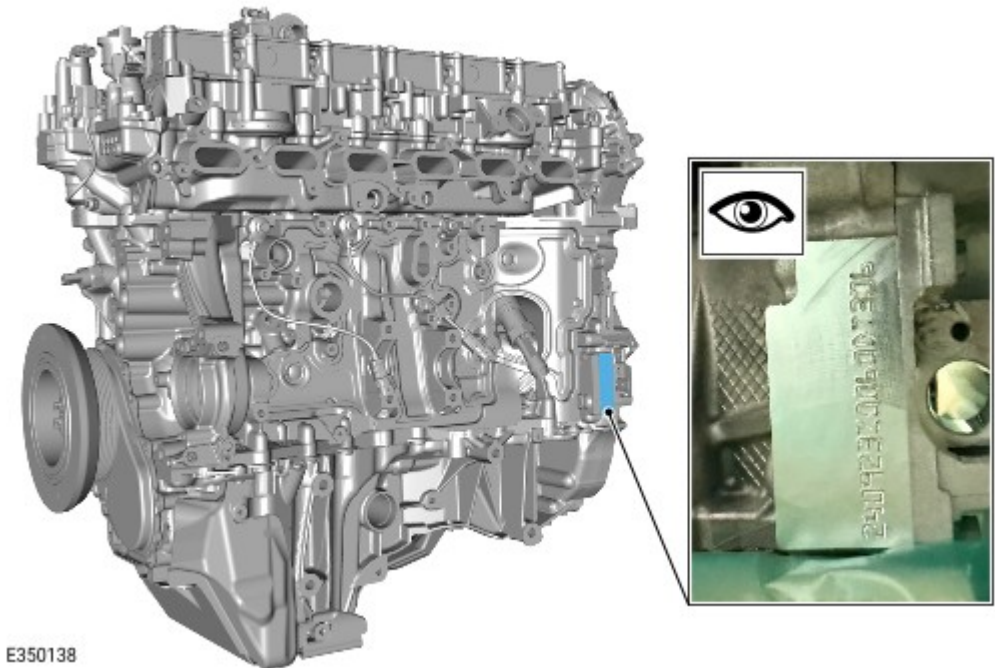
E350138

1. Locate and identify the engine serial number on the new engine assembly and cross reference with the table of affected engine serial numbers above.

- If the engine serial number **is** found within the list, the engine assembly is affected and a new oil filter element and cap must be installed. Email the affected engine serial number and the full 17-digit [VIN](#) of the vehicle the new engine assembly will be installed in to [jlrcomp@jaguarlandrover.com](mailto:jlrcomp@jaguarlandrover.com). The vehicle will then be added to the campaign so the claim for the repair shown below can be submitted. **Continue to the Service Instruction.**
- If the engine serial number **is not** found within the list, the engine assembly is not affected and no further action is required.
