# SAFETY RELATED RECALL

Global Recall Action  
Number: N964

| Subject:<br><br><b>Raised Air Intake Detachment</b> | Publication No.: N964 |
| | Model: Defender (LE) |

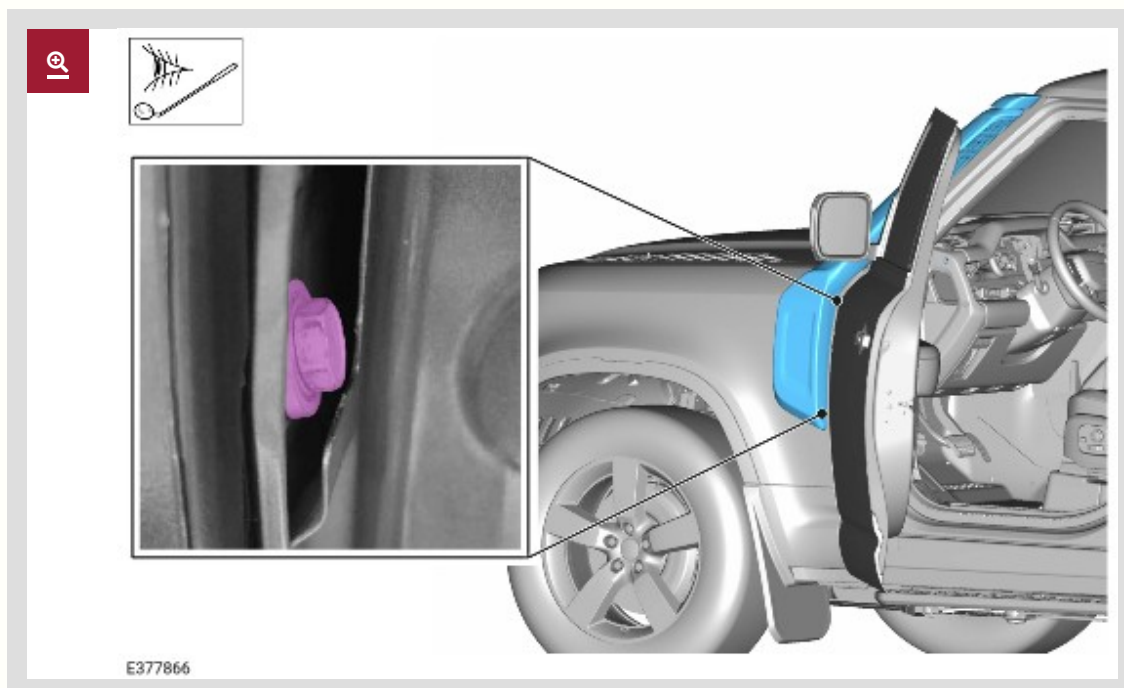
1. Open the front left door, using an extendable mirror inspect the inside of the left fender in the locations shown in the illustration.

- If the raised air intake is fastened with bolts in the locations shown, this raised air intake is part number **VPLEP0435** which **is not** affected by this campaign, **no further action is required. Do not** continue with this campaign.
- If the raised air intake is not fastened with bolts, this raised air intake is part number **VPLEP0543** which **is** affected by this campaign, continue to **Service Instruction**.
