Lucid Group Inc. Technical Service Campaign

TSC Number: TSC-H0224-013-02	Date: 02/15/2024
Document Classification: Perform on next service visit	Model: Lucid Air
	Year: 2022-2023
Title: Coolant Heater May Fail to Defrost Windshield	Region: All Regions

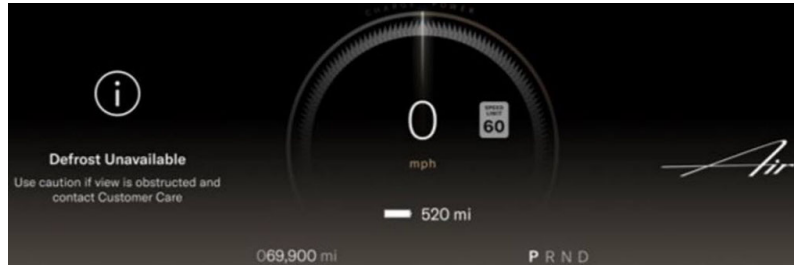
Possible coolant heating element internal failure.

- Run the defrost mode for a minimum of 2 minutes.
- Does the "DEFROST UNAVAILABLE" message appear? (see example)
 - YES: Proceed to **Coolant Heater Replacement**.
 - NO: Proceed to next step.

Update the Software (minimum v2.1.52) and/or replace the High Voltage Coolant Heater if necessary.
