*****July 12, 2024 – Added warning regarding debris in steering gear*****

Safety Recall – 2024 CX-90 - Steering Gear Safety Recall

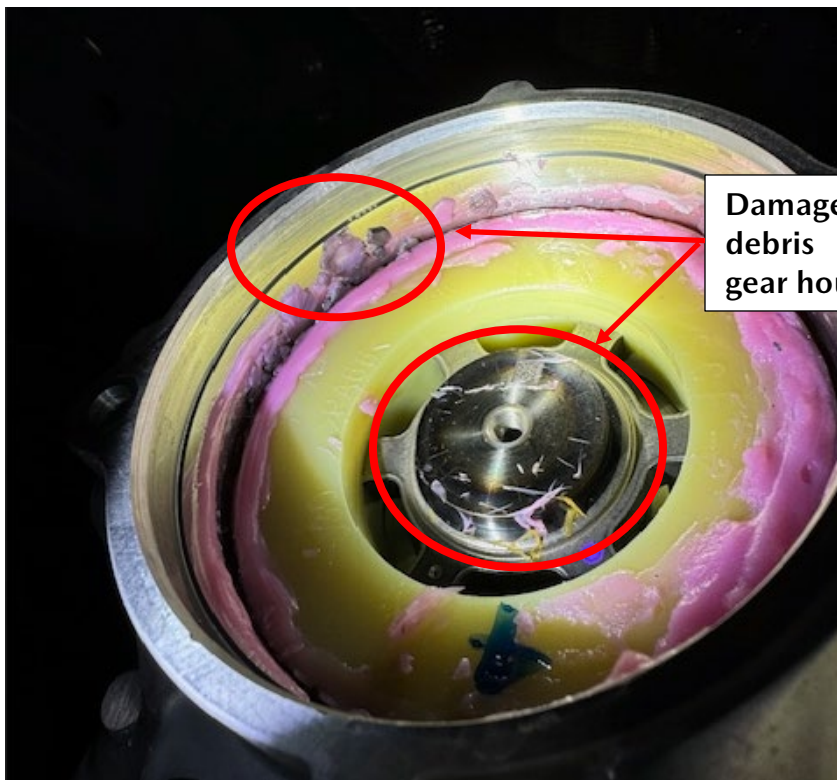
If there is visible damage to the gear similar to the below photo, please fill out Dealer Recall Help on OneMazda with clear photos of the gear and the visible damage and/or foreign debris and the team will advise next steps. If there is no damage present, proceed with the recall repair.

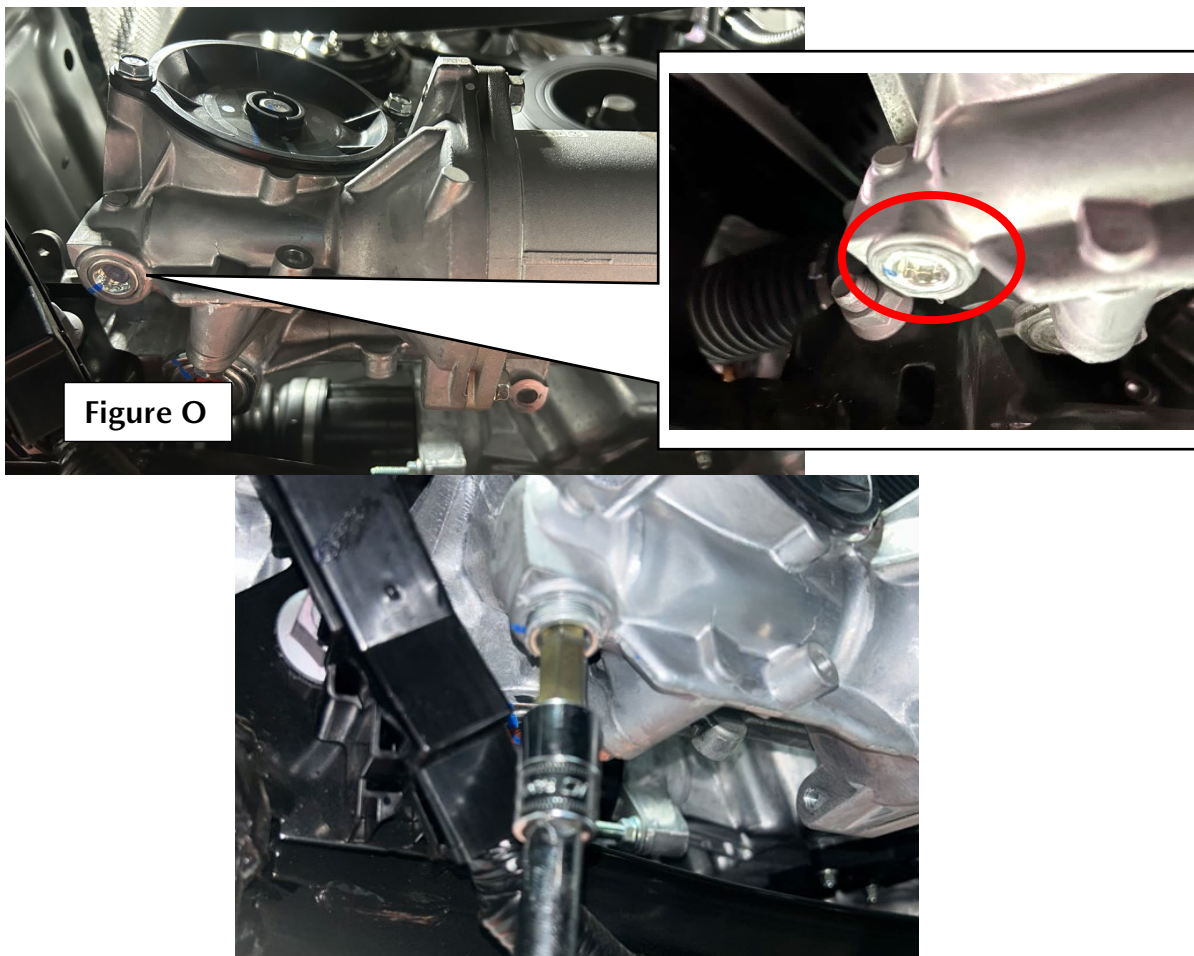
Figure O

If the end cap is damaged or cannot be removed please fill out Dealer Recall Help on OneMazda with photos of the damage to the end cap (removed or not removed) with an explanation of the problem and the team will advise next steps.

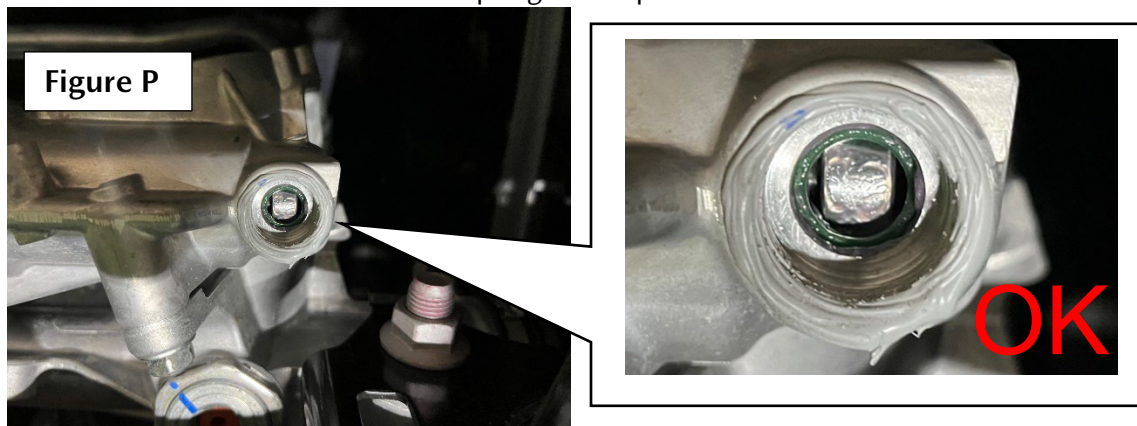
Figure P

Correct - Normal condition: After spring and cap are removed.

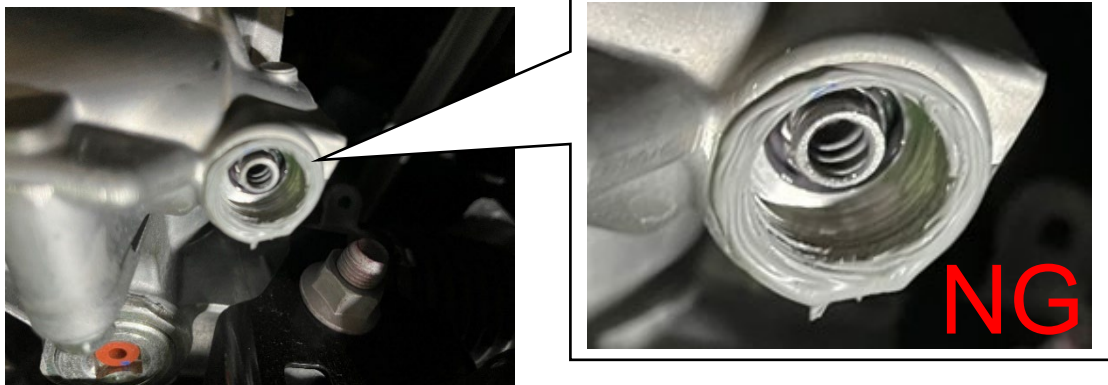
NO GOOD – Incorrect condition: Spring is not removed

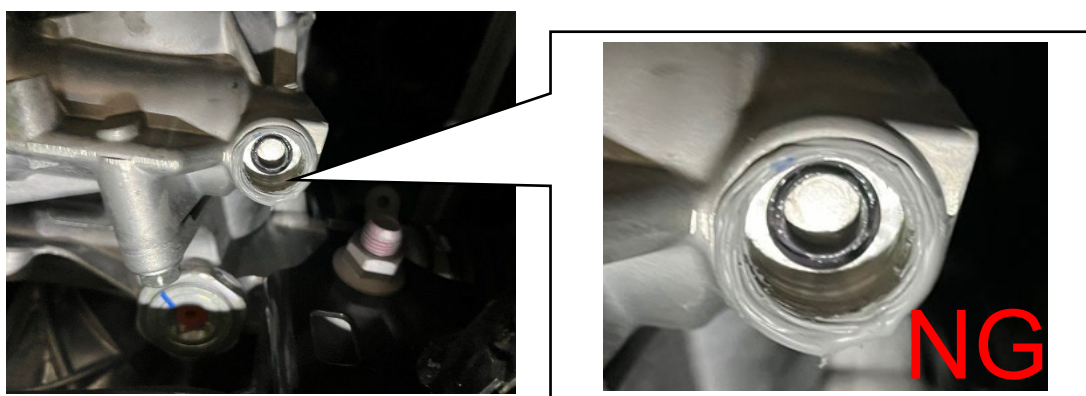
NO GOOD (NG) – Incorrect condition: Cap is not removed AND Cap is caught

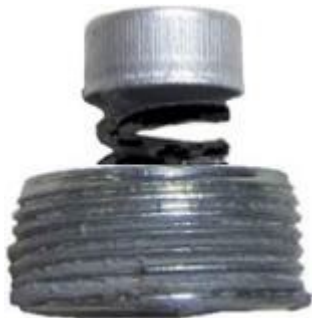
--	The spring seat is placed upside down.	The spring and the spring seat are reversed.
