GROUP	MODEL
Safety Recall Campaign	2023-2024MY Sportage (NQ5a) and 2022-2024MY Carnival (KA4) <u>without Roof Rails</u>
NUMBER	DATE
SC292 (Rev 1, 10/24/2024)	March 2024

ROOF MOLDING INSPECTION, RETENTION AND REPLACEMENT (SC292)

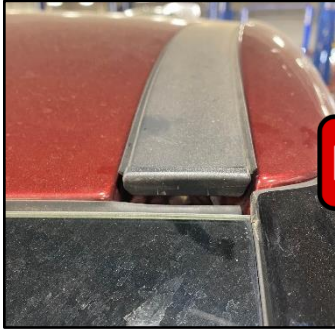
Loose Molding 1

- If the roof molding is not secured and/or is found to be loose/detached (NG), take a video starting from the VIN label and show the loose/detached (NG) roof molding(s) and proceed to the 'Replacement Procedure' on page 5 and replace the affected roof molding (LH, RH or Both).
- If the roof molding is missing (NG), take a video starting from the VIN label and show the missing (NG) roof molding(s) and proceed to the 'Replacement Procedure' on page 5 to replace the affected roof molding (LH, RH or Both).

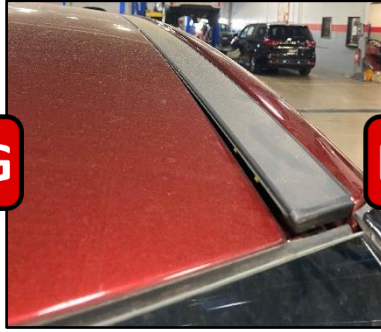
Loose Molding 2

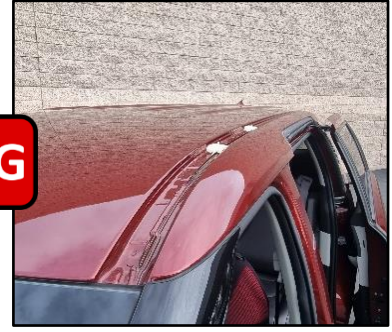
Missing Molding

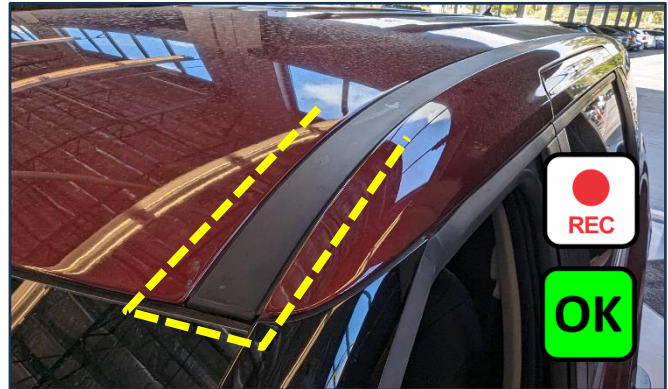
1. Inspect the front area of both the left and right side roof moldings in the area shown. The molding should be flush with the roof body and secured at the front molding windshield area.

- If the molding is secured normally (OK) take a video starting from the VIN label and show the secured (OK) roof molding(s), then proceed to the 'Repair Procedure' on page 3 to secure the affected roof molding.
