GROUP	MODEL
Safety Recall Campaign	2023-2024MY Sportage (NQ5a) and 2022-2024MY Carnival (KA4) <u>without Roof Rails</u>
NUMBER	DATE
SC292 (Rev 3, 12/22/2025)	March 2024

ROOF MOLDING INSPECTION, RETENTION AND REPLACEMENT (SC292)

This bulletin provides information to inspect and, if necessary, secure or replace the roof molding on certain 2023-2024 Sportage (NQ5a) vehicles produced from January 12, 2022 through November 29, 2023, and certain 2022-2024 Carnival (KA4) vehicles (not equipped with roof rails) produced from January 5, 2021 through November 24, 2023. The roof molding may become loose or detach under certain circumstances either due to interference of the roof molding retaining clip(s) with excessive roof panel sealer or due to improper installation of the roof molding during vehicle assembly. A detached roof molding can create a road hazard for other vehicles, increasing the risk of a crash. Follow the procedure, outlined in this publication to inspect the roof moldings, and if necessary, secure the affected molding or replace and secure it with a new part. Before conducting the procedure, verify that the vehicle is included in the list of affected VINs.

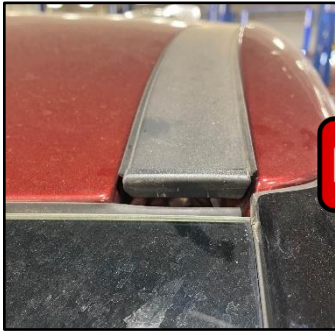
Loose Molding 1

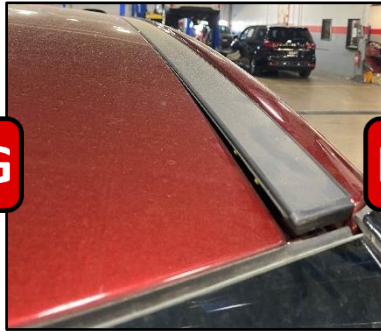
Loose Molding 2

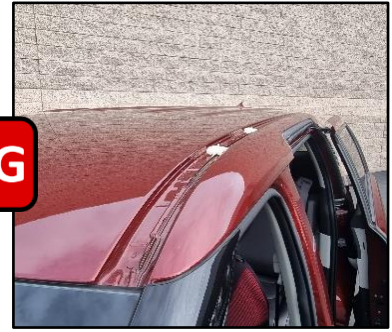
Missing Molding

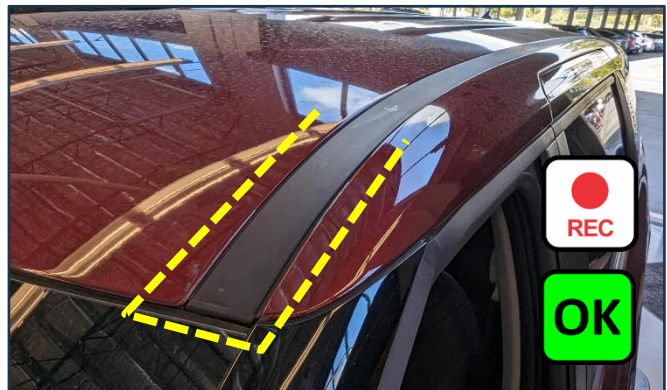
1. Inspect the front area of both the left and right side roof moldings in the area shown. The molding should be flush with the roof body and secured at the front molding windshield area.

- If the molding is secured normally (OK) take one video starting from the VIN label and show the secured (OK) roof molding(s), then proceed to the 'Repair Procedure' on page 3 to secure the affected roof molding.

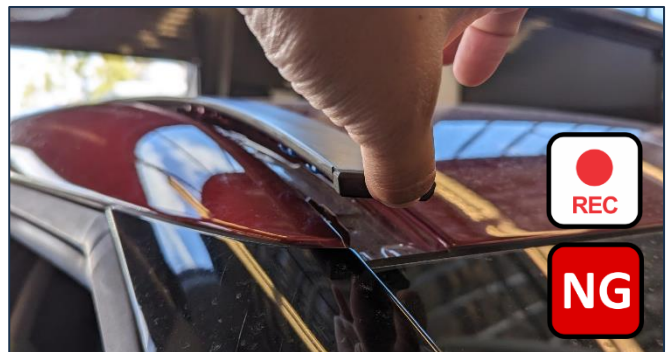
- If the roof molding is not secured and/or is found to be loose/detached (NG), take one video starting from the VIN label and show the loose/detached (NG) roof molding(s) and proceed to the 'Replacement Procedure' on page 5 and replace the affected roof molding (LH, RH or Both).
- If the roof molding is missing (NG), take one video starting from the VIN label and show the missing (NG) roof molding(s) and proceed to the 'Replacement Procedure' on page 5 to replace the affected roof molding (LH, RH or Both).

Note: Use very 'light' upward pressure to verify if the roof molding is not secured/loose/detached. DO NOT try to forcefully pry up the roof molding.
