GROUP	MODEL
Safety Recall Campaign	2023-2024MY Sportage (NQ5a) and 2022-2024MY Carnival (KA4) without Roof Rails
NUMBER	DATE
SC292	March 2024

SAFETY RECALL CAMPAIGN

ROOF MOLDING INSPECTION, RETENTION AND REPLACEMENT (SC292)

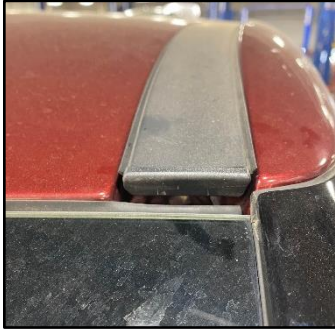
Loose Molding 1

- If the molding is secured normally **(OK)** take a KVID video starting from the VIN label and show the secured **(OK)** roof molding(s), then proceed to the 'Repair Procedure' on page 3 to secure the existing roof molding.
- If the roof molding is not secured and/or is found to be loose/detached **(NG)**, take a KVID video starting from the VIN label and show the loose/detached **(NG)** roof molding(s) and proceed to the 'Replacement Procedure' on page 5 and replace the affected roof molding (left, or right, or both).
- If the roof molding is missing **(NG)**, take a KVID video starting from the VIN label and show the missing **(NG)** roof molding(s) and proceed to the 'Replacement Procedure' on page 5 to replace the affected roof molding (left, or right, or both).

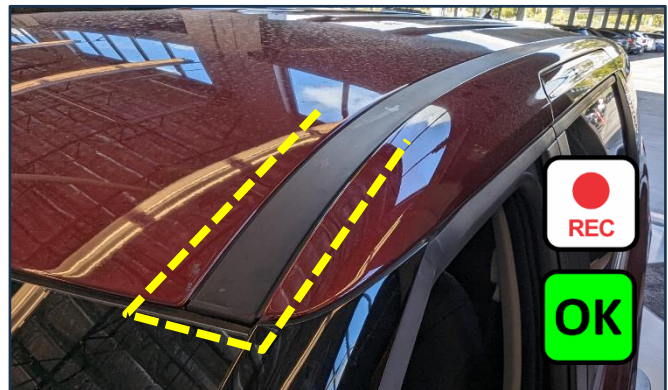
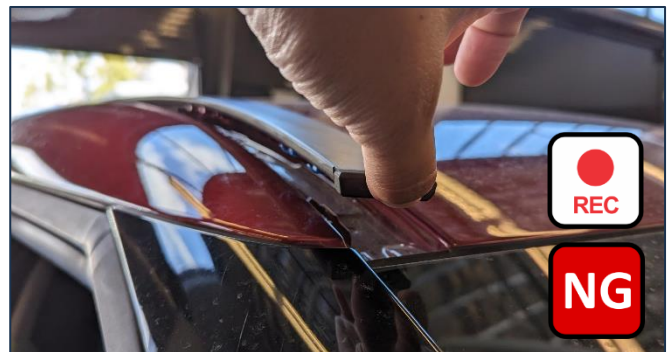
1. Inspect the front area of both the left and right side roof moldings in the area shown. The molding should be flush with the roof body and secured at the front molding windshield area.
