## N232426400 Tailgate May Open Unexpectedly

Release Date: May 2024 Revision: 04

Condition	General Motors has decided that a defect which relates to motor vehicle safety exists in certain 2020 - 2024 model year Chevrolet Silverado Heavy Duty (2500/3500 series) and GMC Sierra Heavy Duty (2500/3500 series) vehicles equipped with power-unlatching tailgates. Under certain conditions water may intrude into these vehicles' tailgates and come into contact with the electronic gate-release switch, potentially causing a short circuit. The gate may inadvertently unlatch while the vehicle is in Park. If the driver does not manually close the gate before beginning a drive, cargo in the bed of the truck may exit the vehicle and become a road hazard, increasing the risk of a crash. Until the recall is completed,
	owners should check that the tailgate closed and latched before driving.
Correction	Dealers will replace the exterior touchpad switch assemblies.

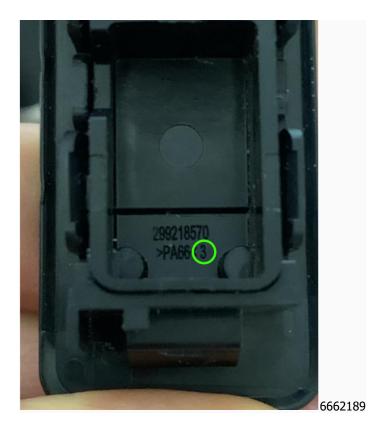
- Inspect the number shown on the replacement switch.
  - If the last digit is "1", the part is BAD and MUST be scrapped.
  - If the last digit is anything other than "1", the part is good and can be installed in the vehicle.

#### IMPORTANT: BEFORE INSTALLATION, YOU MUST INSPECT THE PART PER INSTRUCTIONS BELOW.
