**HYUNDAI**
Technical Service Bulletin

GROUP RECALL	NUMBER 24-01-024H
DATE MARCH 2024	MODEL(S) IONIQ 5 (NE1) IONIQ 6 (CE1)

SUBJECT: INNER SHAFT REPLACEMENT
(RECALL 253)

Description: Certain 2023MY IONIQ 5 (NE1) and IONIQ 6 (CE1) may contain rear inner shafts that could fracture due to improper heat treatment. A fractured inner shaft may result in a loss of motive power while driving, increasing the risk of injury in a crash or impact. Follow the procedures in this TSB to replace the inner shaft.

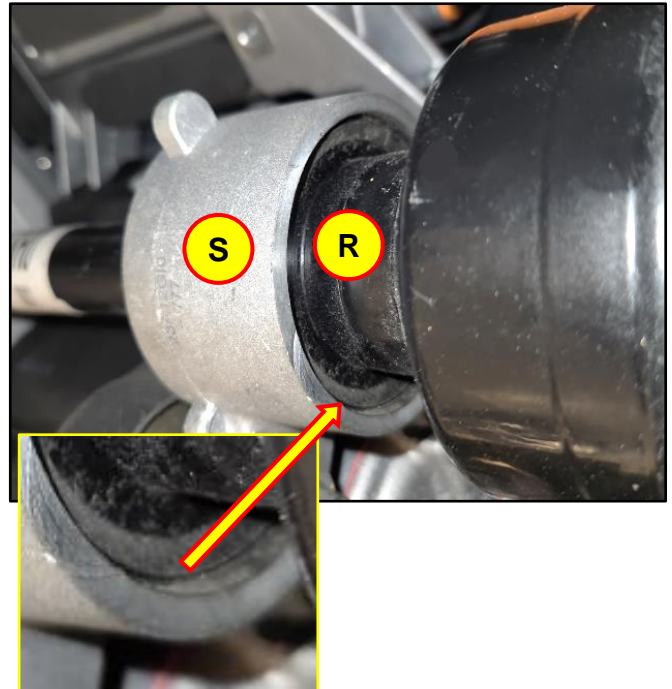
GOOD: IDA dust cover (R) is fully inserted into the inner shaft bracket (S).

18. After installing the new inner shaft, ensure that the IDA is properly installed.

The IDA joint cup (T) should not slide back and forth on the inner shaft. The inner shaft circlip should securely retain the IDA joint cup.

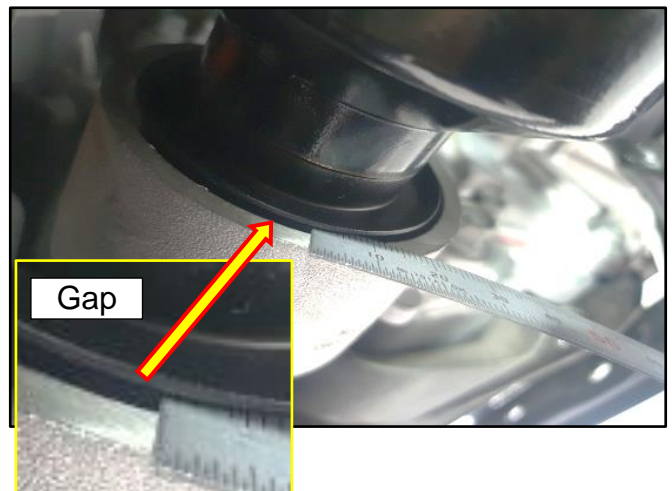
NOT GOOD: A gap remains between the IDA dust cover and inner shaft bracket.
