## Technical Service Bulletin

<b>GROUP</b>	<b>NUMBER</b>
<b>RECALL</b>	<b>24-01-024G</b>
<b>DATE</b>	<b>MODEL(S)</b>
<b>MARCH 2024</b>	<b>GV60 (JW1 EV)</b>

**SUBJECT:** INNER SHAFT REPLACEMENT  
(RECALL 017G)

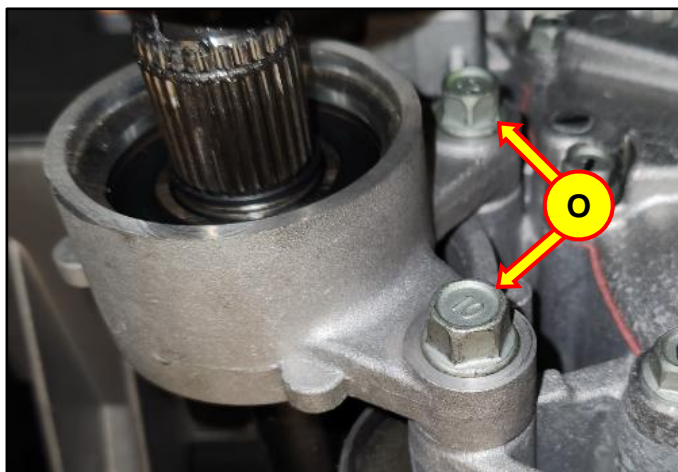
**Description:** Certain 2023MY GV60 (JW1 EV) may contain rear inner shafts that could fracture due to improper heat treatment. A fractured inner shaft may result in a loss of motive power while driving, increasing the risk of injury in a crash or impact. Follow the procedures in this TSB to replace the inner shaft.

15. Remove the bolts (O) to remove the old inner shaft.

**Inner Shaft Bracket Tightening Torque:**

lb-ft	50
N.m	67

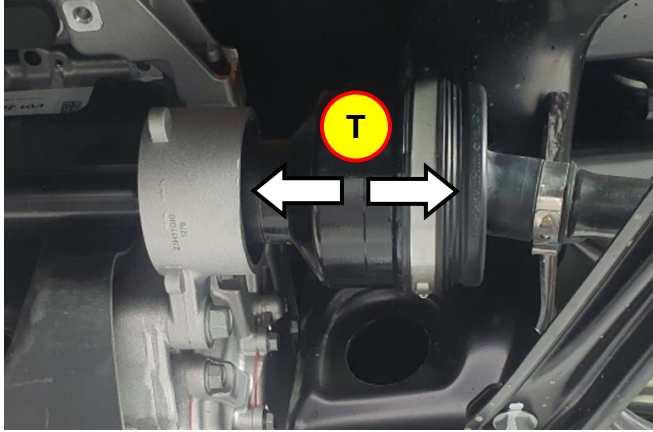
The IDA joint cup (T) should not slide back and forth on the inner shaft. The inner shaft circlip should securely retain the IDA joint cup.

18. After installing the new inner shaft, ensure that the IDA is properly installed.

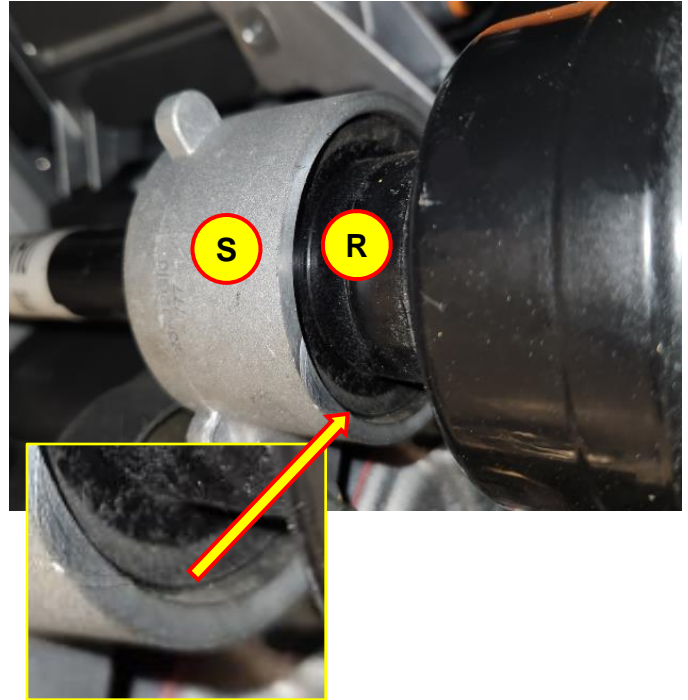
**GOOD:** IDA dust cover (R) is fully inserted into the inner shaft bracket (S).

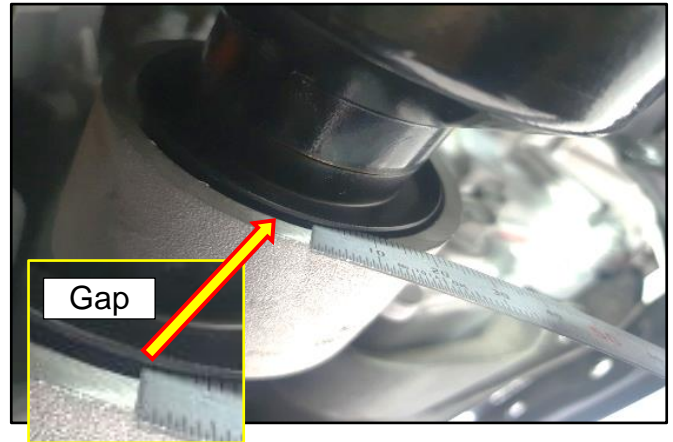
**NOT GOOD:** A gap remains between the IDA dust cover and inner shaft bracket.
