SAFETY RECALL

Communication #: I-24-03

Model Year(s): 2019-2022

SUBJECT: ANTI-LOCK BRAKE (ABS) SOFTWARE UPDATE

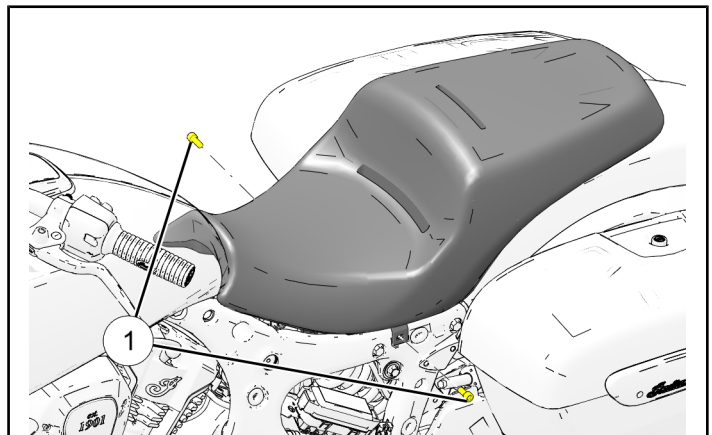
Pursuit models have wires routing through the seat.

8. Remove seat fastener ①.
