GROUP	MODEL
Safety Recall Campaign	2024MY Telluride (ON)
NUMBER	DATE
SC296 (Rev 1, 08/08/2024)	March 2024

Subject: **ENGINE SUB-ASSEMBLY REPLACEMENT (SC296)**

This bulletin provides information to replace the engine sub-assembly on certain 2024MY Telluride (ON) vehicles produced from October 1, 2023 through December 6, 2023. The engine valve springs in the subject vehicles may break while driving due to fatigue cracking as a result of damage to the springs during manufacture by the supplier. A broken valve spring may result in a loss of motive power. In rare cases, a hole in the engine block may occur due to a broken valve entering the combustion chamber. A loss of motive power increases the risk of crash. A hole in the engine block increases the risk of a fire. Customers may experience abnormal engine noise, check engine light illumination, and engine running rough. Follow the procedure outlined in this publication to replace the engine sub-assembly on the applicable vehicle. Before conducting the procedure, verify that the vehicle is included in the list of affected VINs.

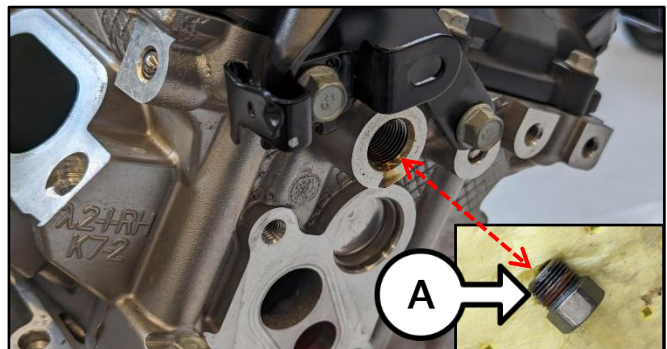
2. Remove the engine oil plug (A) located behind the right rear cylinder head.

Note: Do not lose/discard of the oil plug.

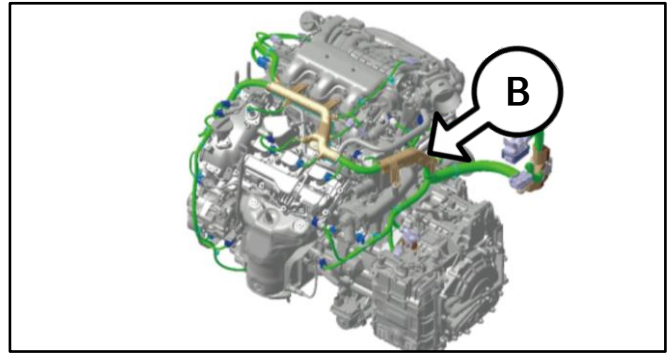
3. Remove the engine wire harness (B) by disconnect all connectors and retaining bolts from the engine.

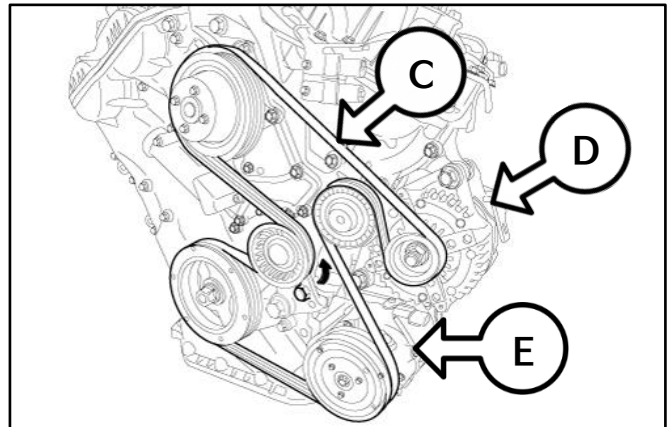
4. Remove the drive belt (C), alternator (D), and air conditioner compressor (E).

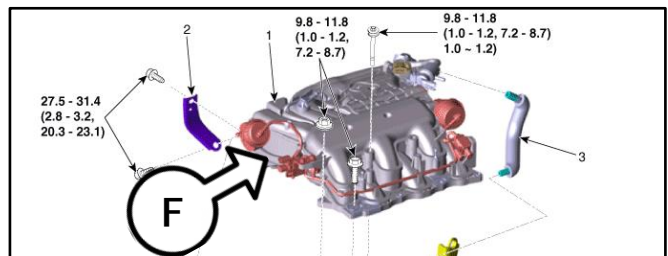
5. Remove the surge tank (F).

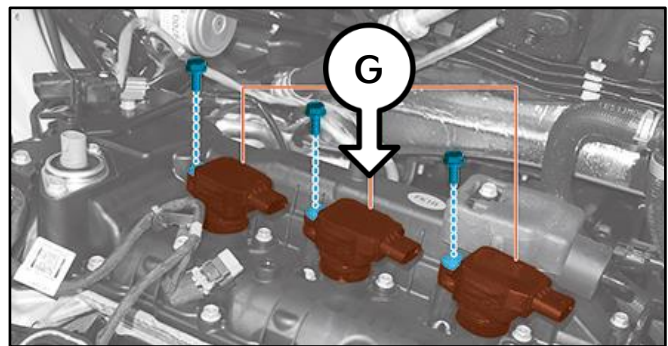
6. Remove the six (6) ignition coils (G) from both bank 1 and bank 2.

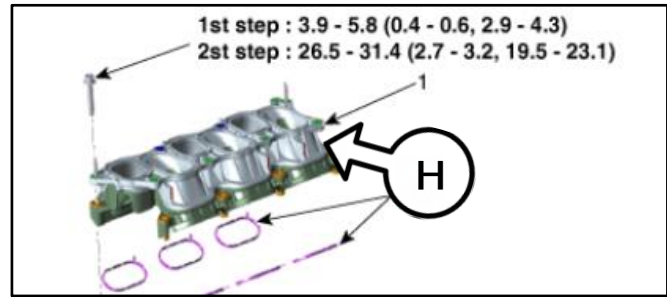
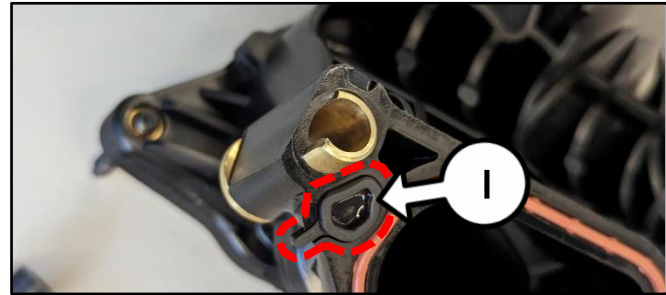
7. Remove the intake manifold (H).

Note: Be sure not to lose/discard the water vent seal (I) located under the intake manifold.

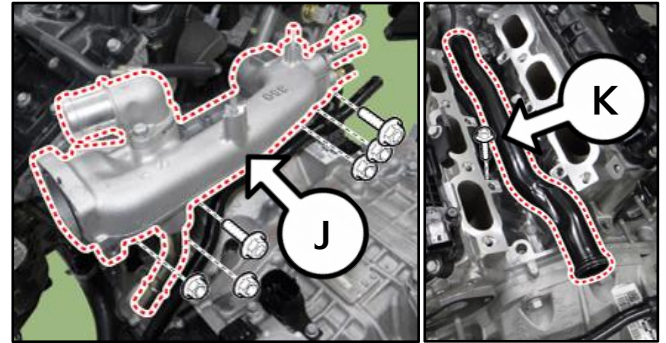
8. Remove the water temperature control assembly (J) and water center pipe (K).

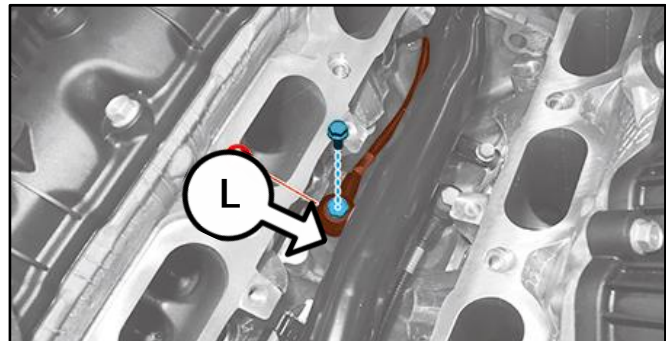
9. Remove the two (2) knock sensors (L) from both bank 1 and bank 2.

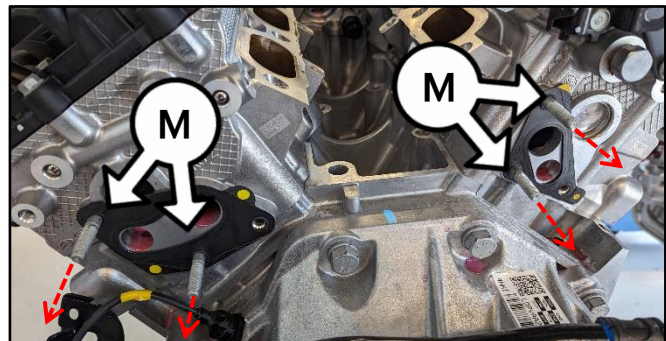
10. Remove the four water temperature control assembly retaining studs bolts (M) from the back of the cylinder heads.

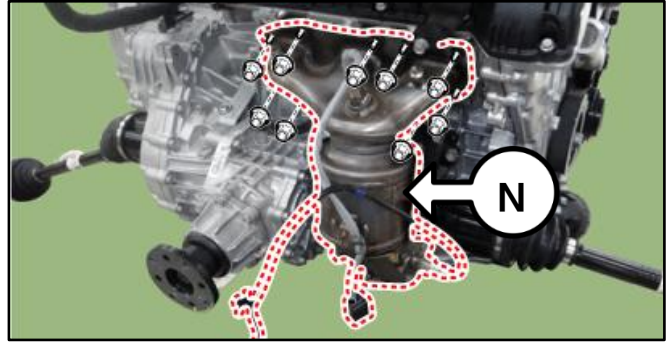
11. Remove both left and right side exhaust manifolds (N).

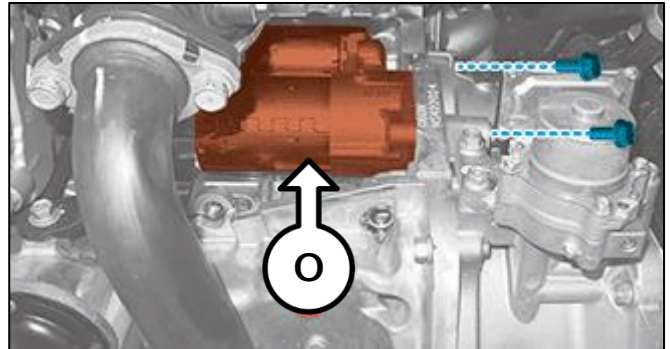
12. Remove the ignition starter assembly (O).

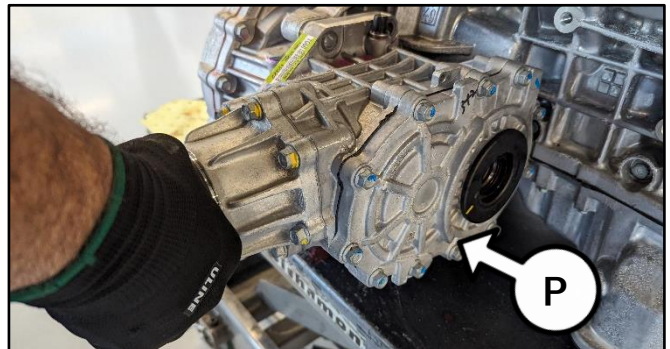
13. Remove the transfer assembly (P).

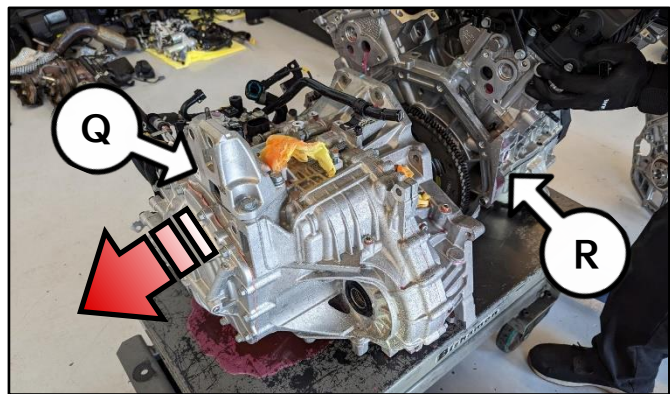
14. Separate the automatic transaxle assembly (Q) from the engine (R).

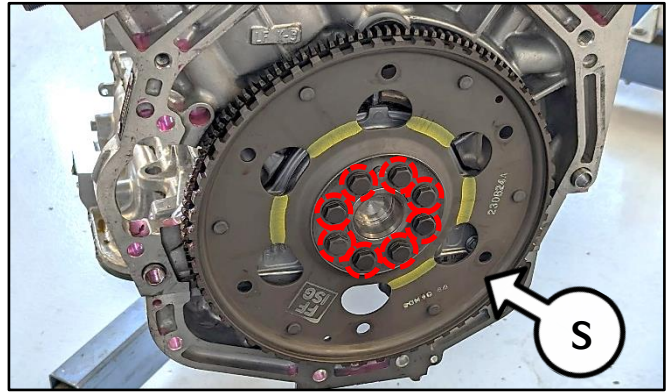
- 15. Loosen the eight (8) bolts to remove drive plate (S) from the engine.

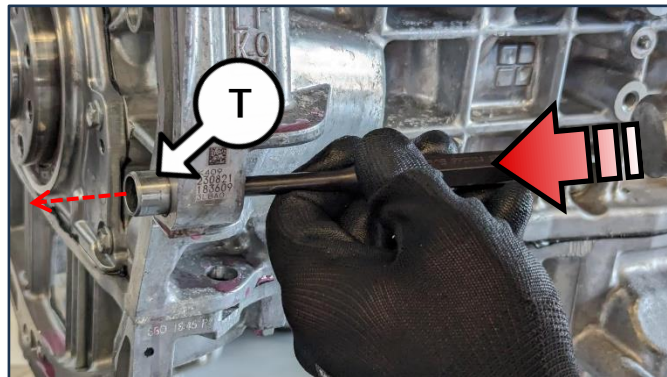
- 16. Remove the two (2) alignment sleeves (T) located on opposite sides of the engine using a push pin and hammer.

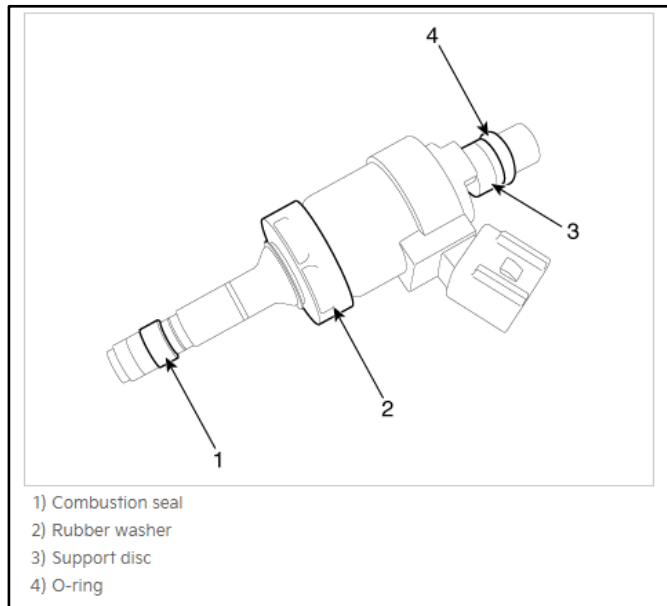
- 17. Replace the injector seals and related parts by referring to "Engine Control/Fuel System → Fuel Delivery System → Injector → Replacement" in the applicable shop manual on KGIS.
