SAFETY RELATED RECALL

Global Recall Action Number: H468

High Voltage (HV) Battery Busbar Fixings

Model: I-PACE (X590)

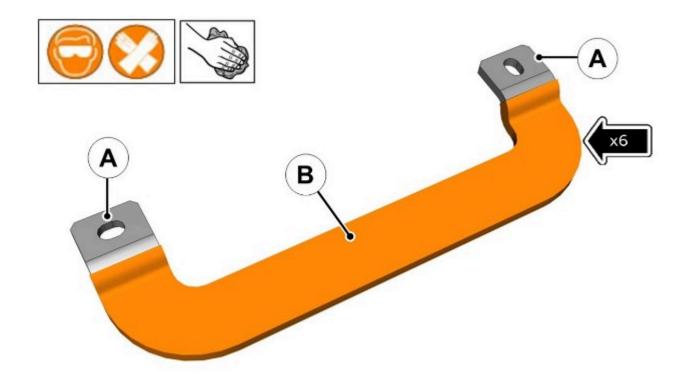
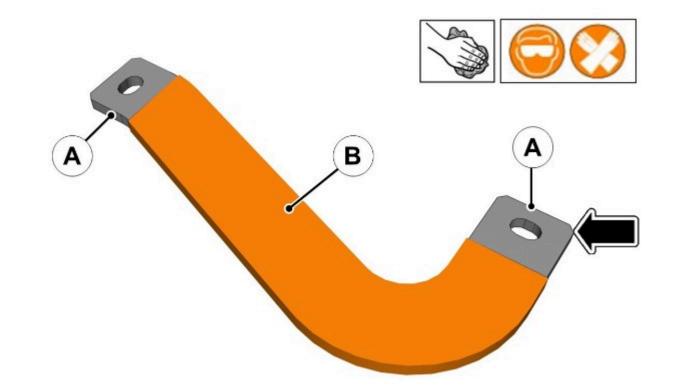
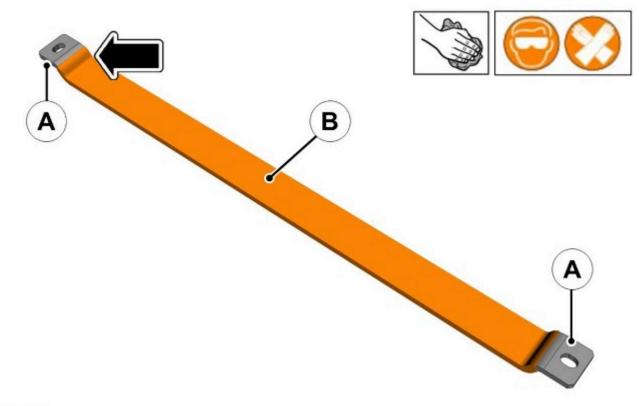
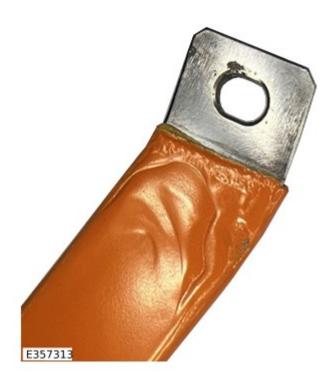
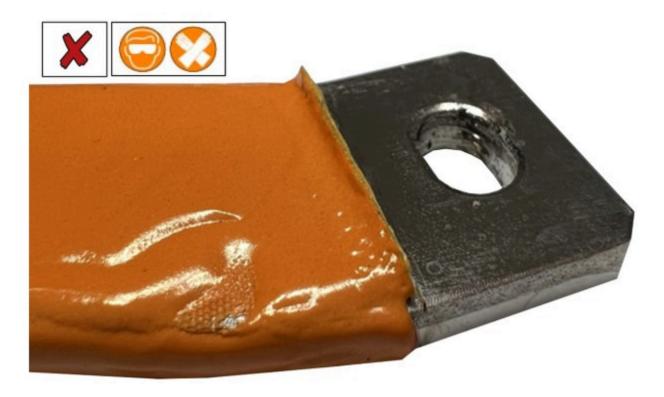
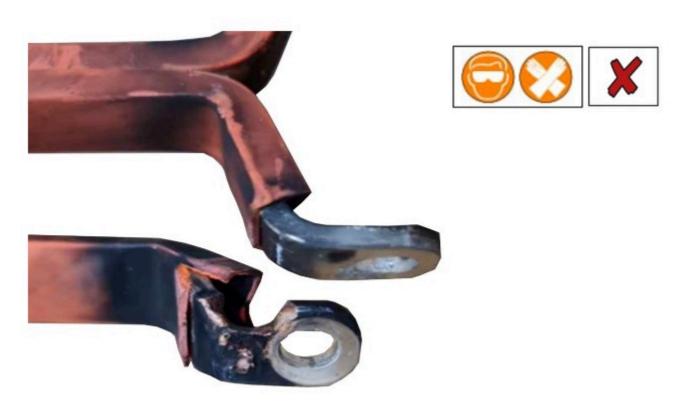
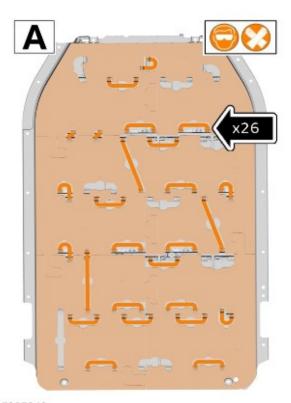
- Make a note of all damage found and the installed position of the damaged busbar within the HV battery.
- All findings must be reported to TA.
- The images marked with a **RED 'X'** show an example of busbar damage caused by overheating, make a note of all damage found.

Throughly inspect the 8 busbars removed for safe voltage reduction.

- Visually inspect the contact areas (A) for signs of damage.
 Visually inspect the protective insulation for damage (B).
 If there ARE any signs of damage as shown in the images marked with a RED 'X', make a note of the installed position of the busbar in the HV battery. Continue to step 16, do not reinstall the busbars..
- If there ARE NOT any signs of damage, continue to step 16, do not reinstall the busbars..

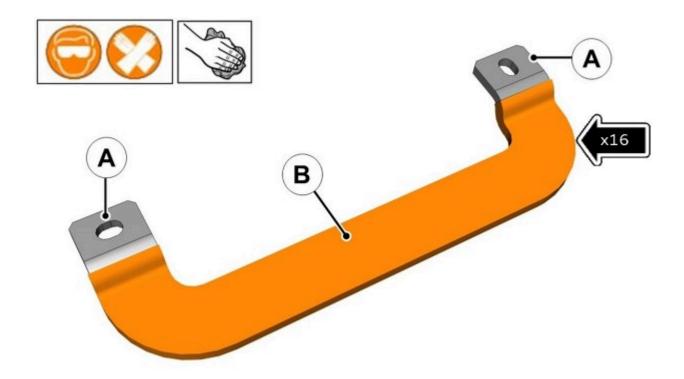
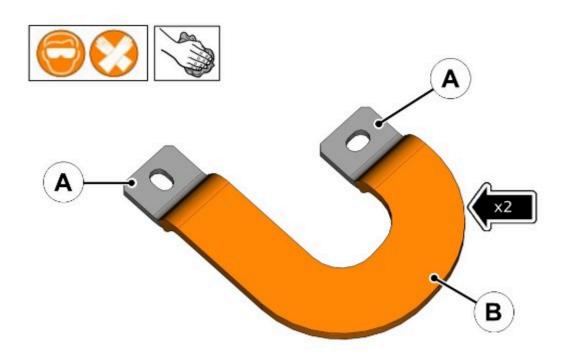
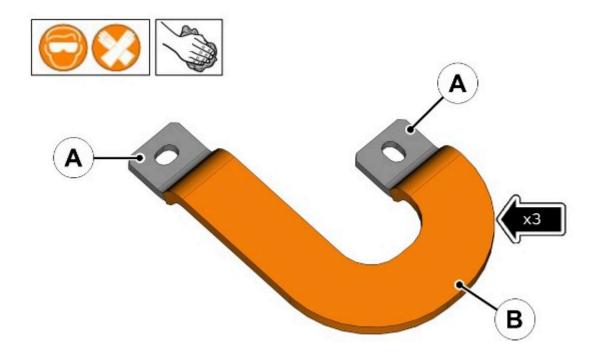
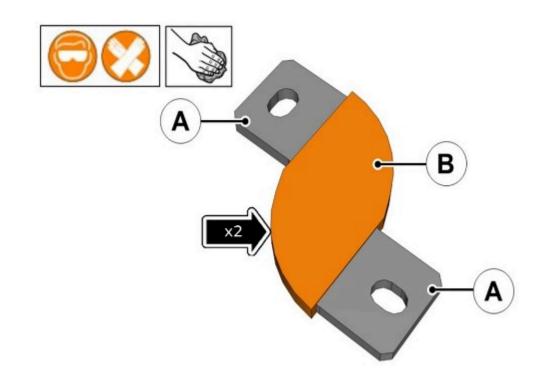
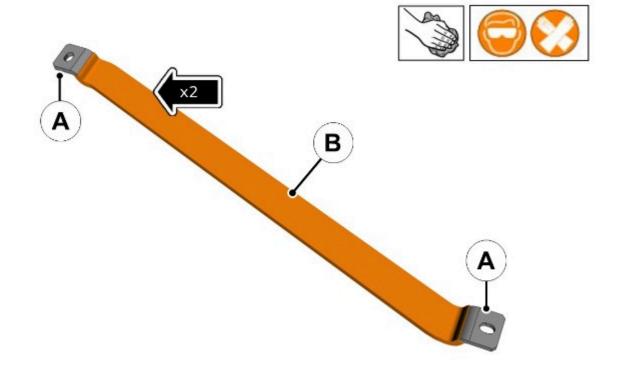
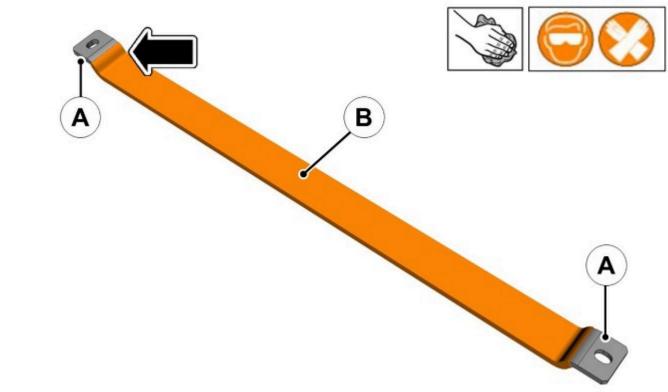
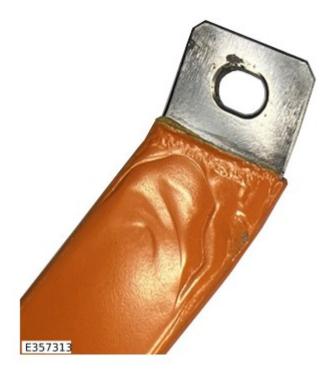
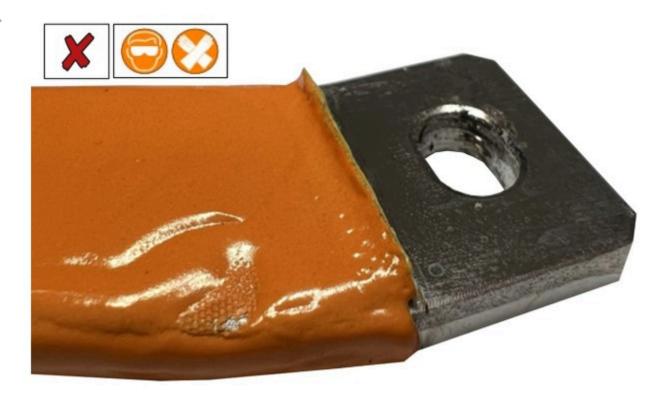
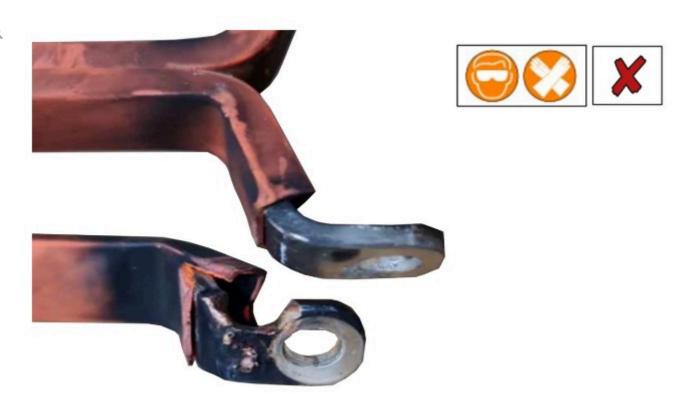
- Make a note of all damage found and the installed position of the damaged busbar within the HV battery.
- All findings must be reported to TA.
- The images marked with a **RED 'X'** show an example of busbar damage caused by overheating, make a note of all damage found.

Throughly inspect the 26 busbars.

- Visually inspect the contact areas (A) for signs of damage.
 Visually inspect the protective insulation for damage (B).
 If there ARE any signs of damage as shown in the images marked with a RED 'X', make a note of the installed position of the busbar in the HV battery. Continue to step 18, do not reinstall the busbars.
- If there ARE NOT any signs of damage, continue to step 18, do not reinstall the busbars.

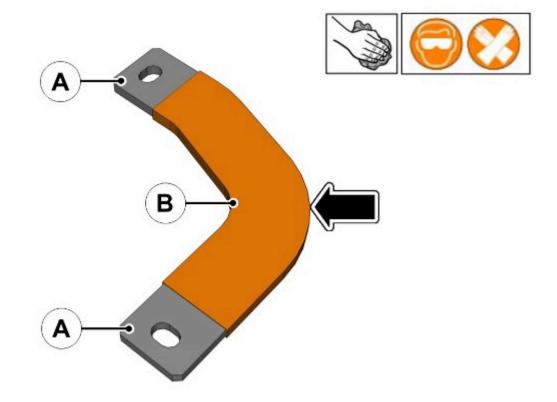
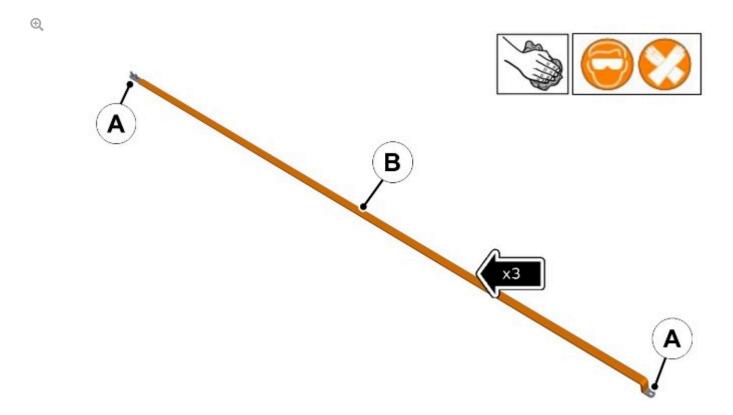
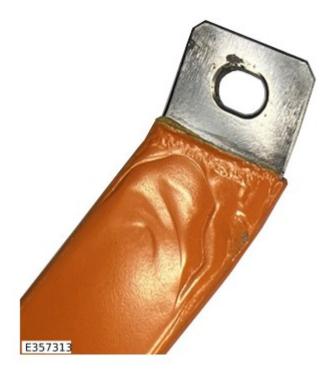
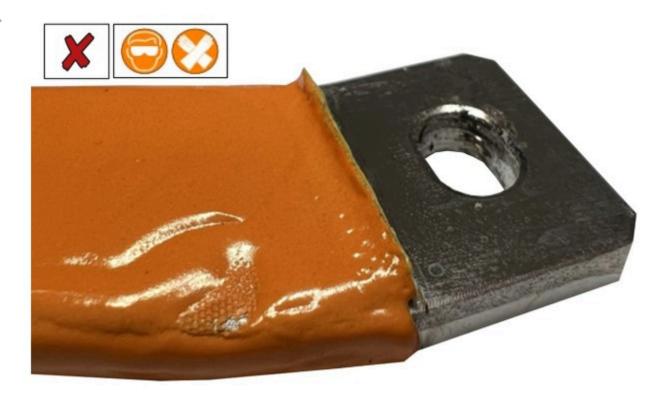
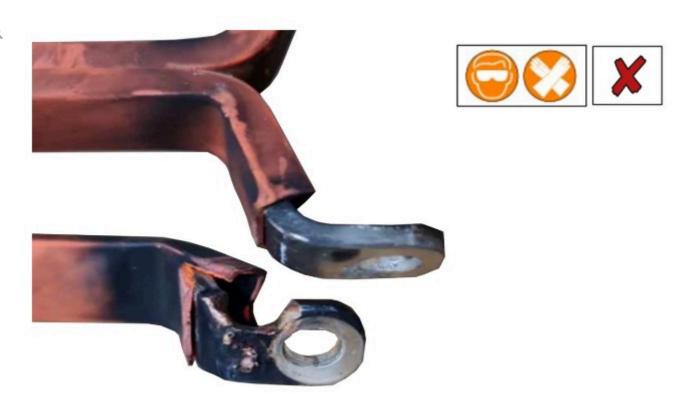
- Make a note of all damage found and the installed position of the damaged busbar within the HV battery.
- All findings must be reported to TA.
- The images marked with a **RED 'X'** show an example of busbar damage caused by overheating, make a note of all damage found.

Thoroughly inspect the 4 busbars removed during **BEM** baseplate removal.

- Visually inspect the contact areas (A) for signs of damage.
 Visually inspect the protective insulation for damage (B).
 If there ARE any signs of damage as shown in the images marked with a RED 'X', make a note of the installed position of the busbar in the HV battery. Continue to step 19.
- If there ARE NOT any signs of damage, continue to step 19.

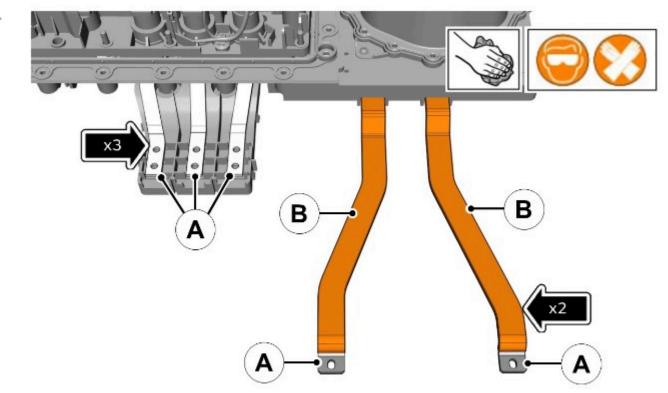
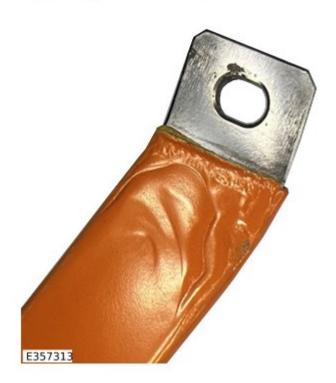
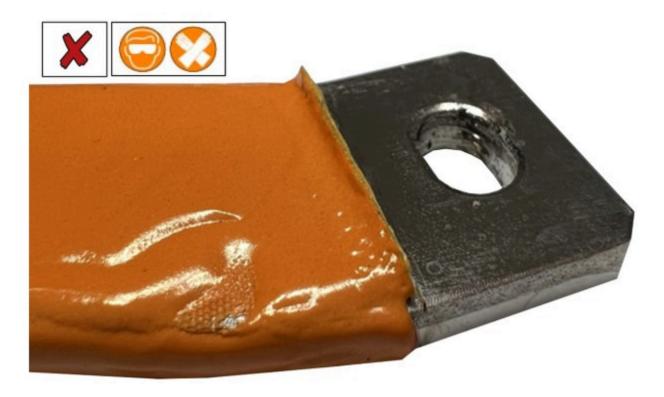
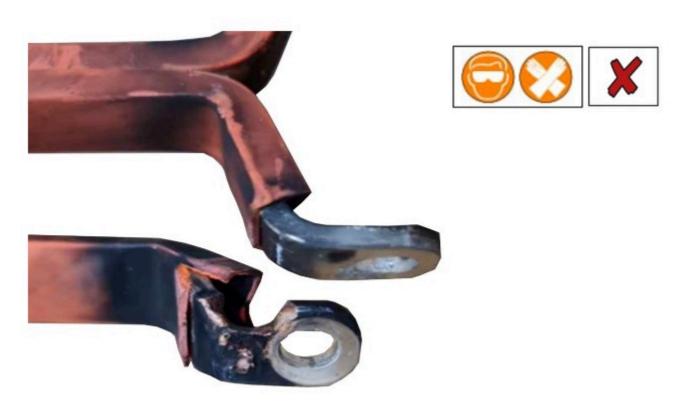
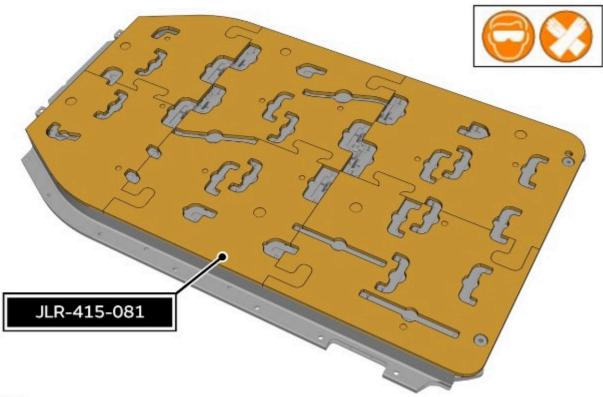
- Make a note of all damage found and the installed position of the damaged busbar within the HV battery.
- All findings must be reported to TA.
- The images marked with a **RED 'X'** show an example of busbar damage caused by overheating, make a note of all damage found.

Thoroughly inspect the 5 **BEM** baseplate busbars.

- Visually inspect the contact areas (A) for signs of damage.
 Visually inspect the protective insulation for damage (B).
 If there ARE any signs of damage as shown in the images marked with a RED 'X', make a note of the installed position of the busbar in the HV battery. Continue to step 20.
- If there ARE NOT any signs of damage, continue to step 20.

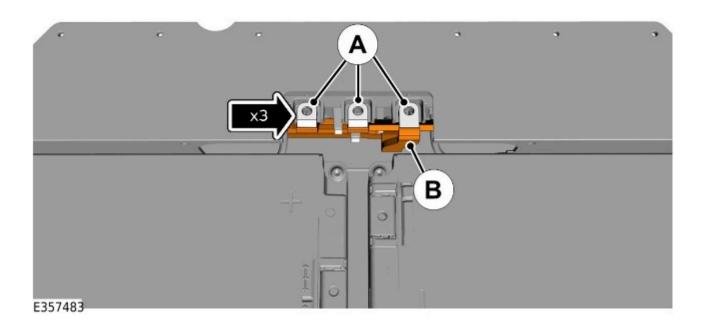
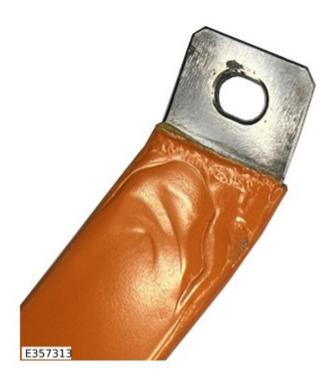
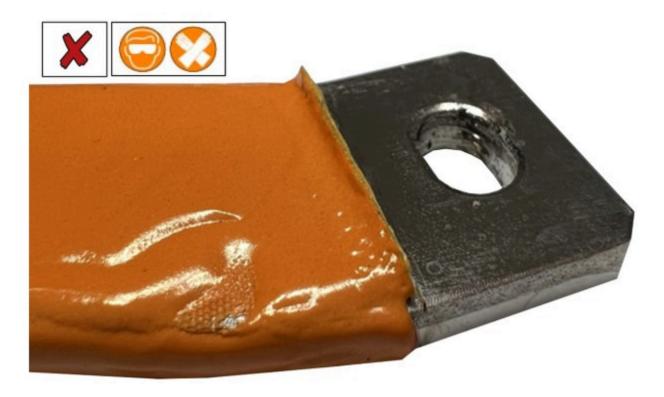
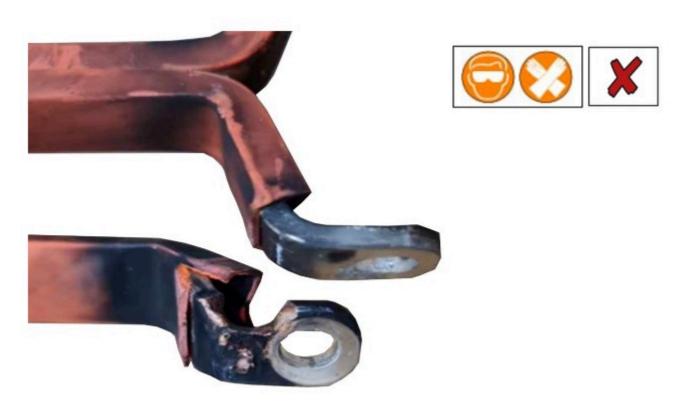
- Make a note of all damage found and the installed position of the damaged busbar within the HV battery.
- All findings must be reported to TA.
- The images marked with a **RED 'X'** show an example of busbar damage caused by overheating, make a note of all damage found.

Thoroughly inspect the 3 HV connector busbars.

- Visually inspect the contact areas (A) for signs of damage.
 Visually inspect the protective insulation for damage (B).
 If there ARE any signs of damage as shown in the images marked with a RED 'X', make a note of the installed position of the busbar in the HV battery. Continue to step 22.
- If there ARE NOT any signs of damage, continue to step 22.

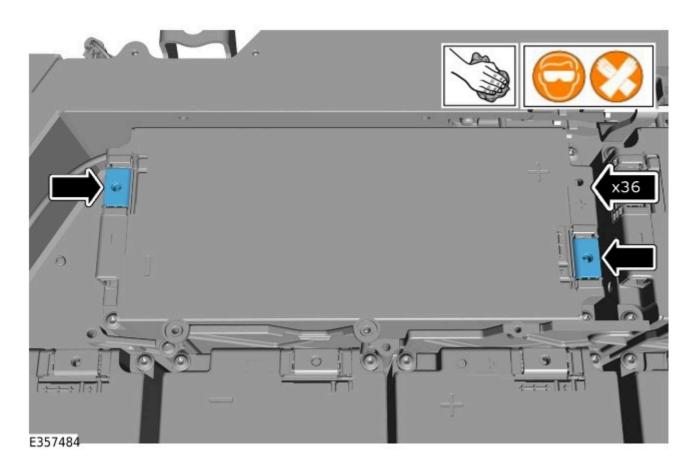
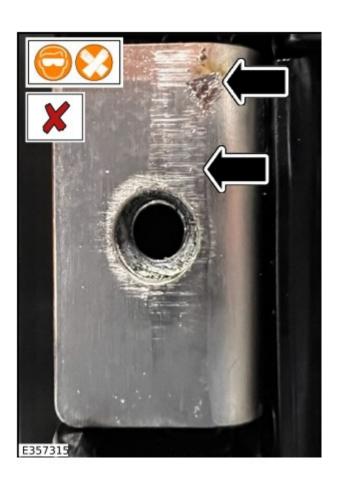
- Each HV battery module has 2 contact areas, all contacts areas **must** be thoroughly inspected.
- All findings **must** be reported to <u>TA</u>.
- The image marked with a RED 'X' show an example of HV battery module damage caused by overheating, make a note of all damage found.

Thoroughly inspect the 36 HV battery module contact areas.

- Remove the battery module terminal blanking caps, JLR-415-016, from the module terminals.
- Clean the HV battery module contact areas with alcohol based cleaning fluid and a lint free cloth.
- Visually inspect the HV battery module contact areas for signs of damage.
- If there ARE any signs of damage as shown in the images marked with a RED 'X', make a note of the installed position of the busbar in the HV battery. Continue to step 23.
- If there ARE NOT any signs of damage, continue to step 23.
