## SAFETY RELATED RECALL

Global Recall Action  
Number: H468v5

<b>Subject:</b>  <b>High Voltage (HV) Battery Busbar Fixings</b>	Publication No.: H468v5
	Model: I-PACE (X590)
	Model Year: 2019 - 2024
	Date of Issue: 01 July 2025

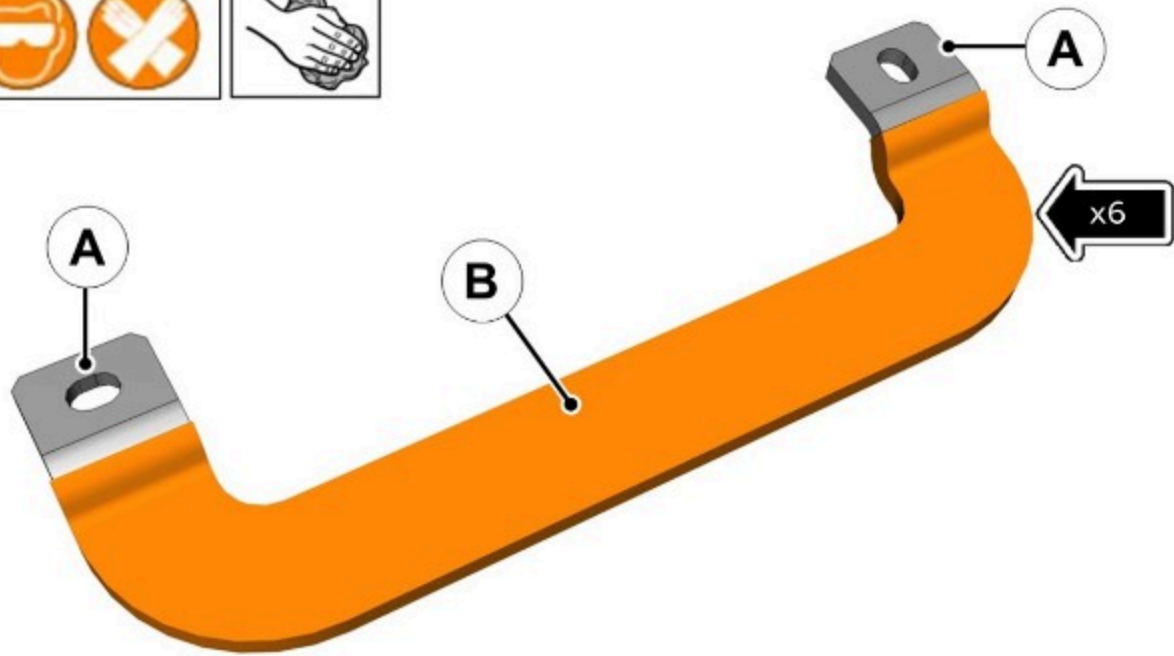
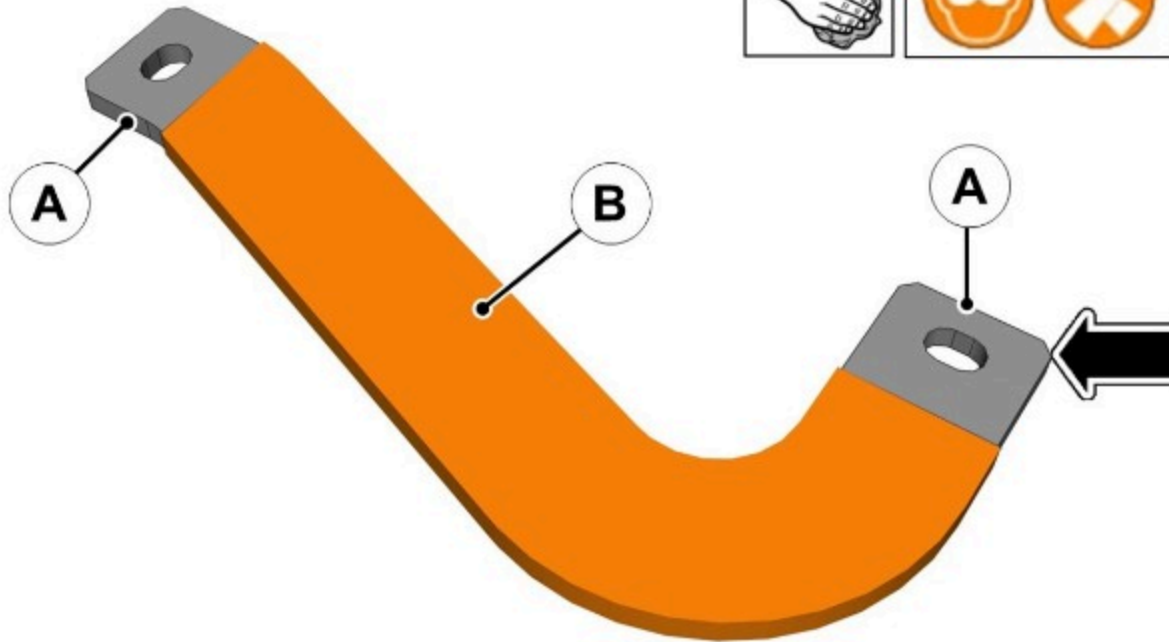
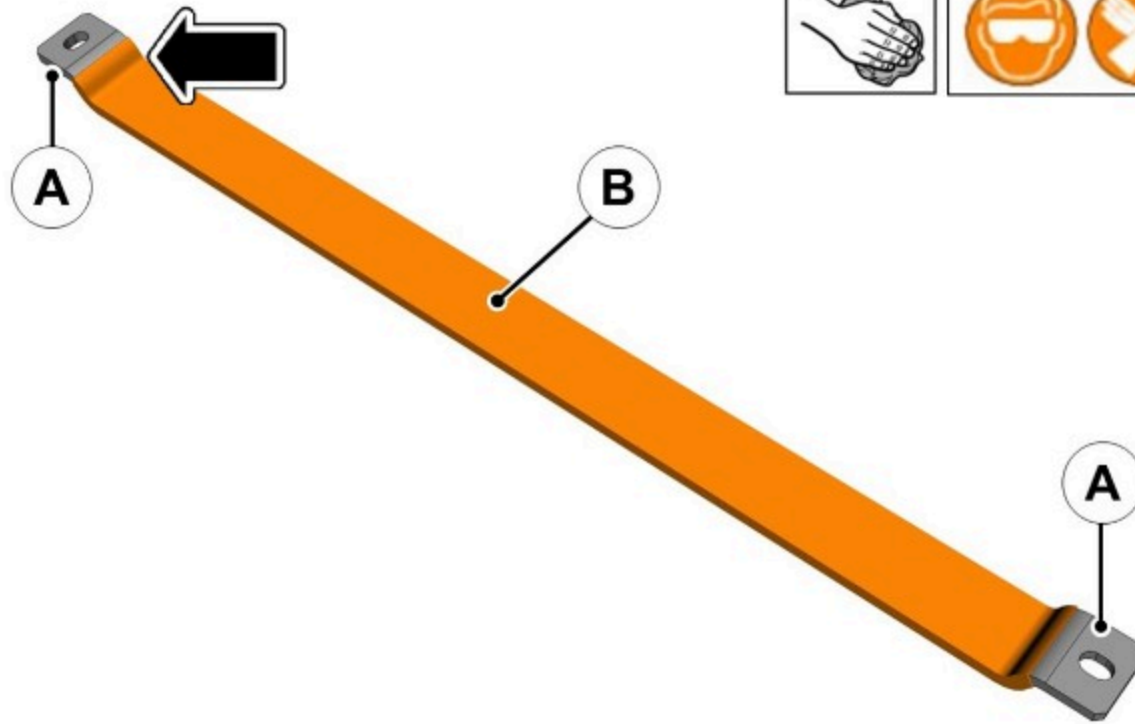
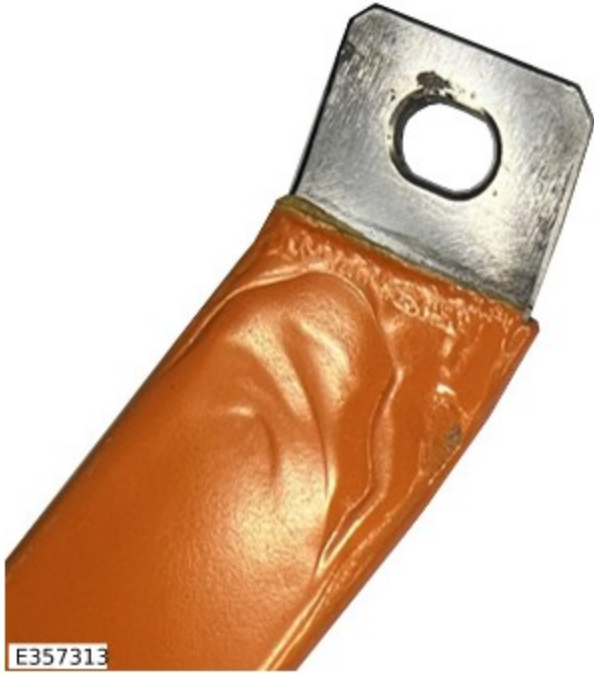
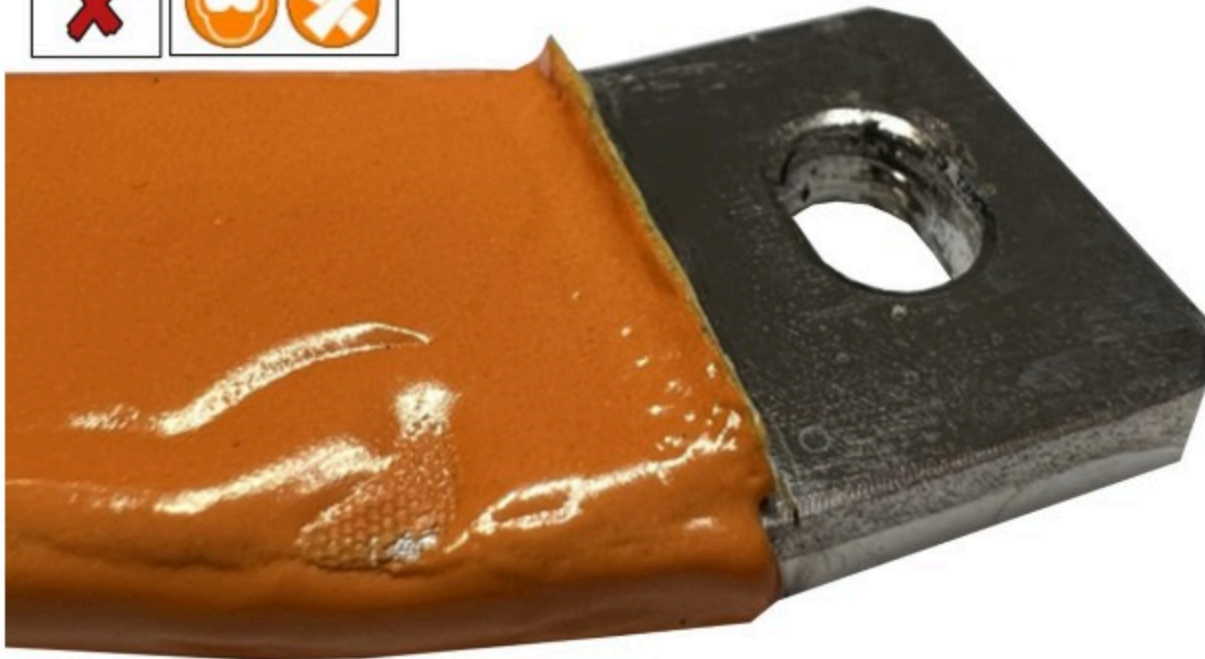
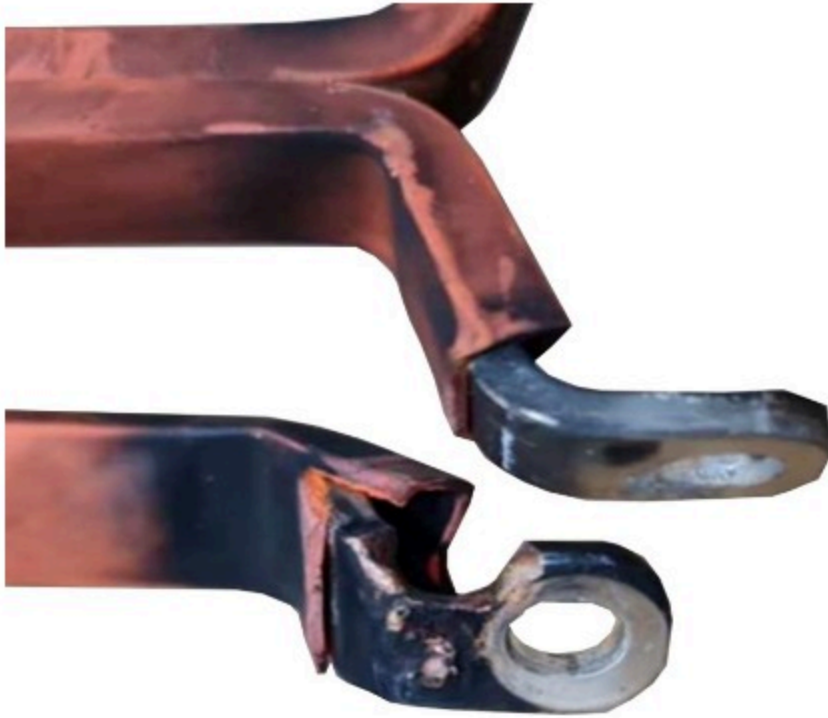
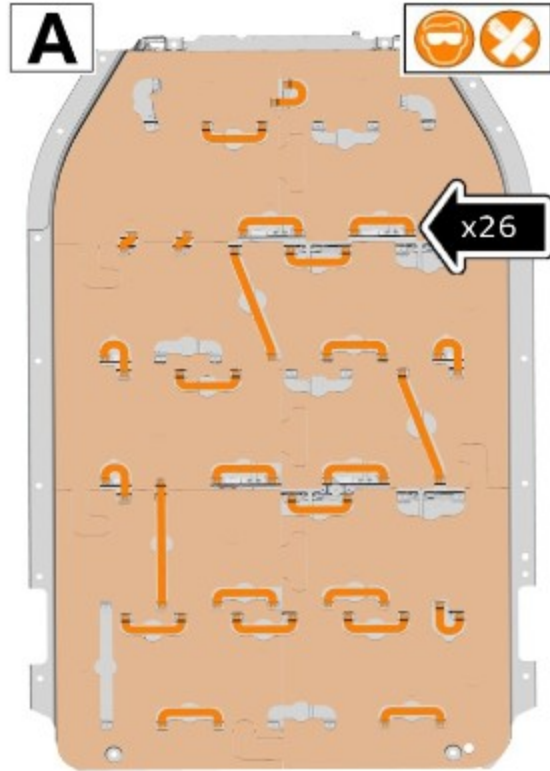
- Make a note of all damage found and the installed position of the damaged busbar within the [HV](#) battery.
- All findings **must** be reported to [TA](#).
- The images marked with a **RED 'X'** show an example of busbar damage caused by overheating, make a note of all damage found.

Thoroughly inspect the 8 busbars removed for safe voltage reduction.

- Clean the busbar contact areas (**A**) with alcohol based cleaning fluid and a lint free cloth.
- Visually inspect the contact areas (**A**) for signs of damage.
- Visually inspect the protective insulation for damage (**B**).
- If there **ARE** any signs of damage as shown in the images marked with a **RED 'X'**, make a note of the installed position of the busbar in the [HV](#) battery. **Continue to step 16, do not reinstall the busbars.**
- If there **ARE NOT** any signs of damage, **continue to step 16, do not reinstall the busbars.**

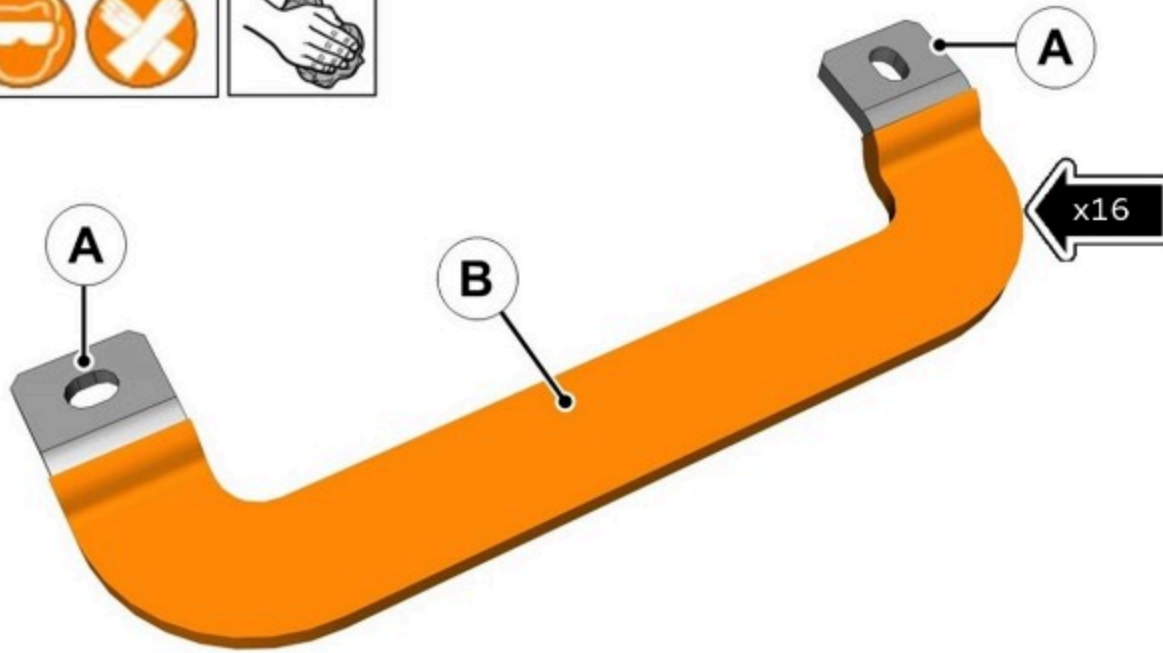
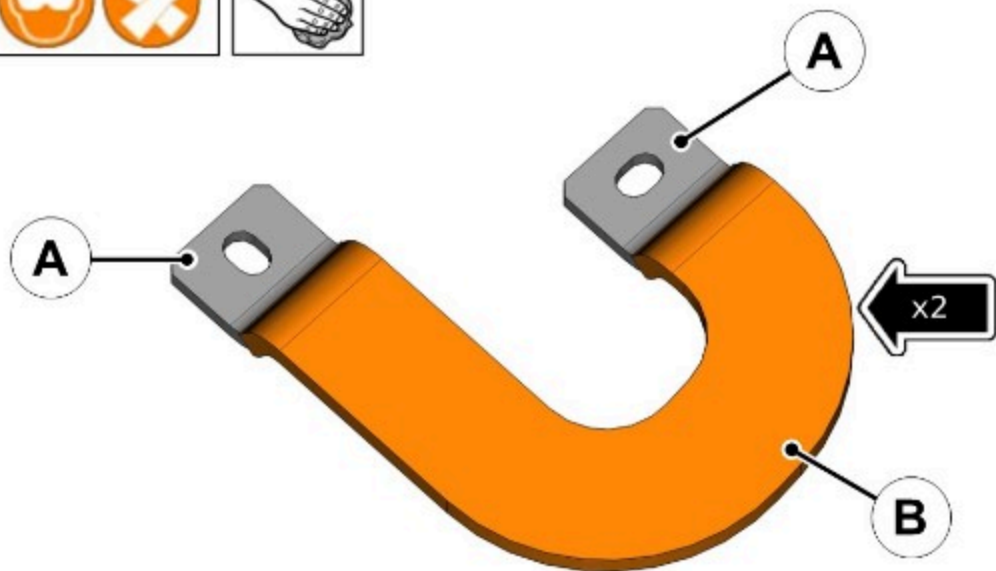
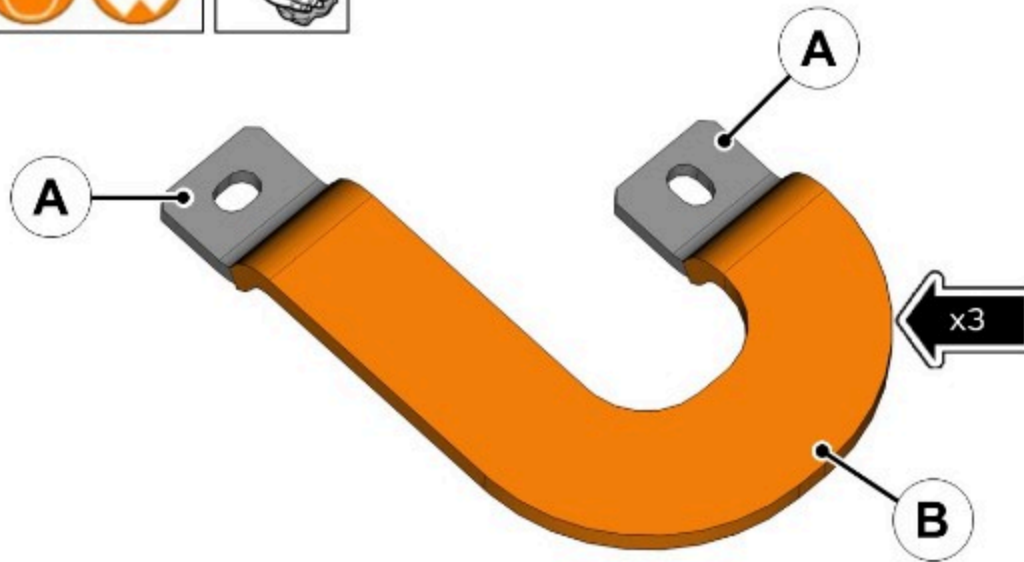
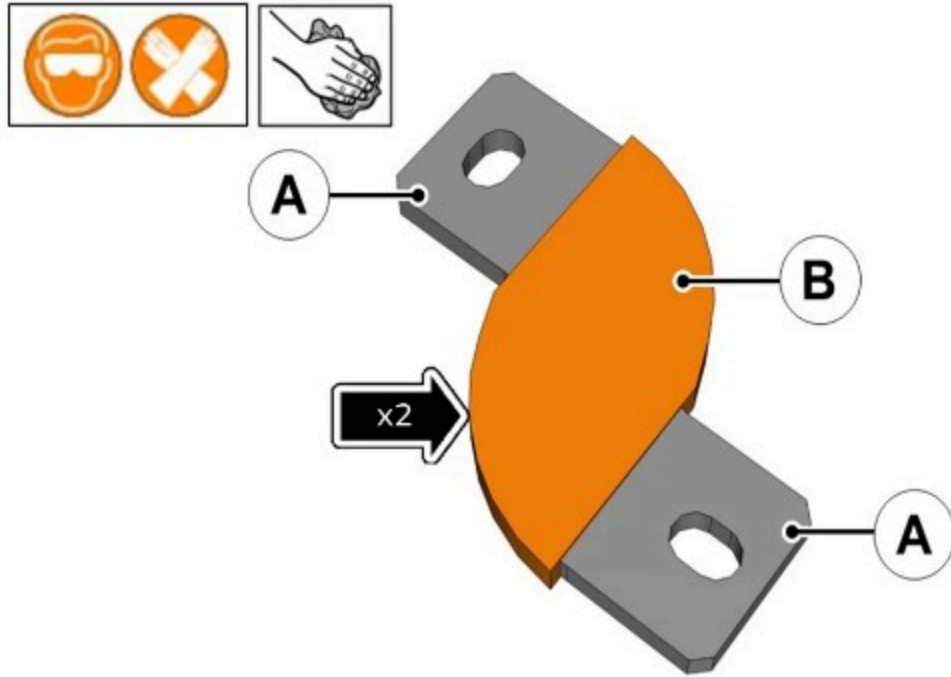
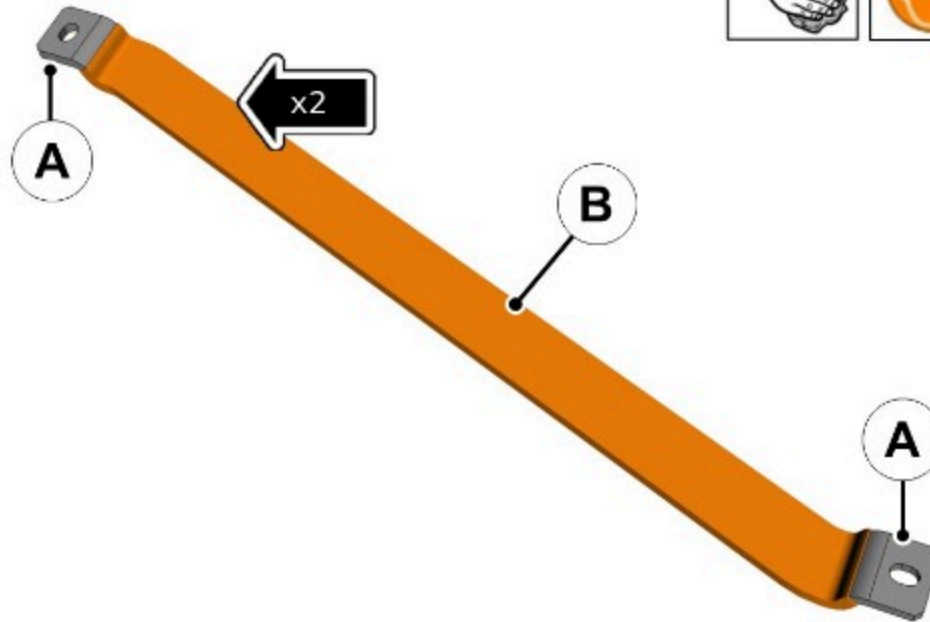
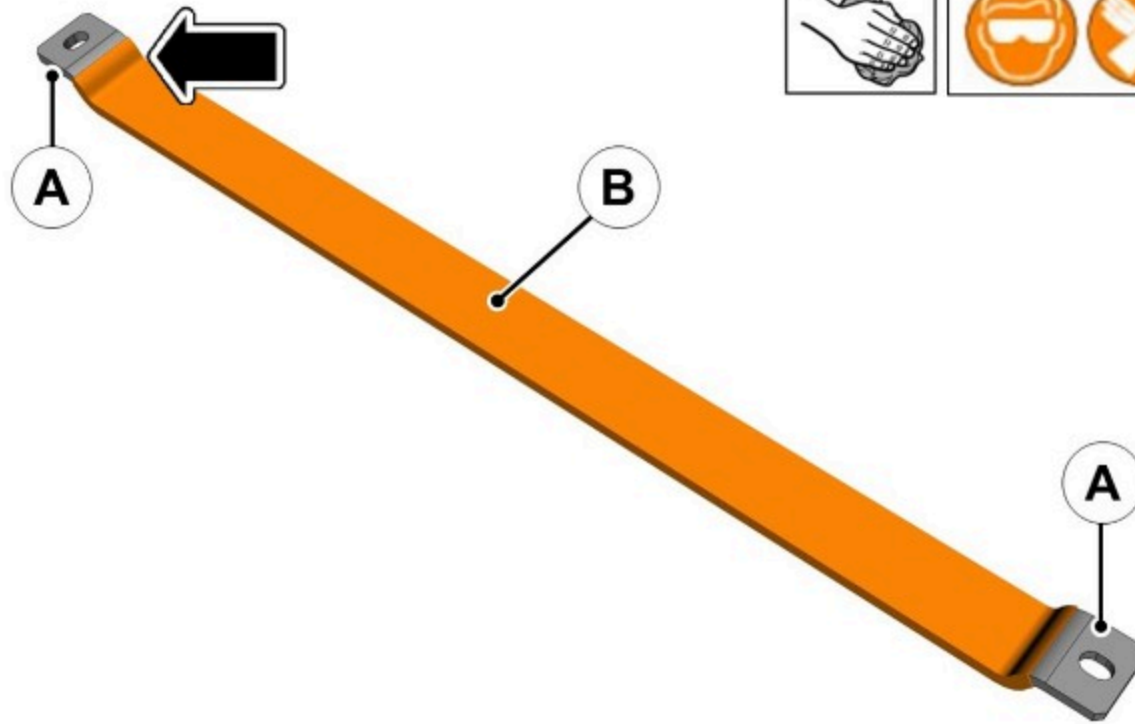
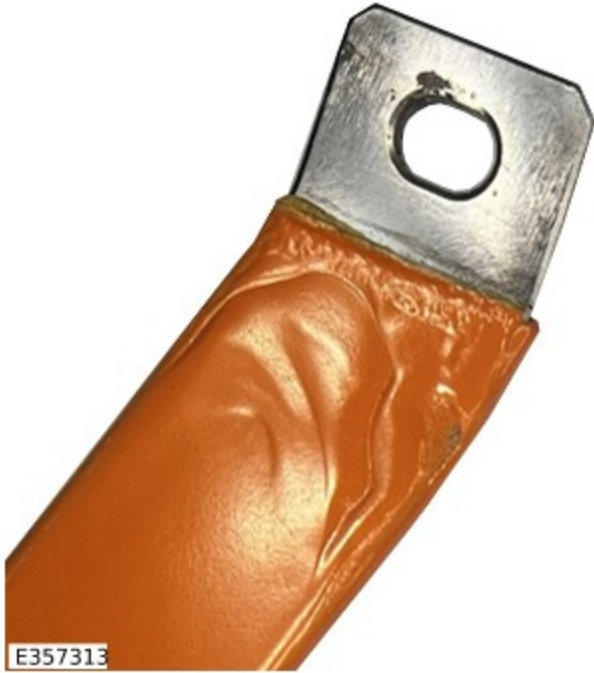
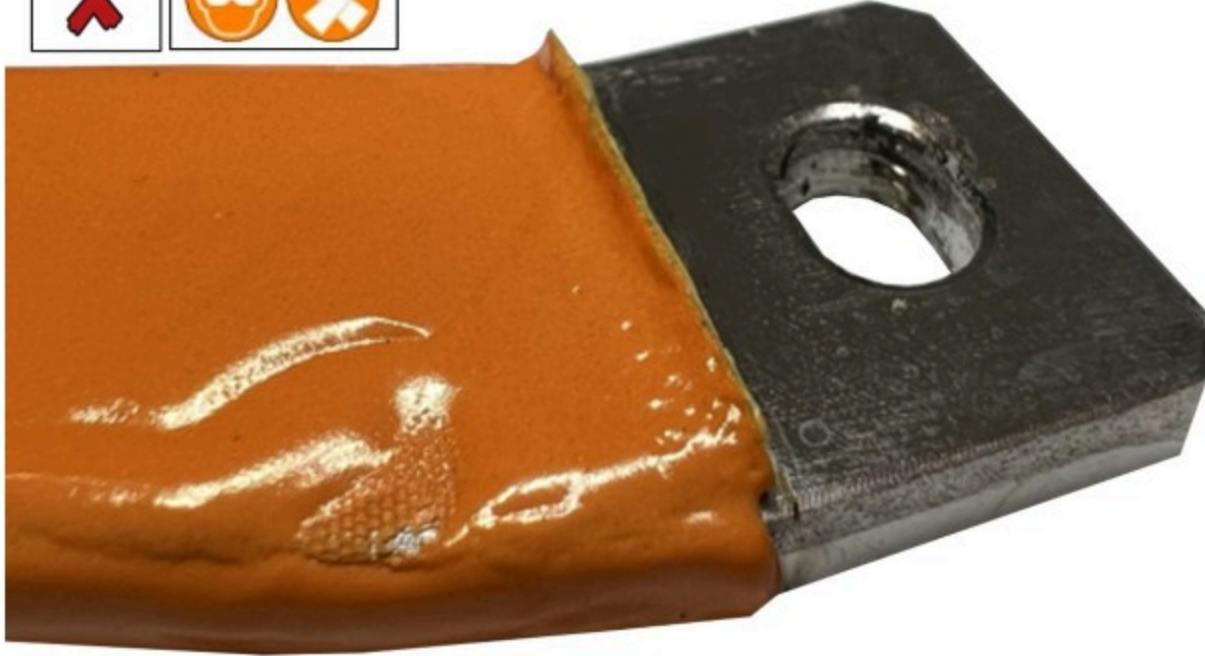
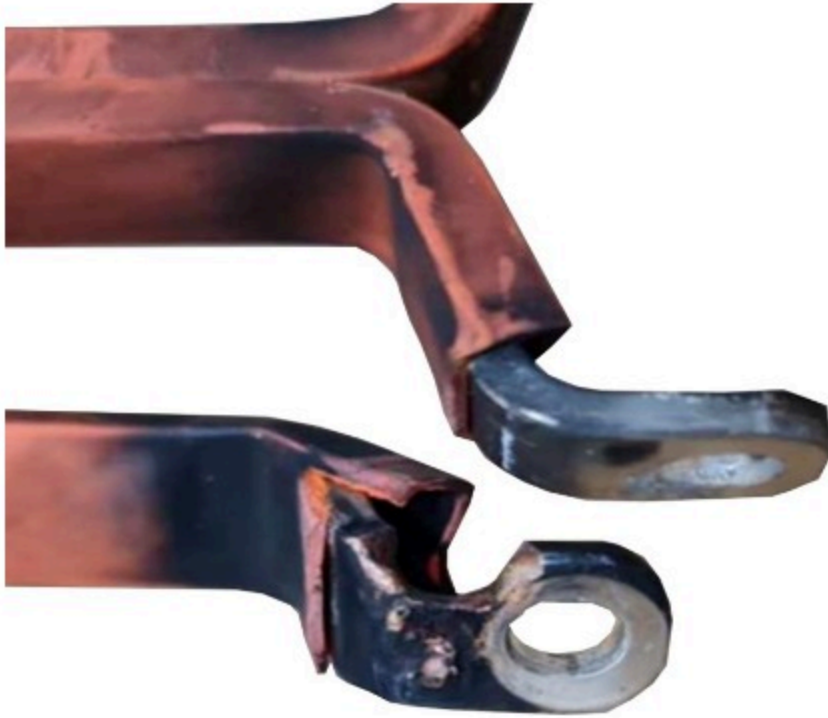
- Make a note of all damage found and the installed position of the damaged busbar within the [HV](#) battery.
- All findings **must** be reported to [TA](#).
- The images marked with a **RED 'X'** show an example of busbar damage caused by overheating, make a note of all damage found.

Thoroughly inspect the 26 busbars.

- Clean the busbar contact areas (**A**) with alcohol based cleaning fluid and a lint free cloth.
- Visually inspect the contact areas (**A**) for signs of damage.
- Visually inspect the protective insulation for damage (**B**).
- If there **ARE** any signs of damage as shown in the images marked with a **RED 'X'**, make a note of the installed position of the busbar in the [HV](#) battery. **Continue to step 18, do not reinstall the busbars.**
- If there **ARE NOT** any signs of damage, **continue to step 18, do not reinstall the busbars.**

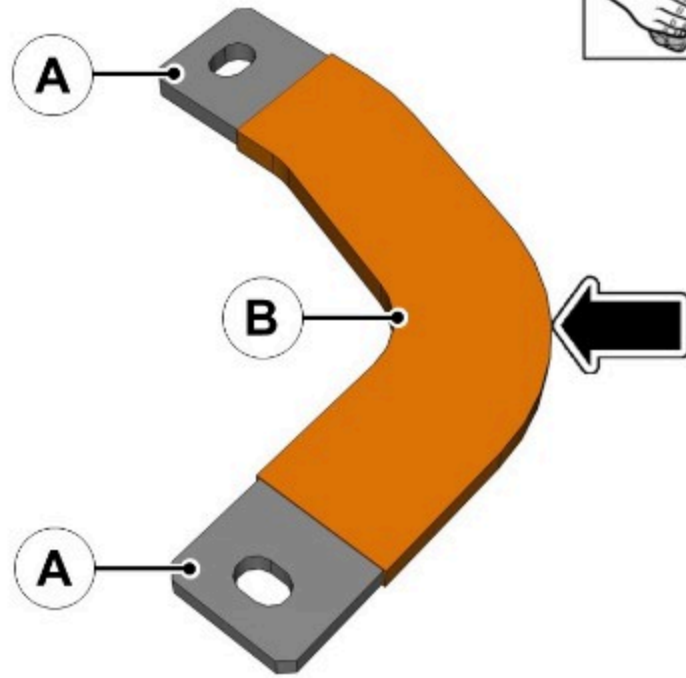
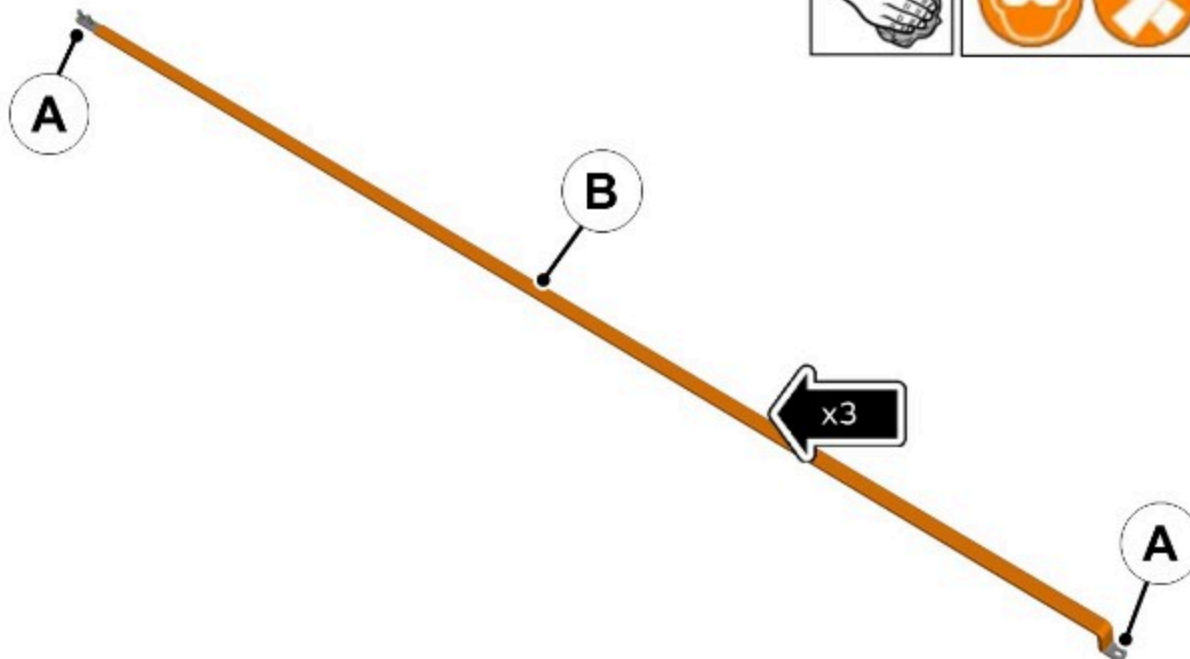
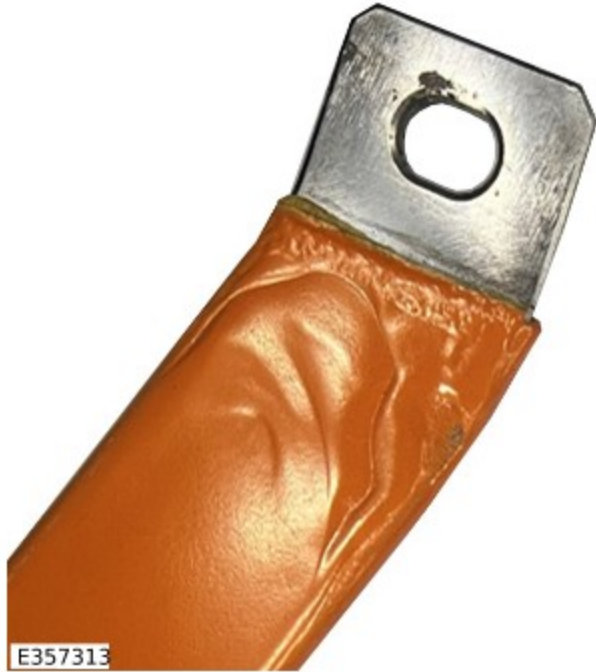
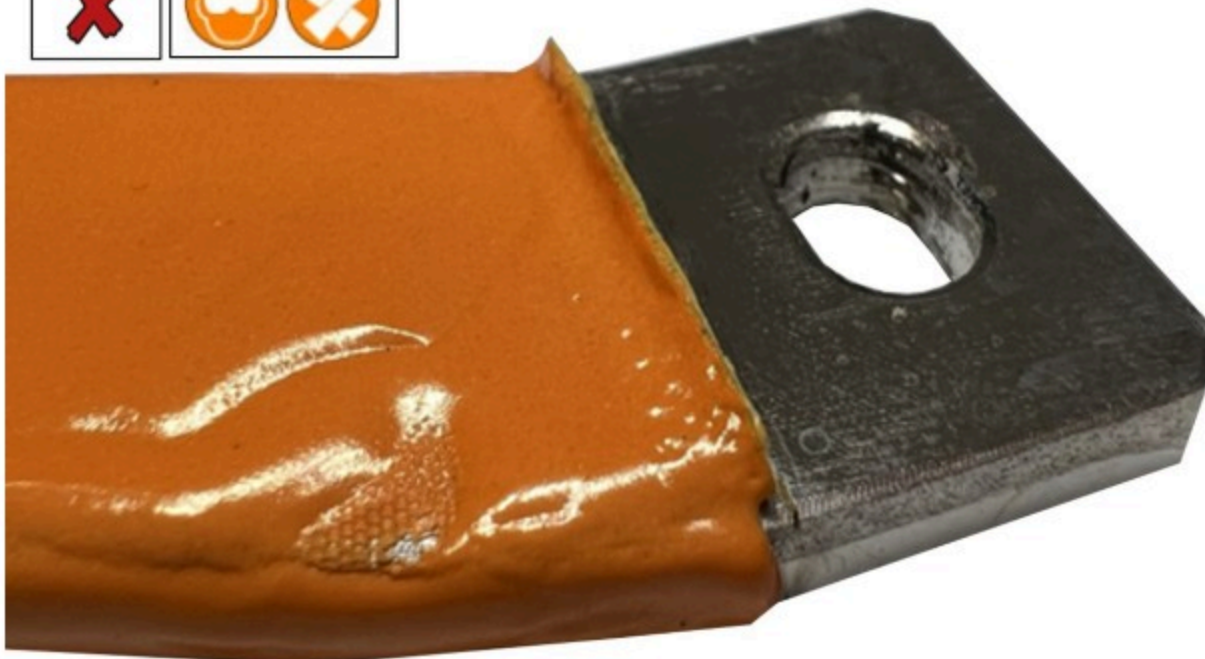
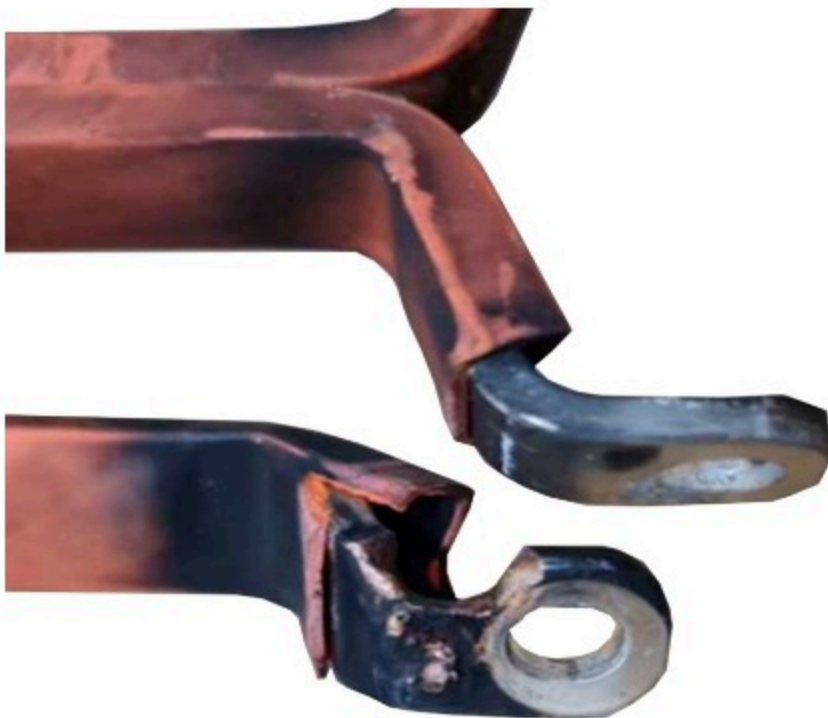
- Make a note of all damage found and the installed position of the damaged busbar within the [HV](#) battery.
- All findings **must** be reported to [TA](#).
- The images marked with a **RED 'X'** show an example of busbar damage caused by overheating, make a note of all damage found.

Thoroughly inspect the 4 busbars removed during [BEM](#) baseplate removal.

- Clean the busbar contact areas (**A**) with alcohol based cleaning fluid and a lint free cloth.
- Visually inspect the contact areas (**A**) for signs of damage.
- Visually inspect the protective insulation for damage (**B**).
- If there **ARE** any signs of damage as shown in the images marked with a **RED 'X'**, make a note of the installed position of the busbar in the [HV](#) battery. **Continue to step 19.**
- If there **ARE NOT** any signs of damage, **continue to step 19.**

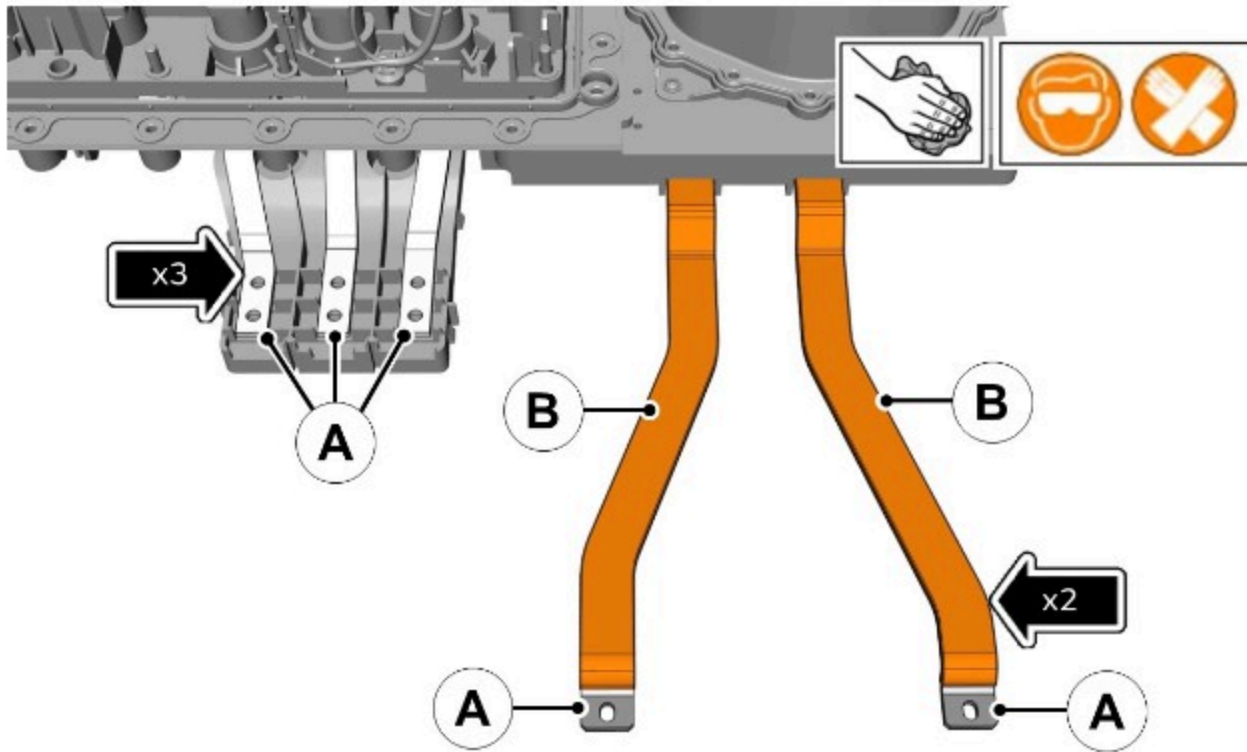
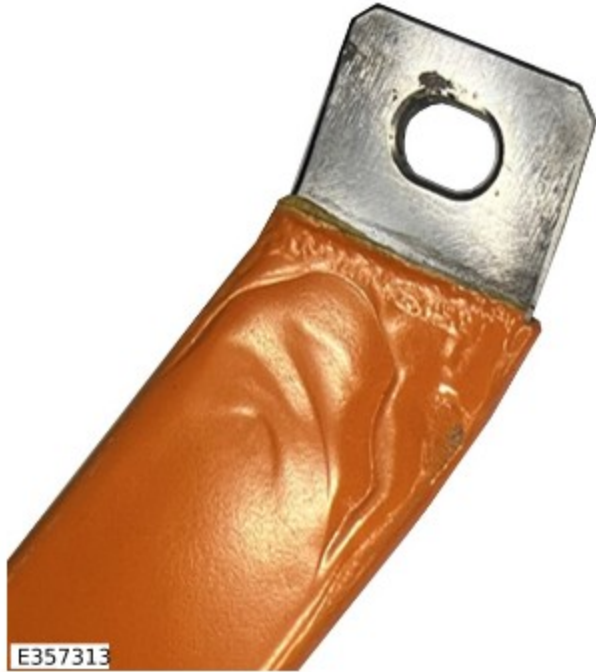
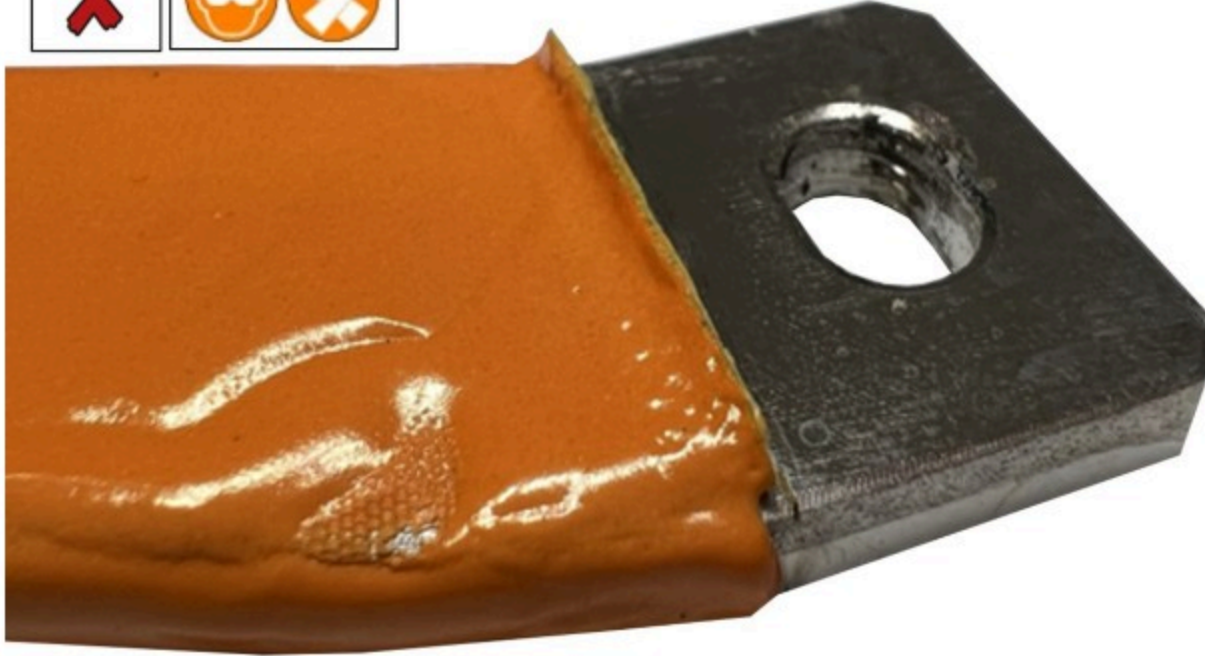
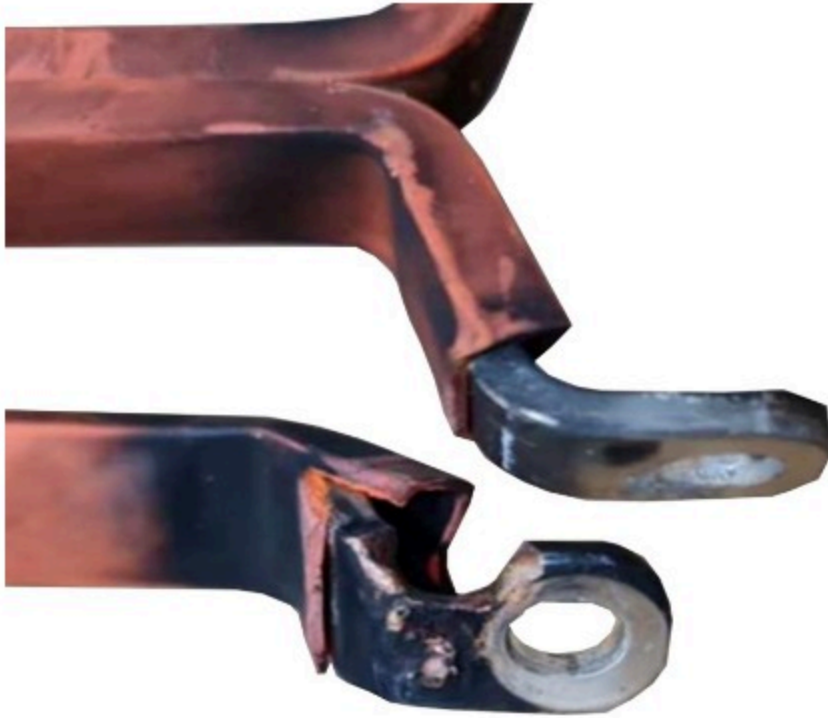
- Make a note of all damage found and the installed position of the damaged busbar within the [HV](#) battery.
- All findings **must** be reported to [TA](#).
- The images marked with a **RED 'X'** show an example of busbar damage caused by overheating, make a note of all damage found.

Thoroughly inspect the 5 [BEM](#) baseplate busbars.

- Clean the busbar contact areas (**A**) with alcohol based cleaning fluid and a lint free cloth.
- Visually inspect the contact areas (**A**) for signs of damage.
- Visually inspect the protective insulation for damage (**B**).
- If there **ARE** any signs of damage as shown in the images marked with a **RED 'X'**, make a note of the installed position of the busbar in the [HV](#) battery. **Continue to step 20.**
- If there **ARE NOT** any signs of damage, **continue to step 20.**

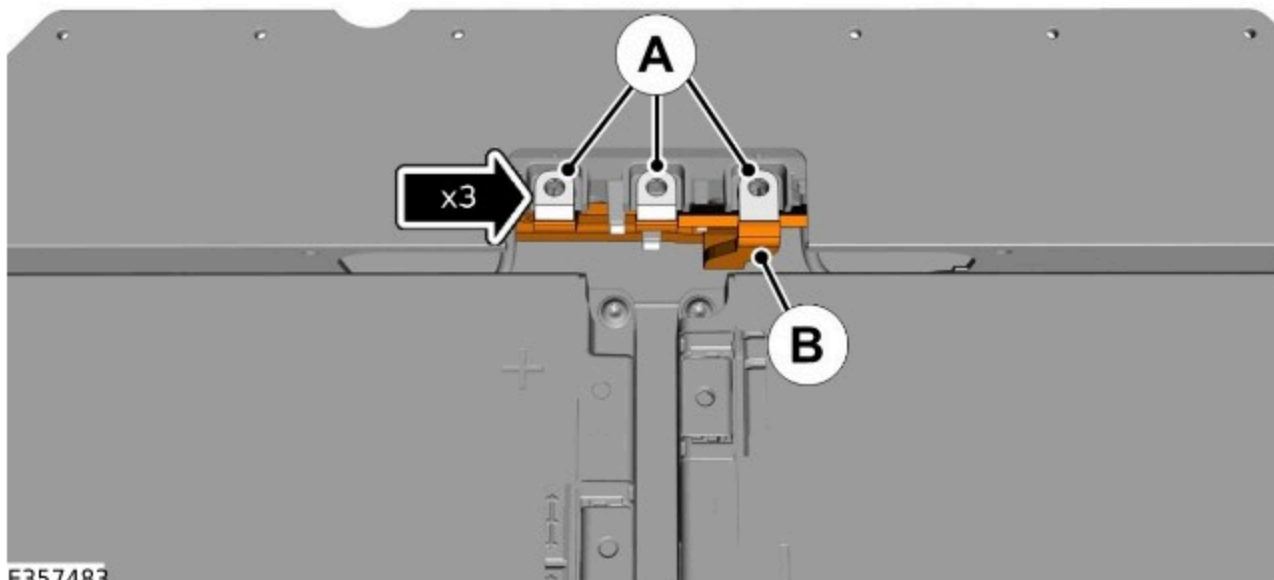
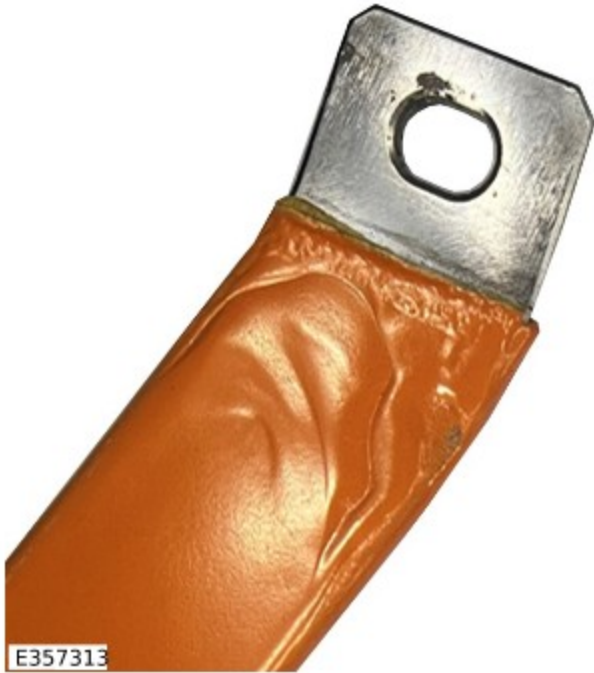
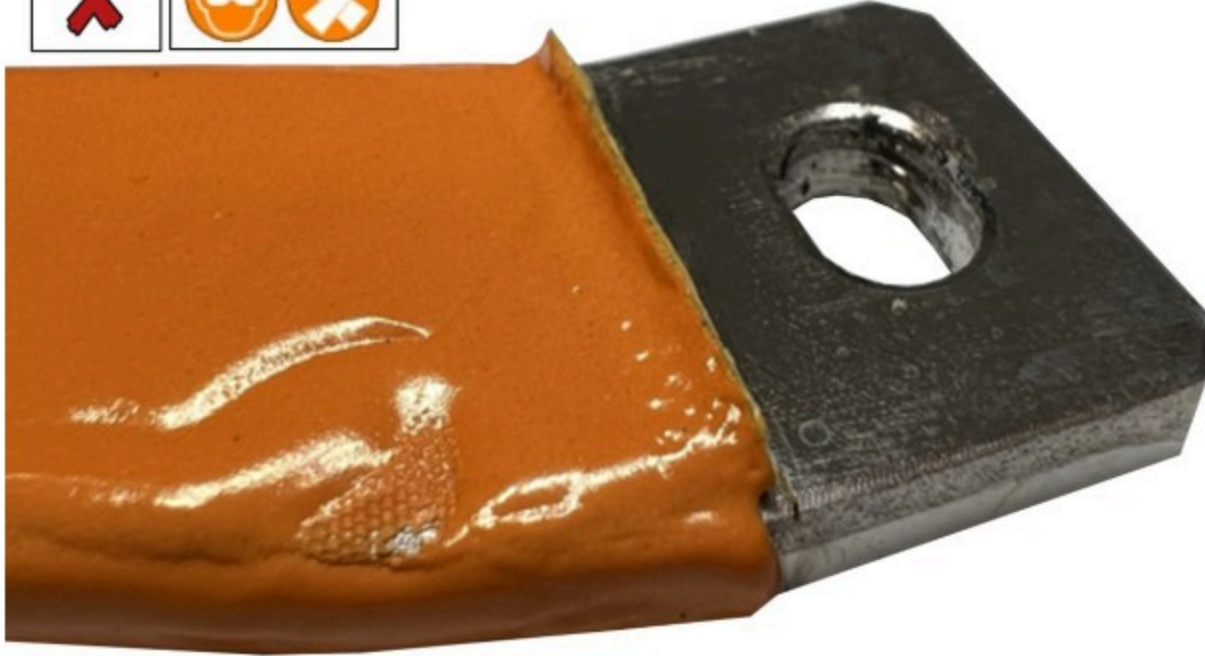
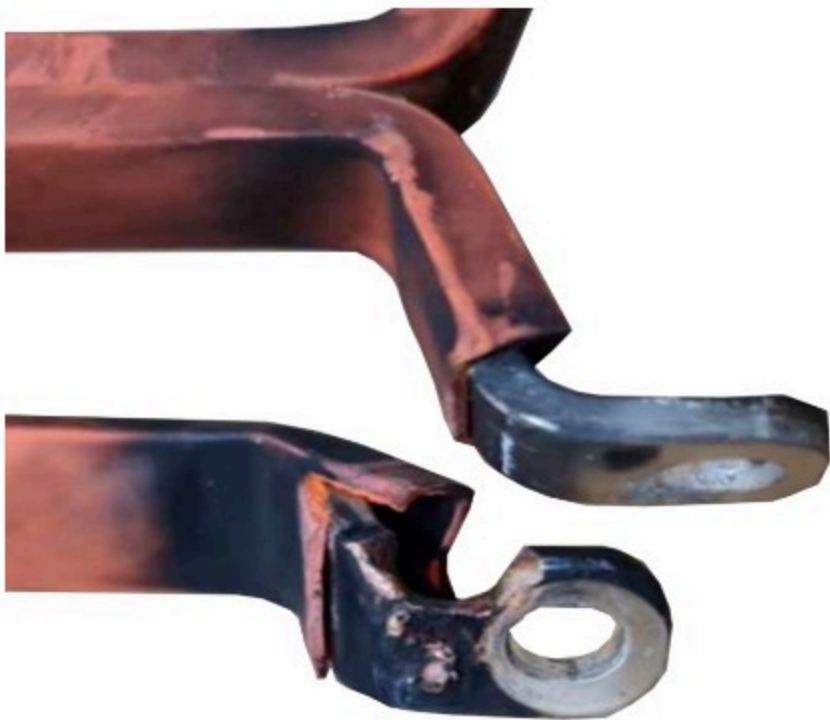
- Make a note of all damage found and the installed position of the damaged busbar within the [HV](#) battery.
- All findings **must** be reported to [TA](#).
- The images marked with a **RED 'X'** show an example of busbar damage caused by overheating, make a note of all damage found.

Thoroughly inspect the 3 [HV](#) connector busbars.

- Clean the busbar contact areas (**A**) with alcohol based cleaning fluid and a lint free cloth.
- Visually inspect the contact areas (**A**) for signs of damage.
- Visually inspect the protective insulation for damage (**B**).
- If there **ARE** any signs of damage as shown in the images marked with a **RED 'X'**, make a note of the installed position of the busbar in the [HV](#) battery. **Continue to step 22.**
- If there **ARE NOT** any signs of damage, **continue to step 22.**

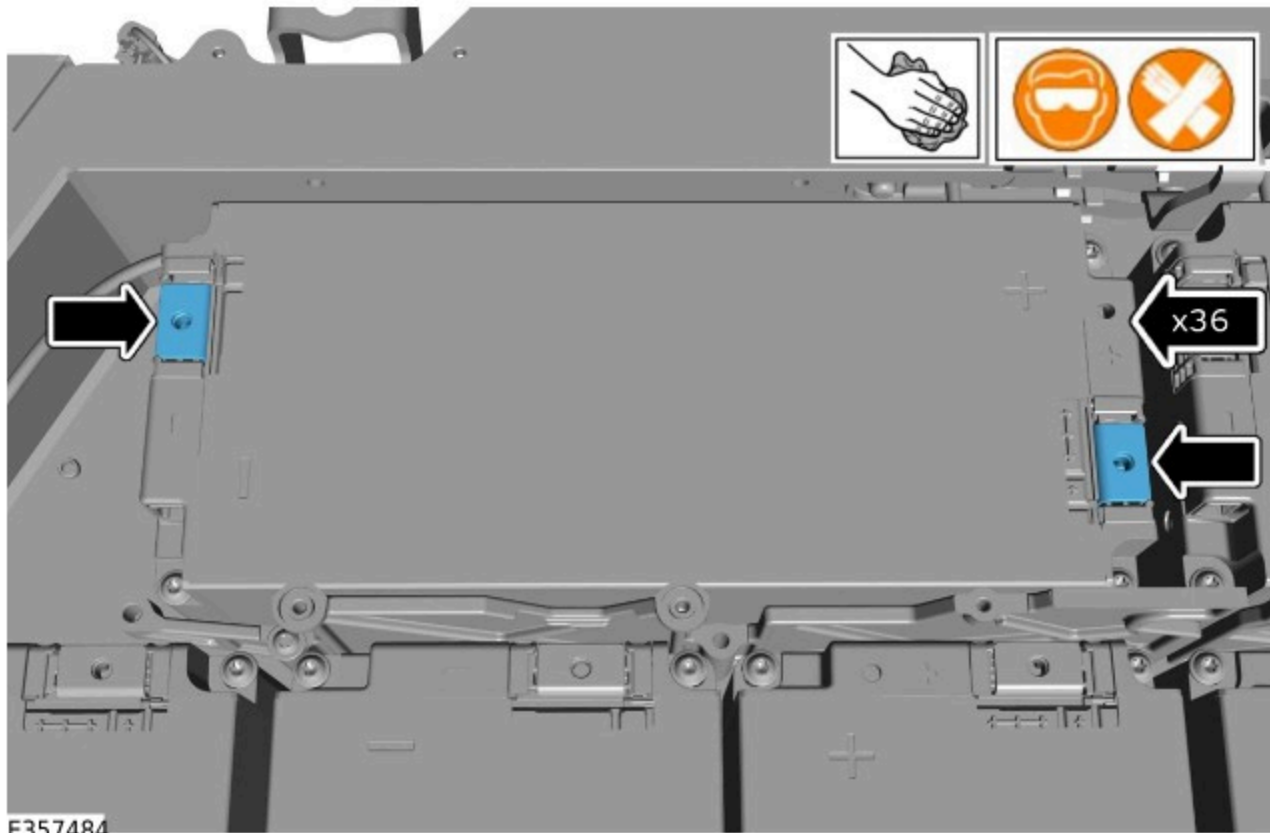
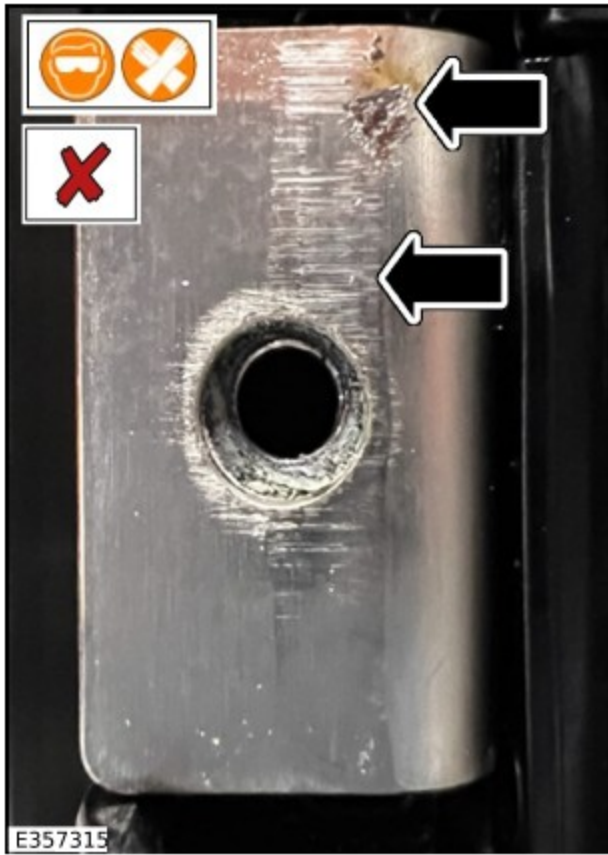
- Each [HV](#) battery module has 2 contact areas, all contacts areas **must** be thoroughly inspected.
- All findings **must** be reported to [TA](#).
- The image marked with a **RED 'X'** show an example of [HV](#) battery module damage caused by overheating, make a note of all damage found.

Thoroughly inspect the 36 [HV](#) battery module contact areas.

- Remove the battery module terminal blanking caps, JLR-415-016, from the module terminals.
- Clean the [HV](#) battery module contact areas with alcohol based cleaning fluid and a lint free cloth.
- Visually inspect the [HV](#) battery module contact areas for signs of damage.
- If there **ARE** any signs of damage as shown in the images marked with a **RED 'X'**, make a note of the installed position of the busbar in the [HV](#) battery. **Continue to step 23.**
- If there **ARE NOT** any signs of damage, **continue to step 23.**
