SAFETY RELATED RECALL

Global Recall Action
Number: H468v3

Subject: High Voltage (HV) Battery Busbar Fixings	Publication No.: H468v3
	Model: I-PACE (X590)
	Model Year: 2019 - 2021
	Date of Issue: 29 April 2024

SERVICE INSTRUCTION - H468V3

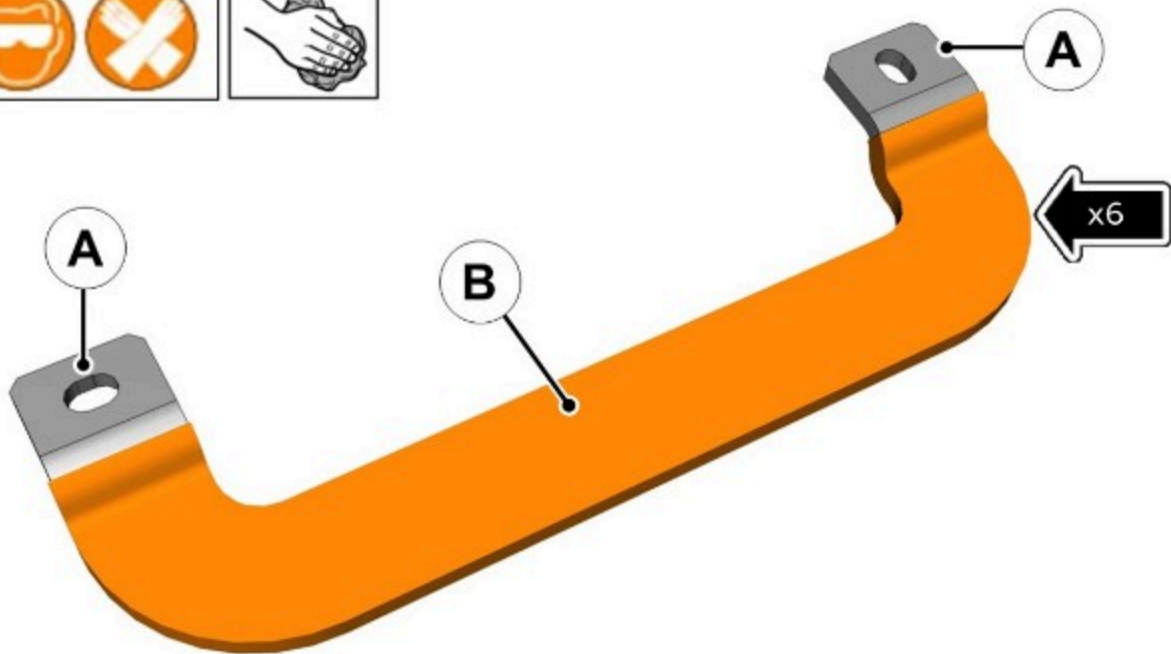
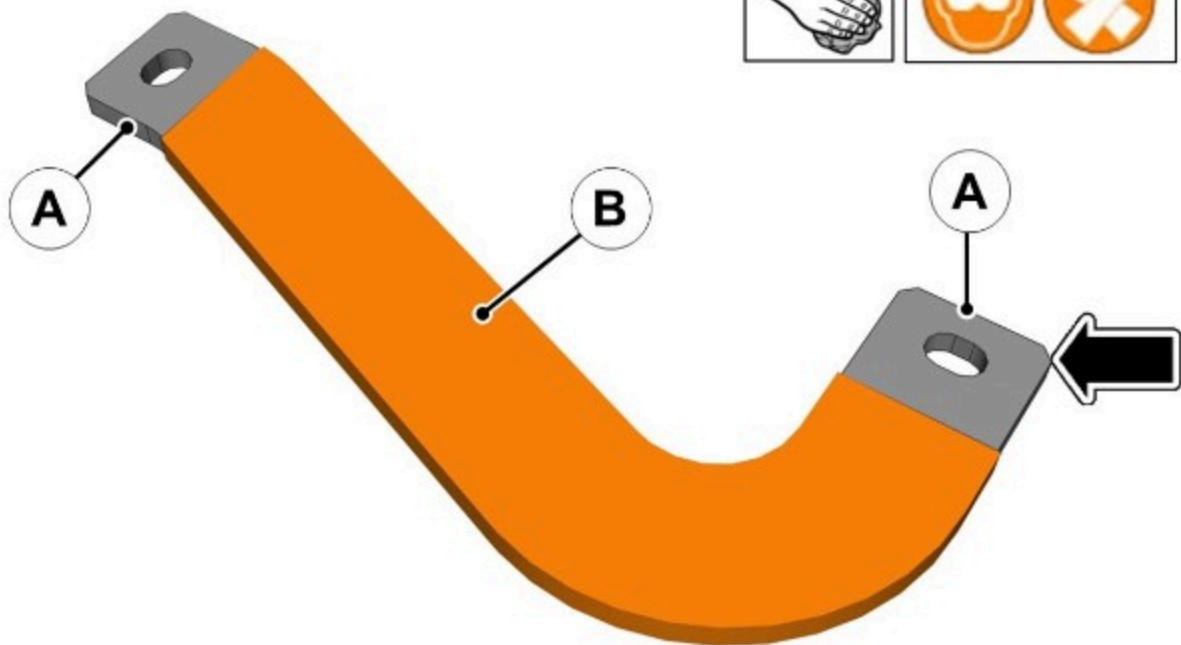
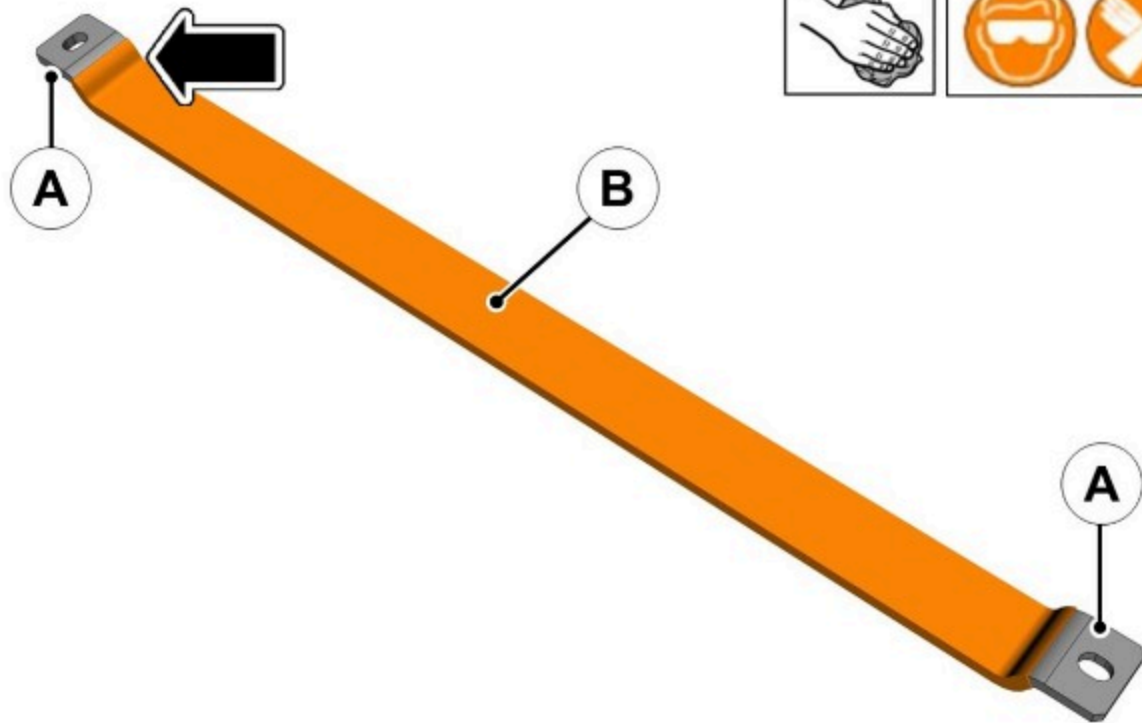
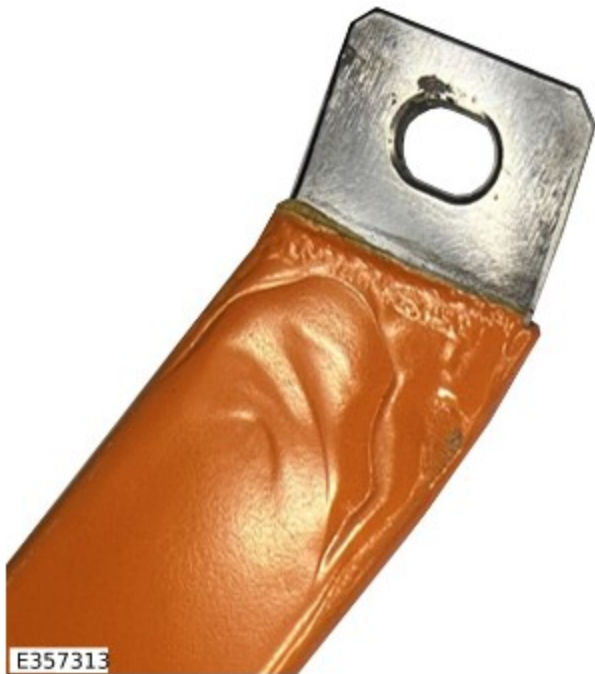
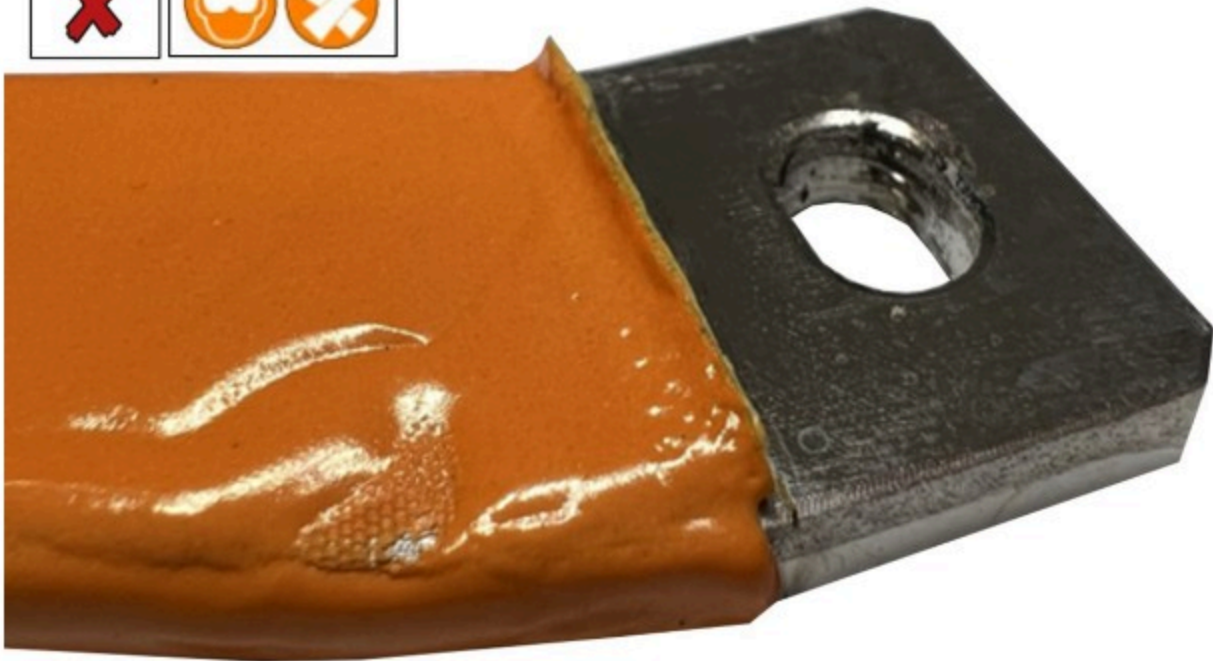
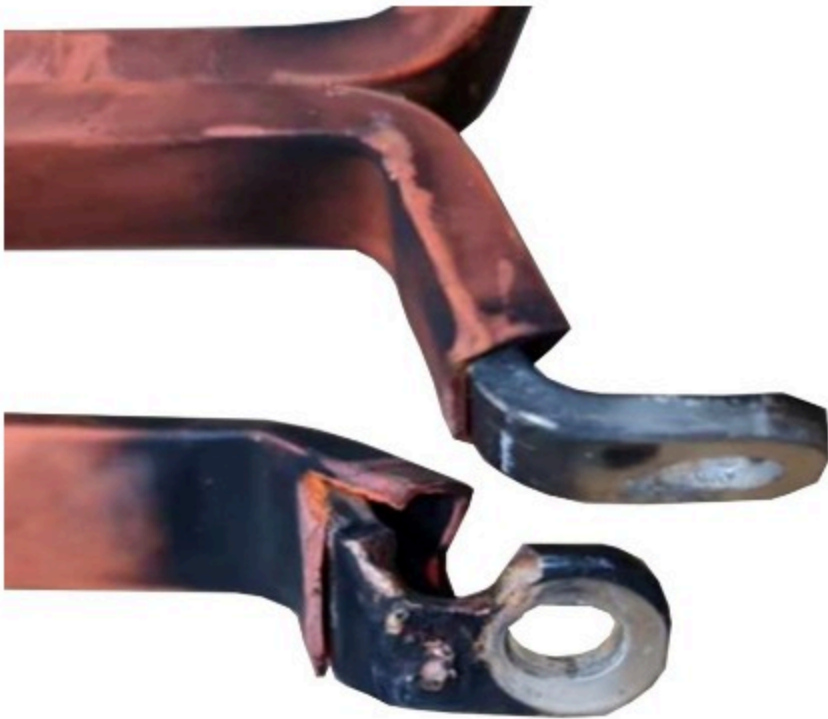
- Make a note of all damage found and the installed position of the damaged busbar within the [H.V.](#) battery.
- All findings **must** be reported to [T.A.](#)
- The images marked with a **RED 'X'** show an example of busbar damage caused by overheating, make a note of all damage found.

Thoroughly inspect the 8 busbars removed for safe voltage reduction.

- Clean the busbar contact areas (**A**) with alcohol based cleaning fluid and a lint free cloth.
- Visually inspect the contact areas (**A**) for signs of damage.
- Visually inspect the protective insulation for damage (**B**).
- If there **ARE** any signs of damage as shown in the images marked with a **RED 'X'**, make a note of the installed position of the busbar in the [H.V.](#) battery. **Continue to step 16, do not reinstall the busbars..**
- If there **ARE NOT** any signs of damage, **continue to step 16, do not reinstall the busbars..**

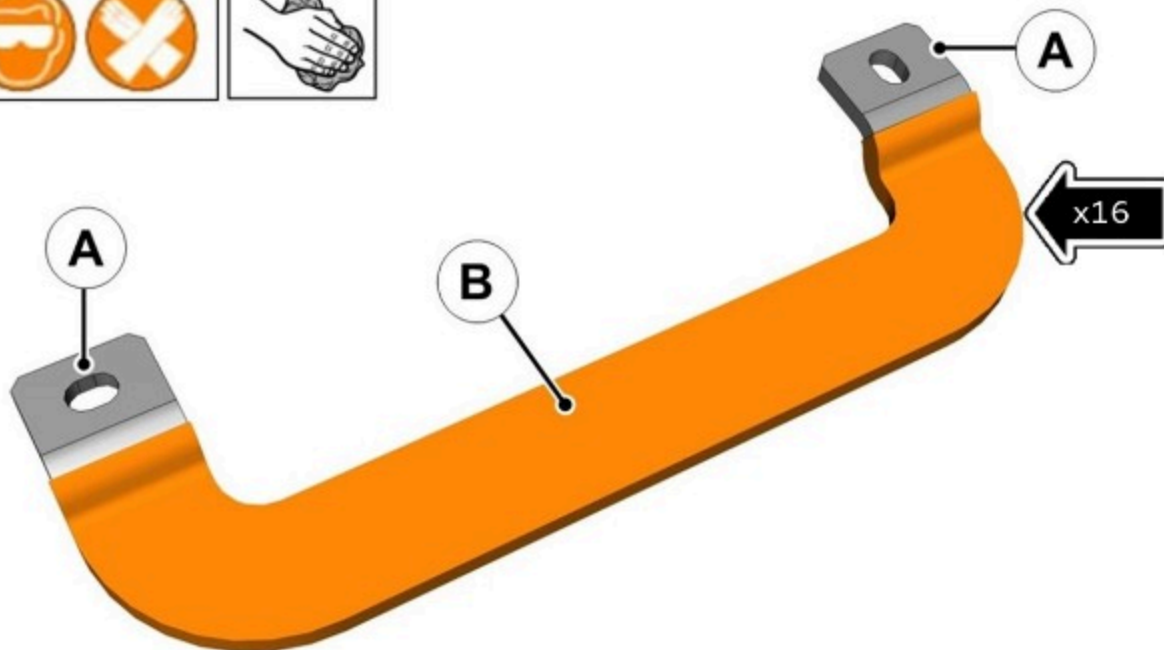
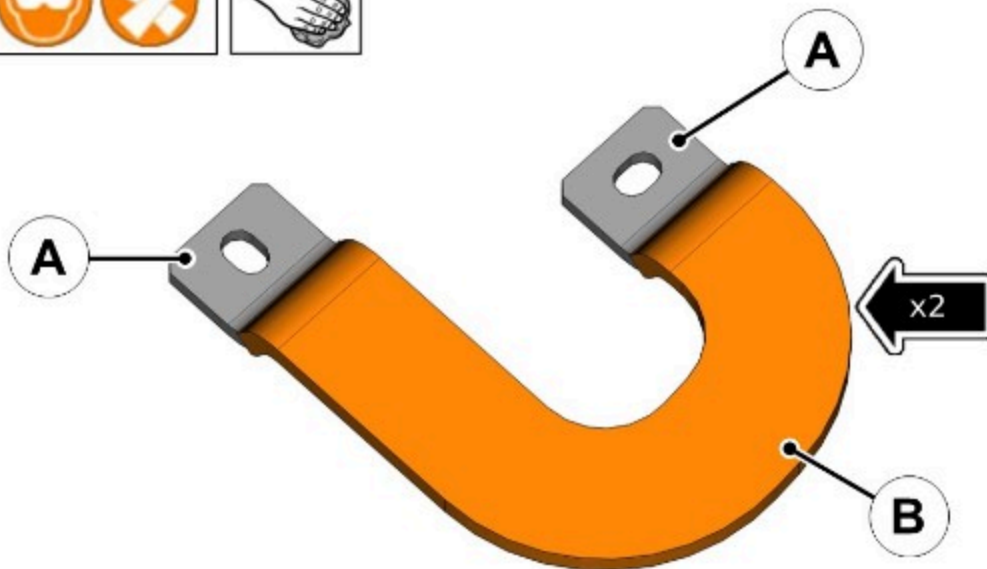
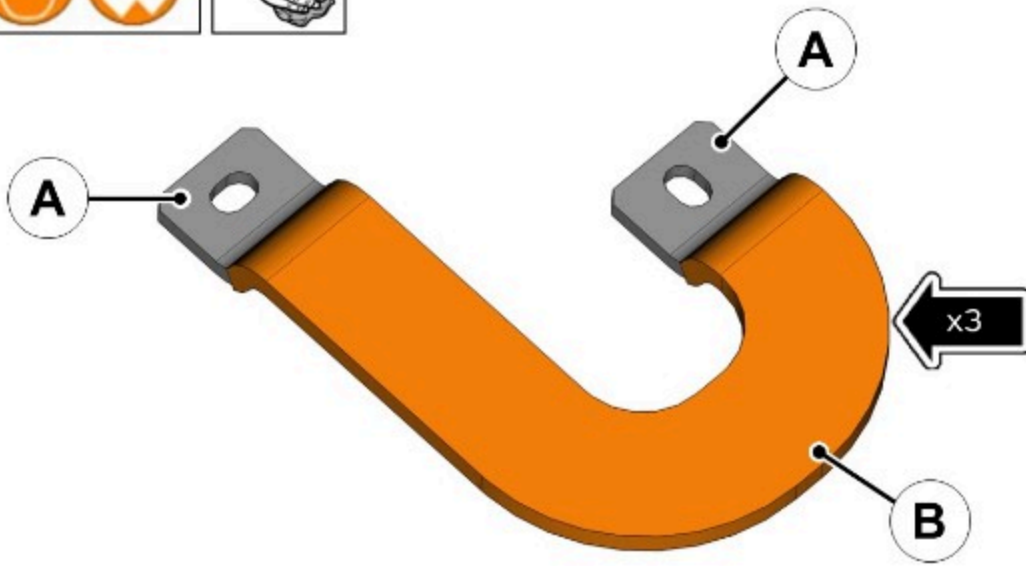
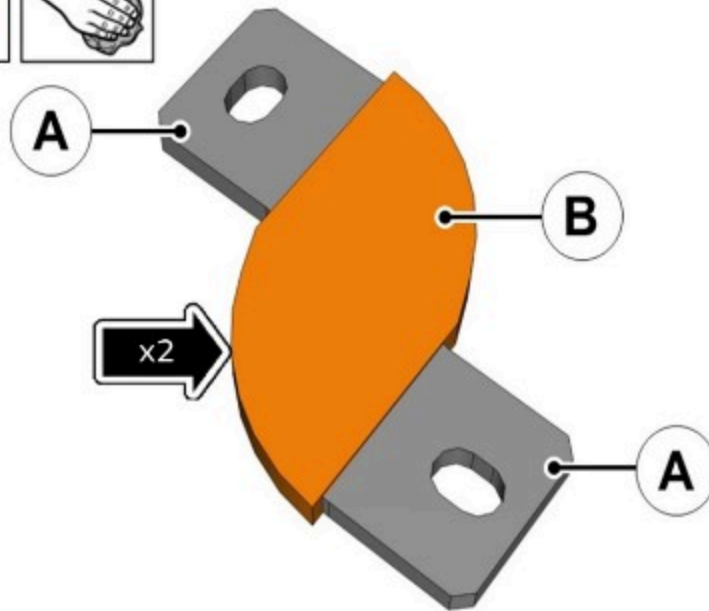
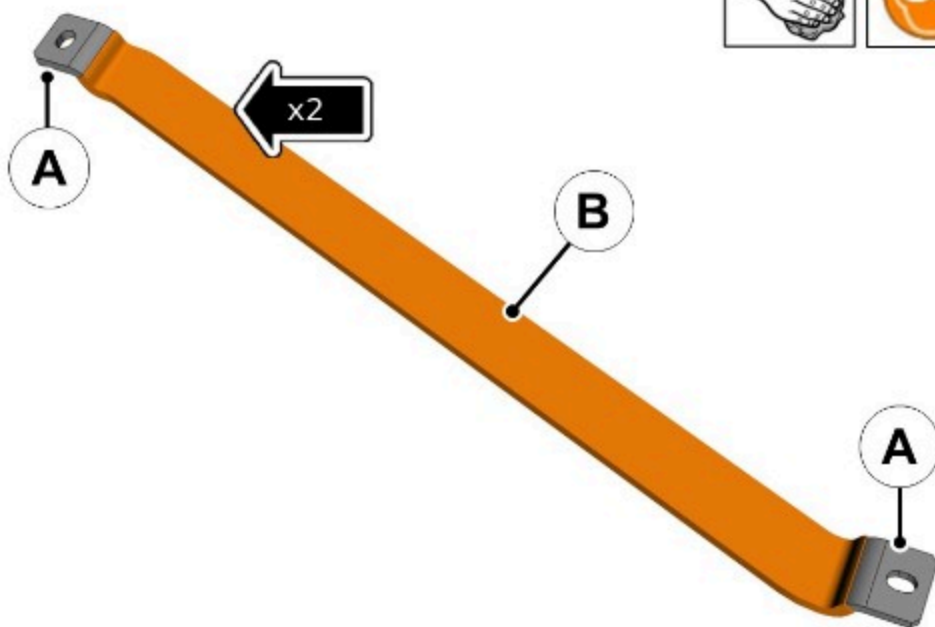
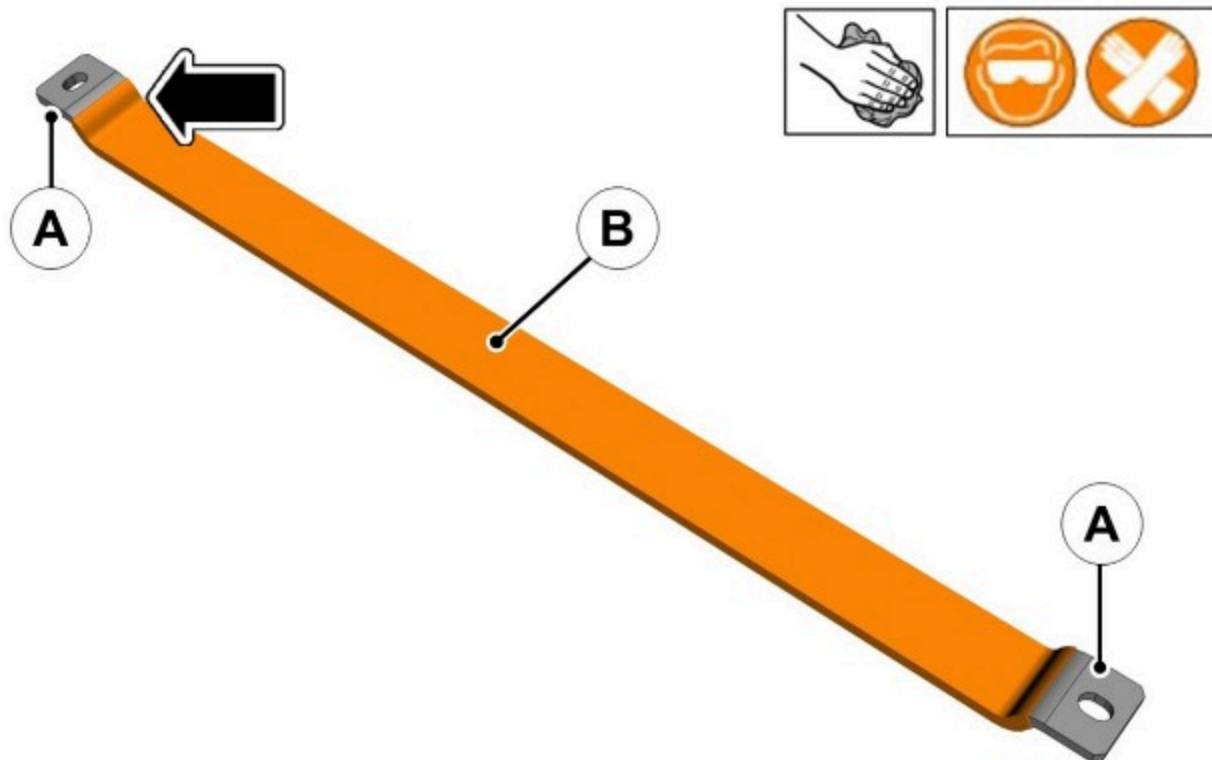
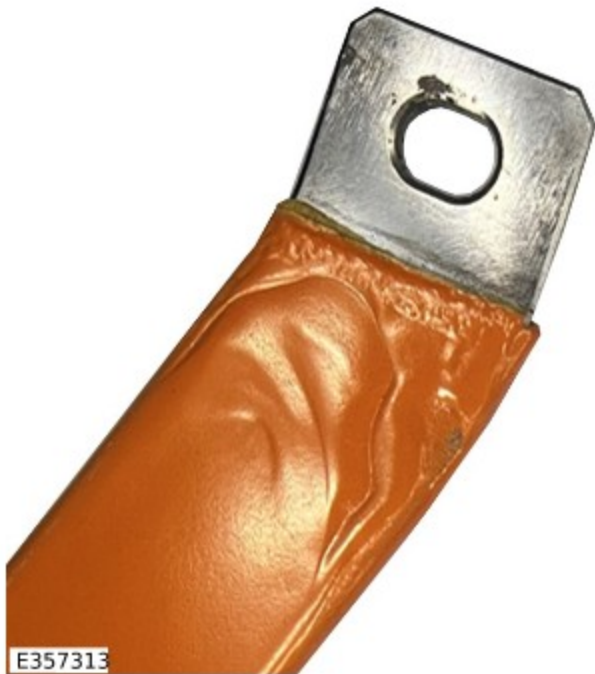
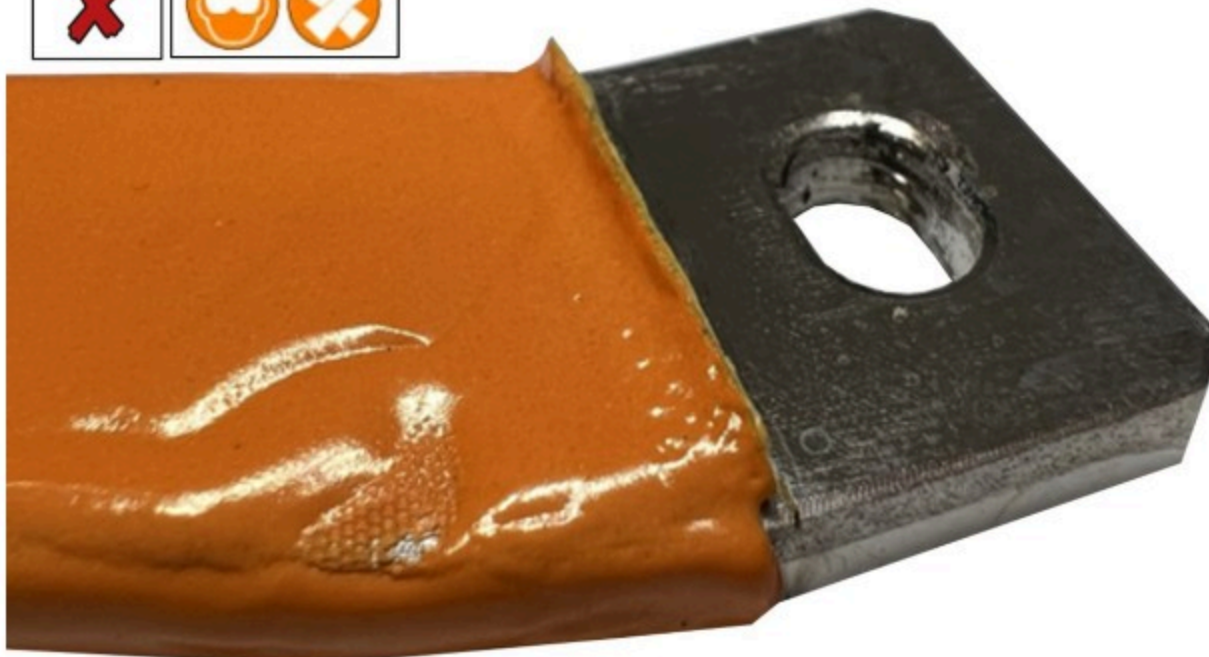
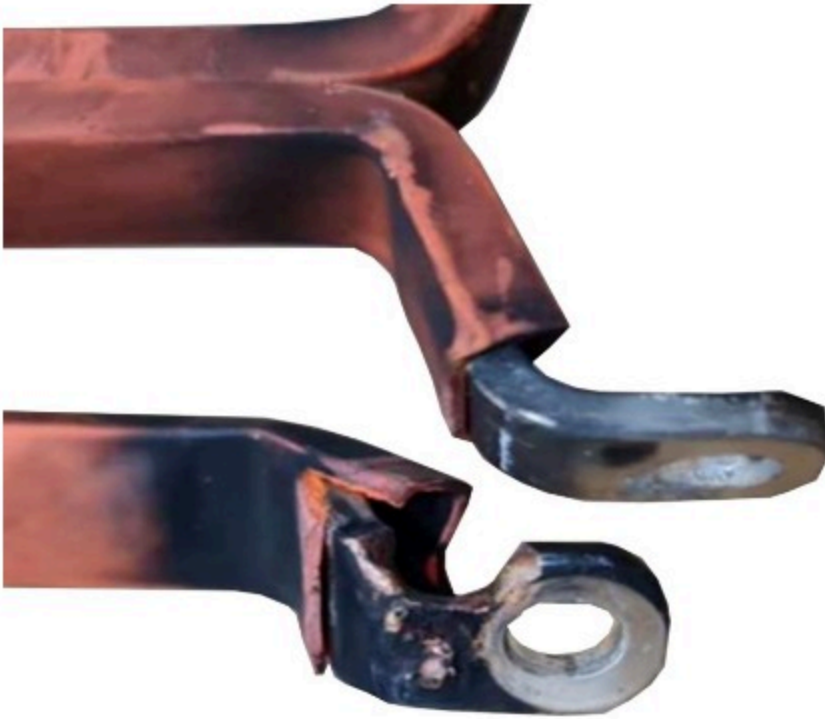
- Make a note of all damage found and the installed position of the damaged busbar within the [H.V.](#) battery.
- All findings **must** be reported to [T.A.](#)
- The images marked with a **RED 'X'** show an example of busbar damage caused by overheating, make a note of all damage found.

Thoroughly inspect the 26 busbars.

- Clean the busbar contact areas (**A**) with alcohol based cleaning fluid and a lint free cloth.
- Visually inspect the contact areas (**A**) for signs of damage.
- Visually inspect the protective insulation for damage (**B**).
- If there **ARE** any signs of damage as shown in the images marked with a **RED 'X'**, make a note of the installed position of the busbar in the [H.V.](#) battery. **Continue to step 18, do not reinstall the busbars.**
- If there **ARE NOT** any signs of damage, **continue to step 18, do not reinstall the busbars.**

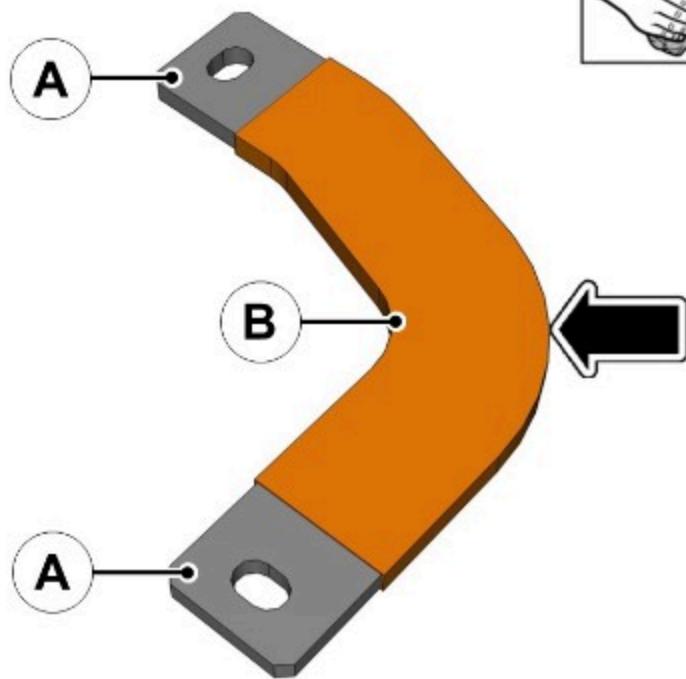
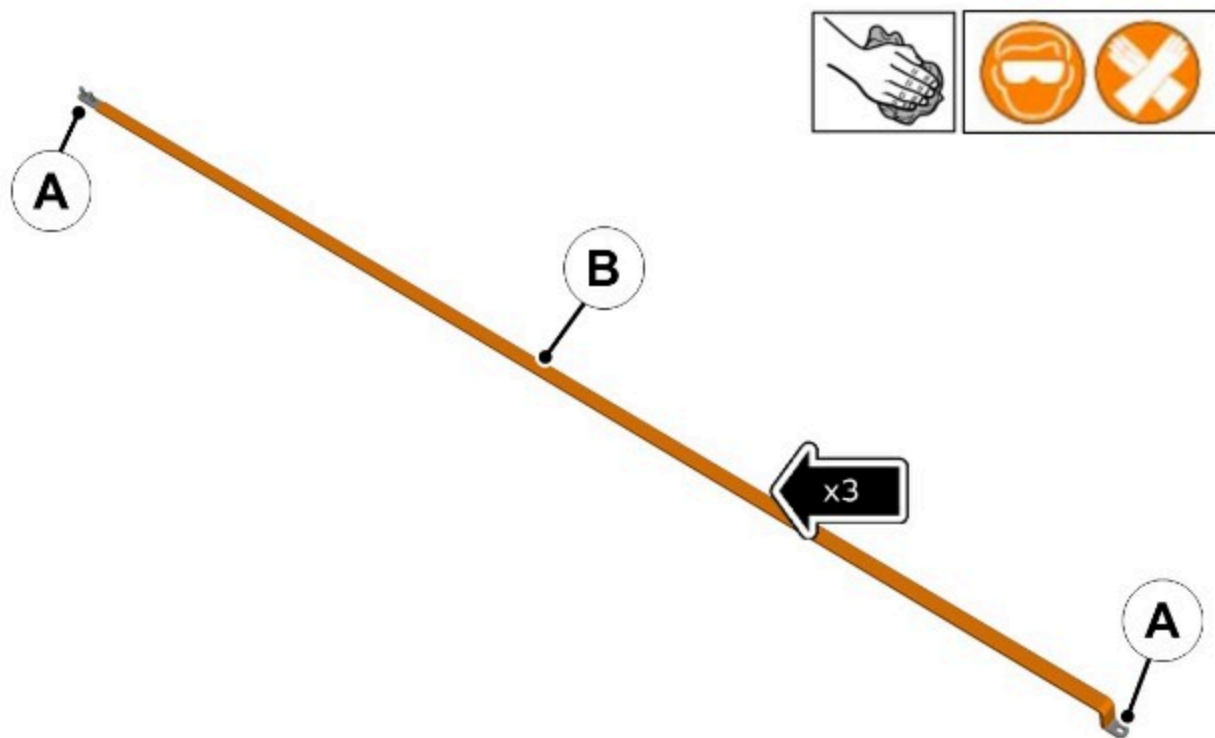
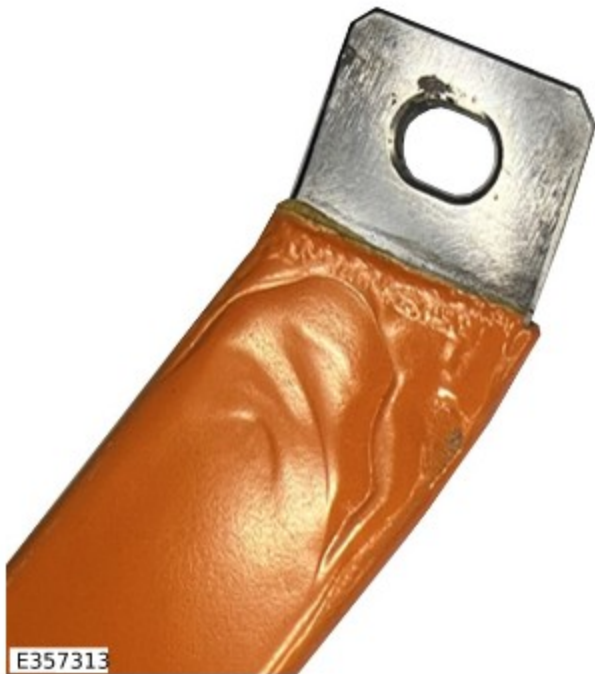
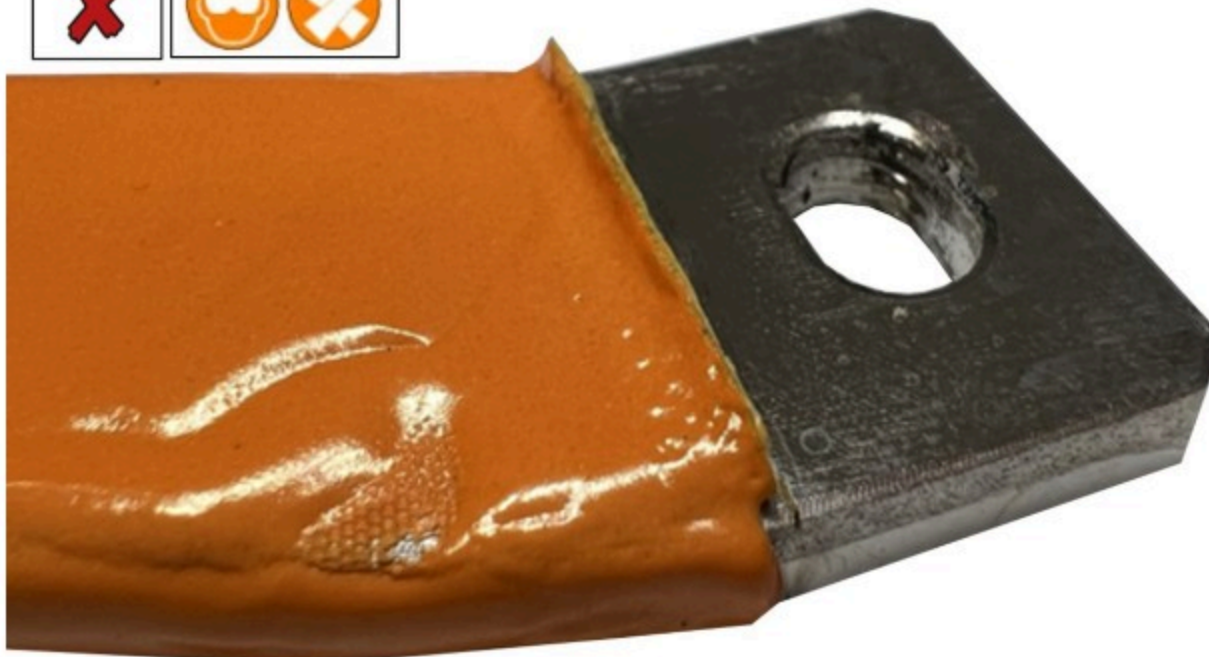
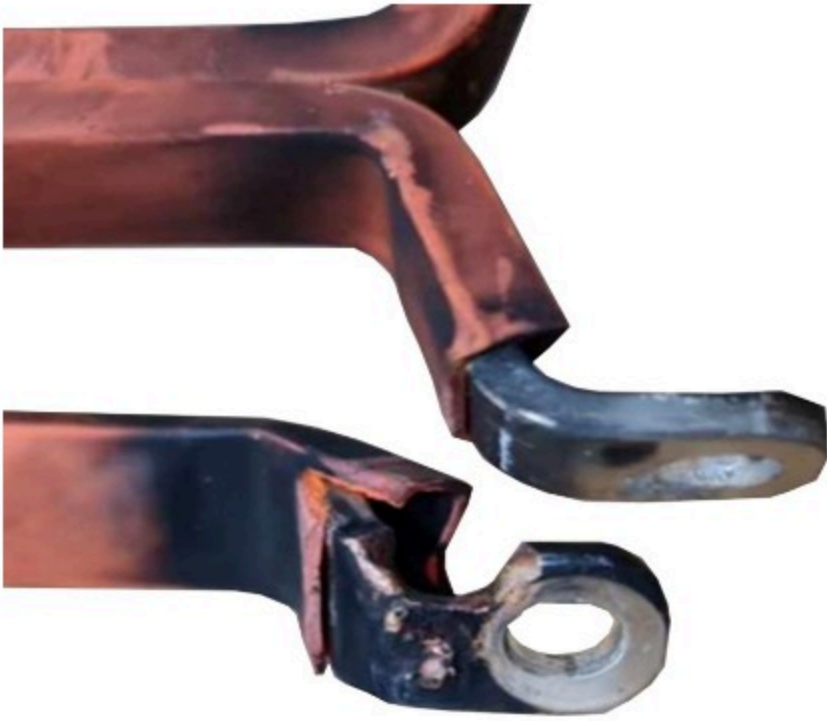
- Make a note of all damage found and the installed position of the damaged busbar within the [H.V.](#) battery.
- All findings **must** be reported to [T.A.](#)
- The images marked with a **RED 'X'** show an example of busbar damage caused by overheating, make a note of all damage found.

Thoroughly inspect the 4 busbars removed during [BEM](#) baseplate removal.

- Clean the busbar contact areas (**A**) with alcohol based cleaning fluid and a lint free cloth.
- Visually inspect the contact areas (**A**) for signs of damage.
- Visually inspect the protective insulation for damage (**B**).
- If there **ARE** any signs of damage as shown in the images marked with a **RED 'X'**, make a note of the installed position of the busbar in the [H.V.](#) battery. **Continue to step 19.**
- If there **ARE NOT** any signs of damage, **continue to step 19.**

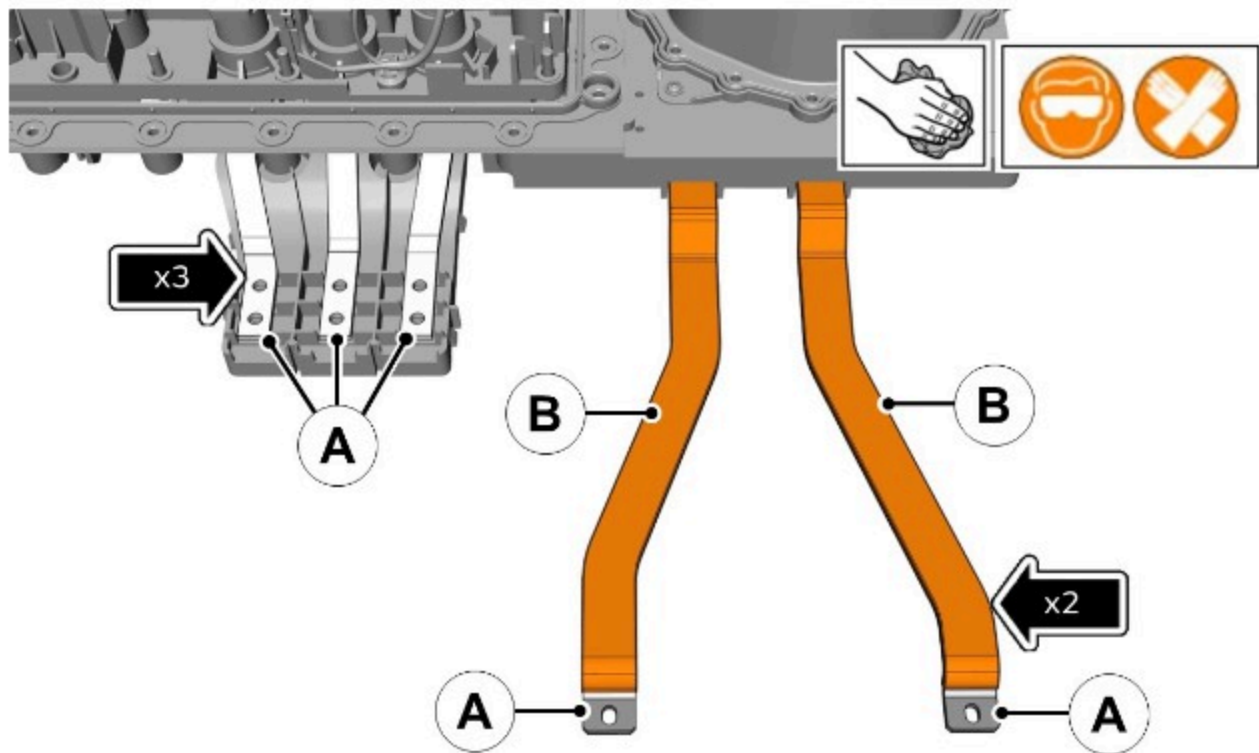
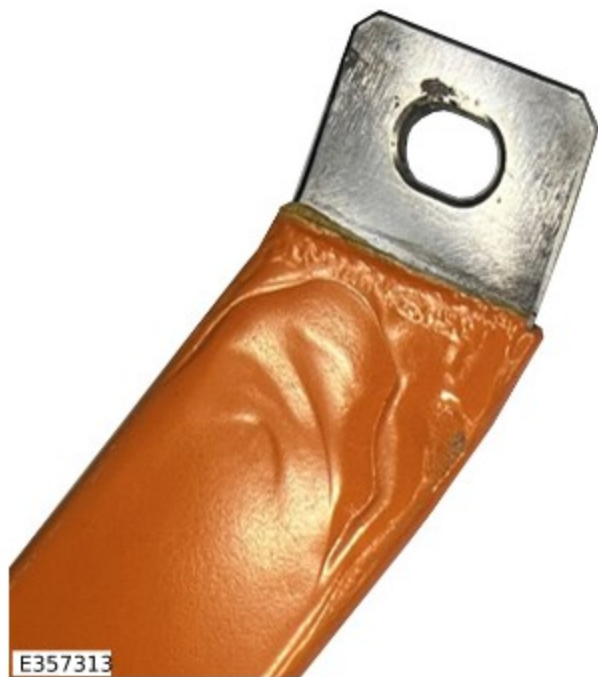
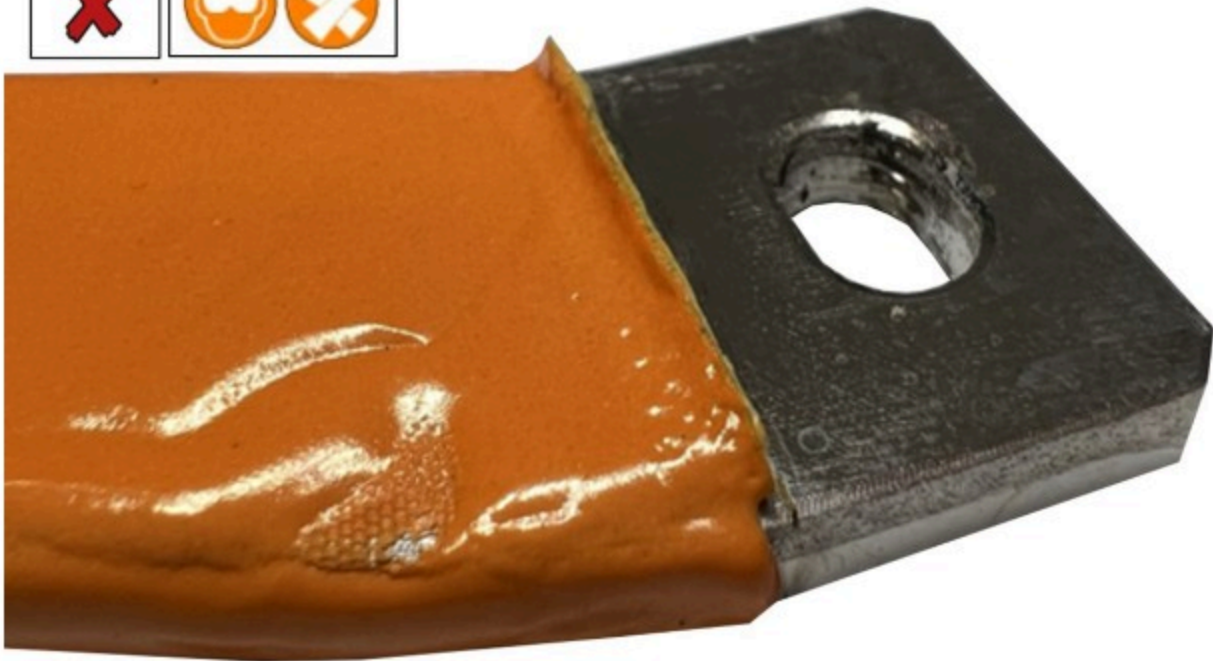
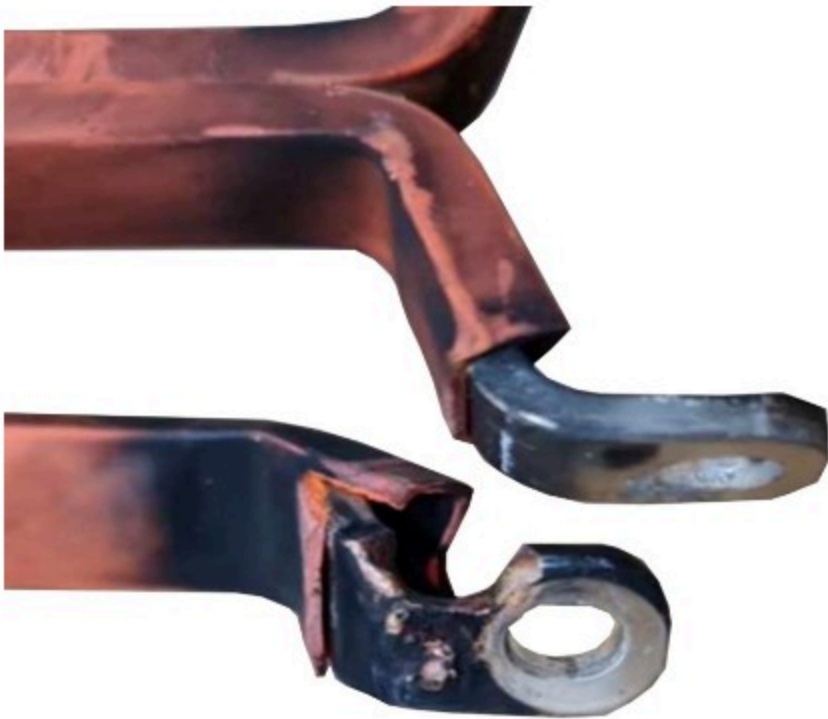
- Make a note of all damage found and the installed position of the damaged busbar within the [H.V.](#) battery.
- All findings **must** be reported to [T.A.](#)
- The images marked with a **RED 'X'** show an example of busbar damage caused by overheating, make a note of all damage found.

Thoroughly inspect the 5 [B.E.M](#) baseplate busbars.

- Clean the busbar contact areas (**A**) with alcohol based cleaning fluid and a lint free cloth.
- Visually inspect the contact areas (**A**) for signs of damage.
- Visually inspect the protective insulation for damage (**B**).
- If there **ARE** any signs of damage as shown in the images marked with a **RED 'X'**, make a note of the installed position of the busbar in the [H.V](#) battery. **Continue to step 20.**
- If there **ARE NOT** any signs of damage, **continue to step 20.**

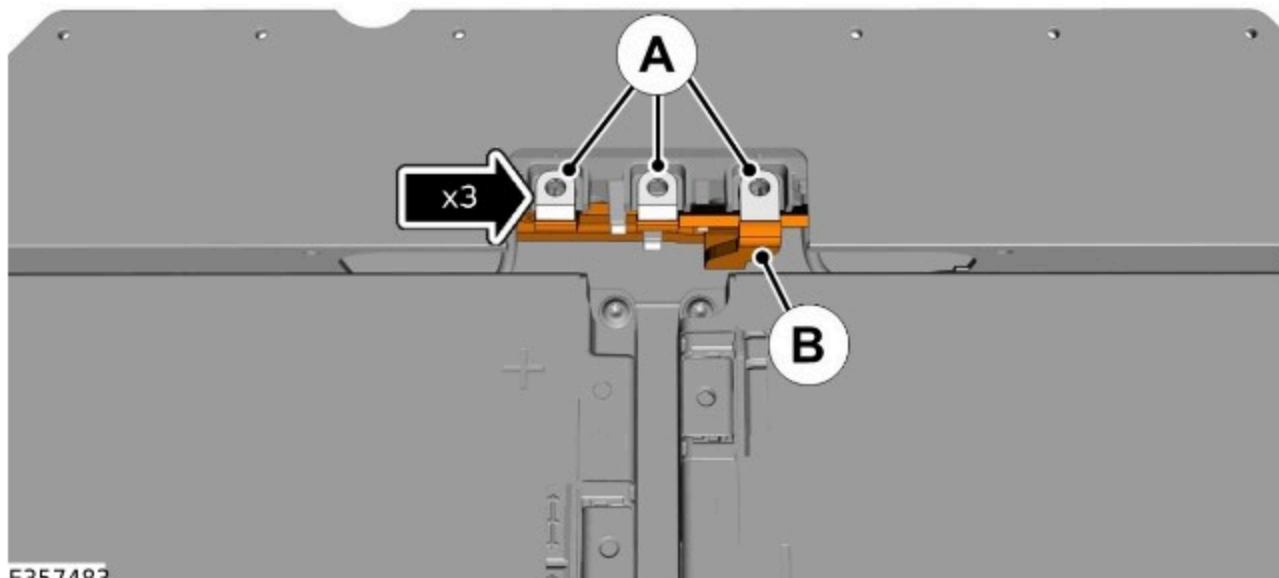
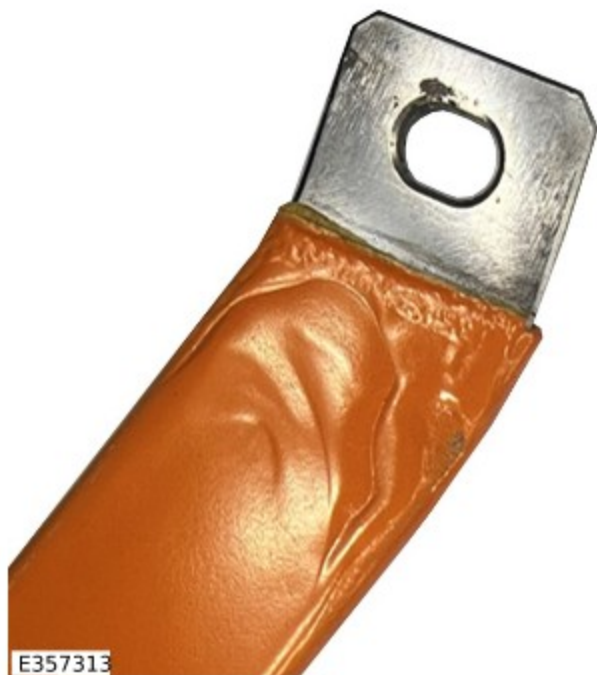
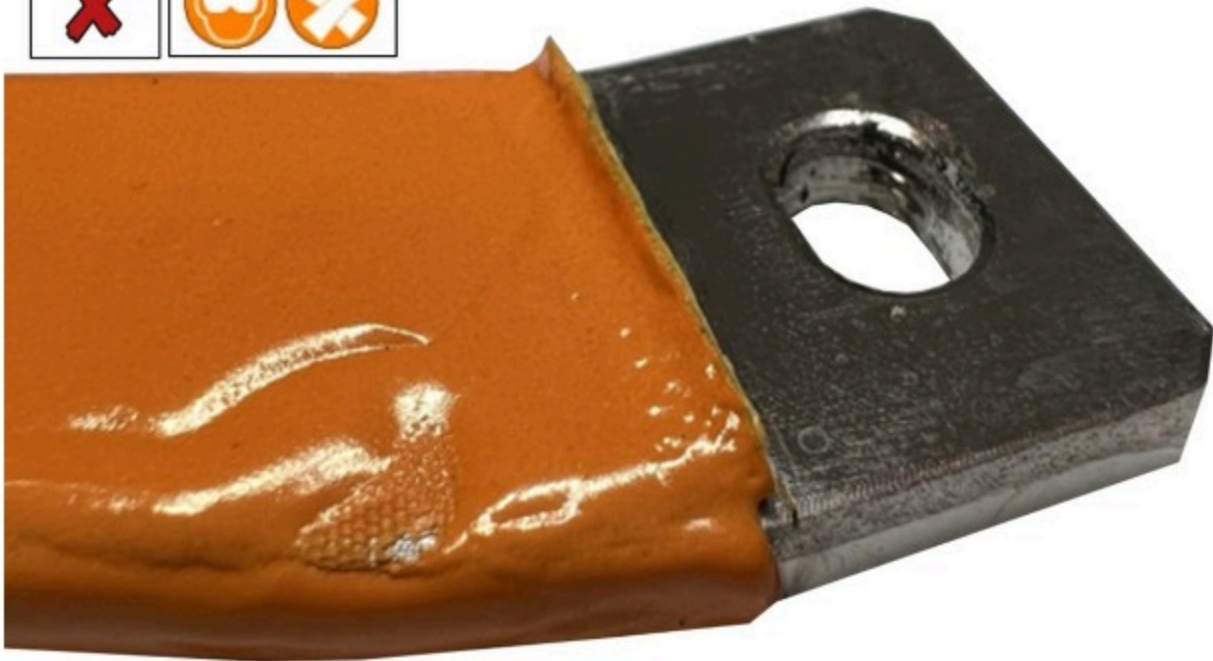
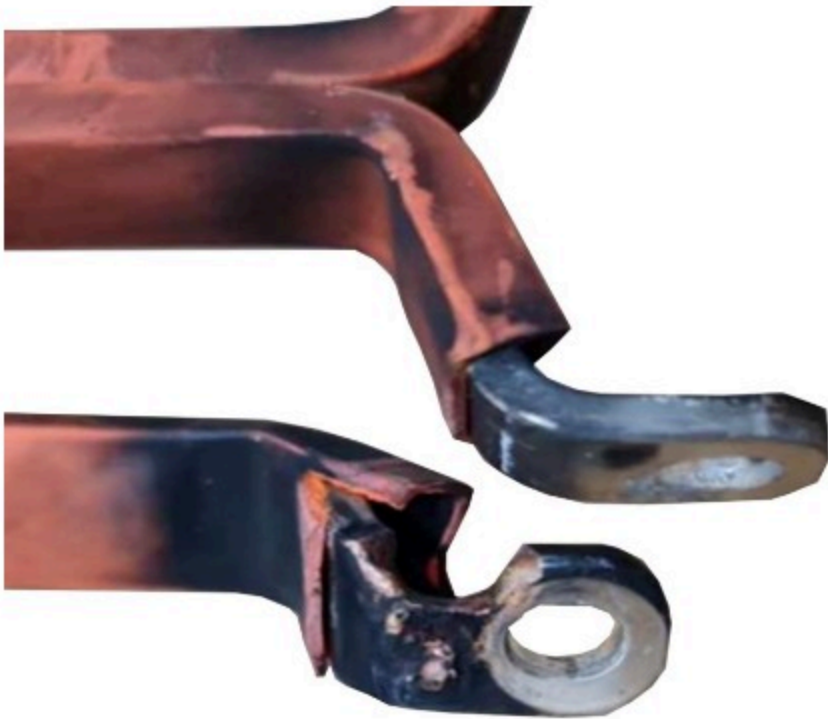
- Make a note of all damage found and the installed position of the damaged busbar within the [H.V.](#) battery.
- All findings **must** be reported to [T.A.](#)
- The images marked with a **RED 'X'** show an example of busbar damage caused by overheating, make a note of all damage found.

Thoroughly inspect the 3 [H.V.](#) connector busbars.

- Clean the busbar contact areas (**A**) with alcohol based cleaning fluid and a lint free cloth.
- Visually inspect the contact areas (**A**) for signs of damage.
- Visually inspect the protective insulation for damage (**B**).
- If there **ARE** any signs of damage as shown in the images marked with a **RED 'X'**, make a note of the installed position of the busbar in the [H.V.](#) battery. **Continue to step 22.**
- If there **ARE NOT** any signs of damage, **continue to step 22.**

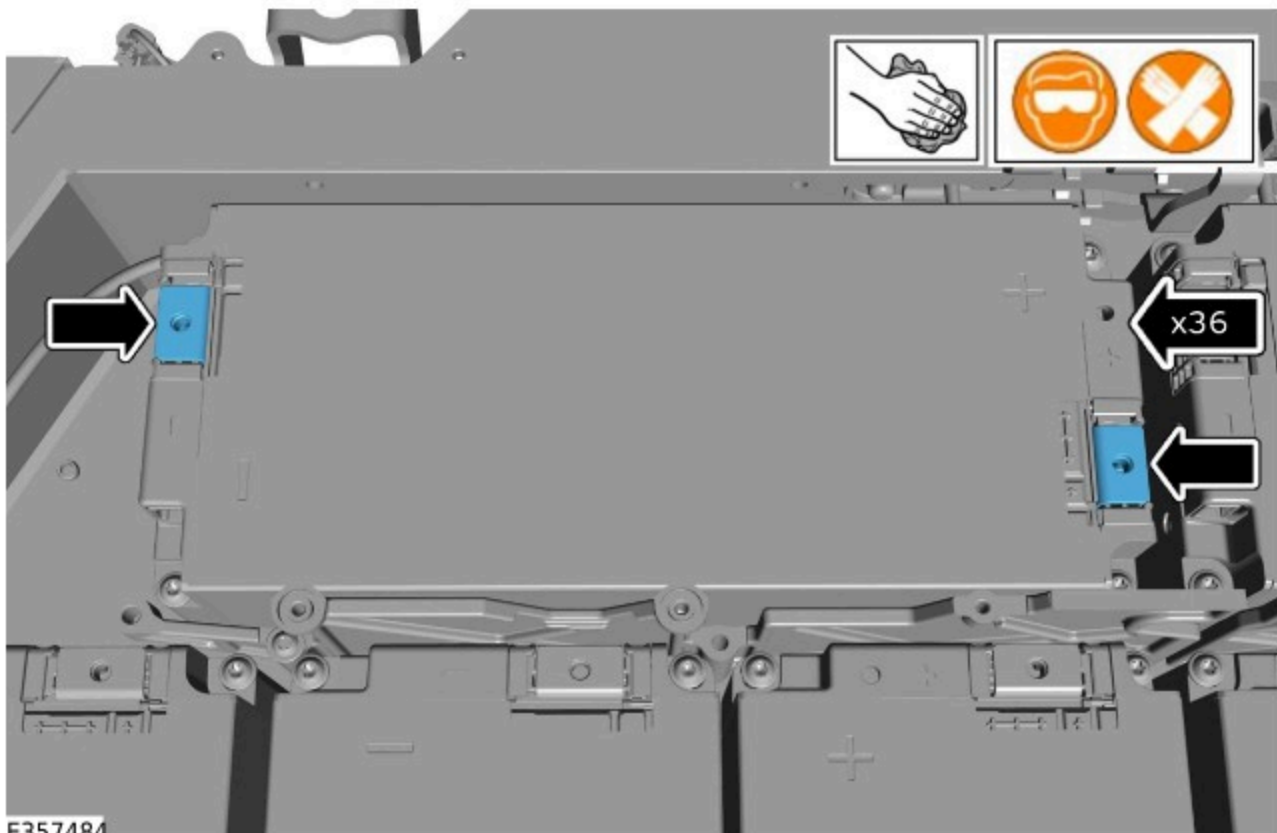
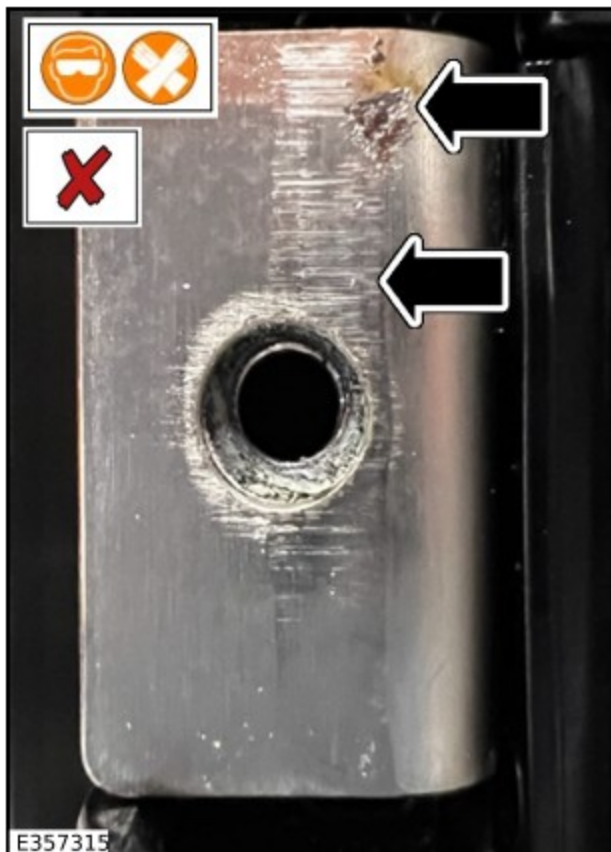
- Each [HV](#) battery module has 2 contact areas, all contacts areas **must** be thoroughly inspected.
- All findings **must** be reported to [T.A.](#)
- The image marked with a **RED 'X'** show an example of [HV](#) battery module damage caused by overheating, make a note of all damage found.

Thoroughly inspect the 36 [HV](#) battery module contact areas.

- Remove the battery module terminal blanking caps, JLR-415-016, from the module terminals.
- Clean the [HV](#) battery module contact areas with alcohol based cleaning fluid and a lint free cloth.
- Visually inspect the [HV](#) battery module contact areas for signs of damage.
- If there **ARE** any signs of damage as shown in the images marked with a **RED 'X'**, make a note of the installed position of the busbar in the [HV](#) battery. **Continue to step 23.**
- If there **ARE NOT** any signs of damage, **continue to step 23.**
