# SAFETY RELATED RECALL

Global Recall Action  
Number: H468v2

<b>Subject:</b>  <b>High Voltage (HV) Battery Busbar Fixings</b>	Publication No.: H468v2
	Model: I-PACE (X590)
	Model Year: 2019 - 2021
	Date of Issue: 22 April 2024

# SERVICE INSTRUCTION - H468V2

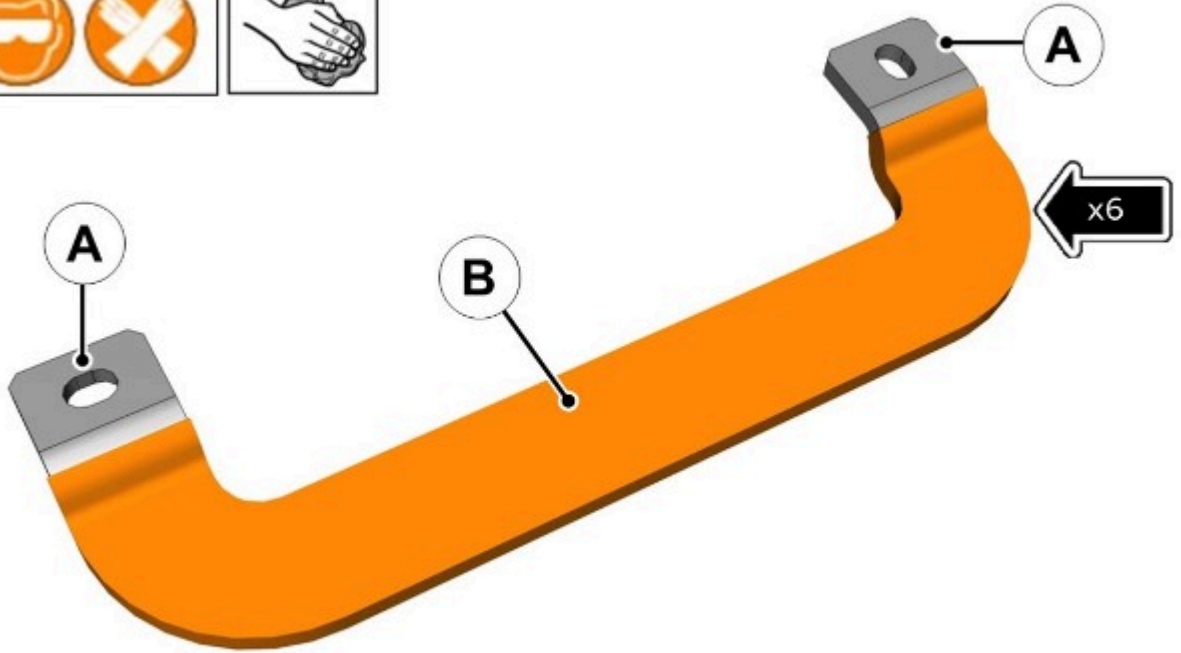
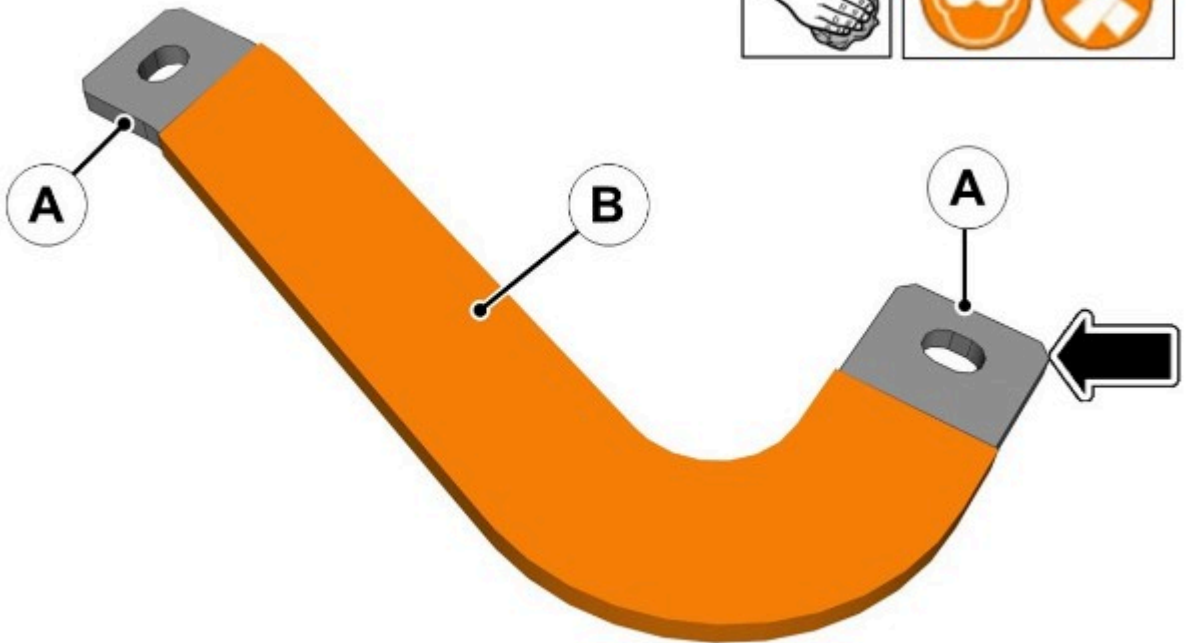
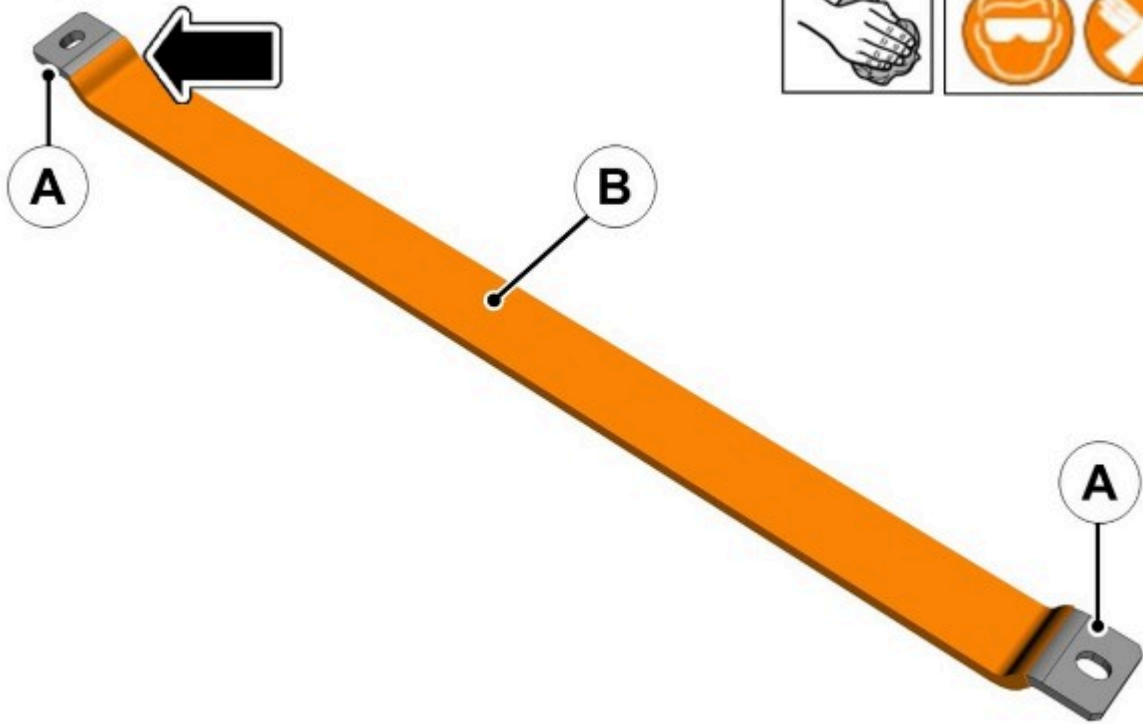
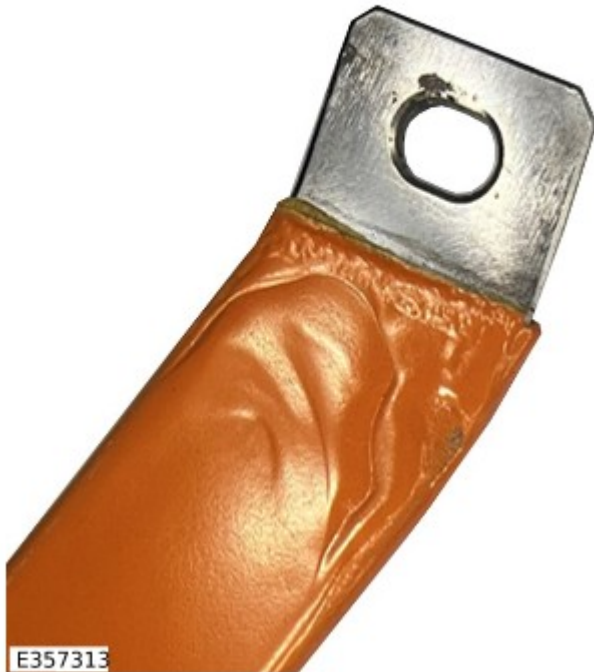
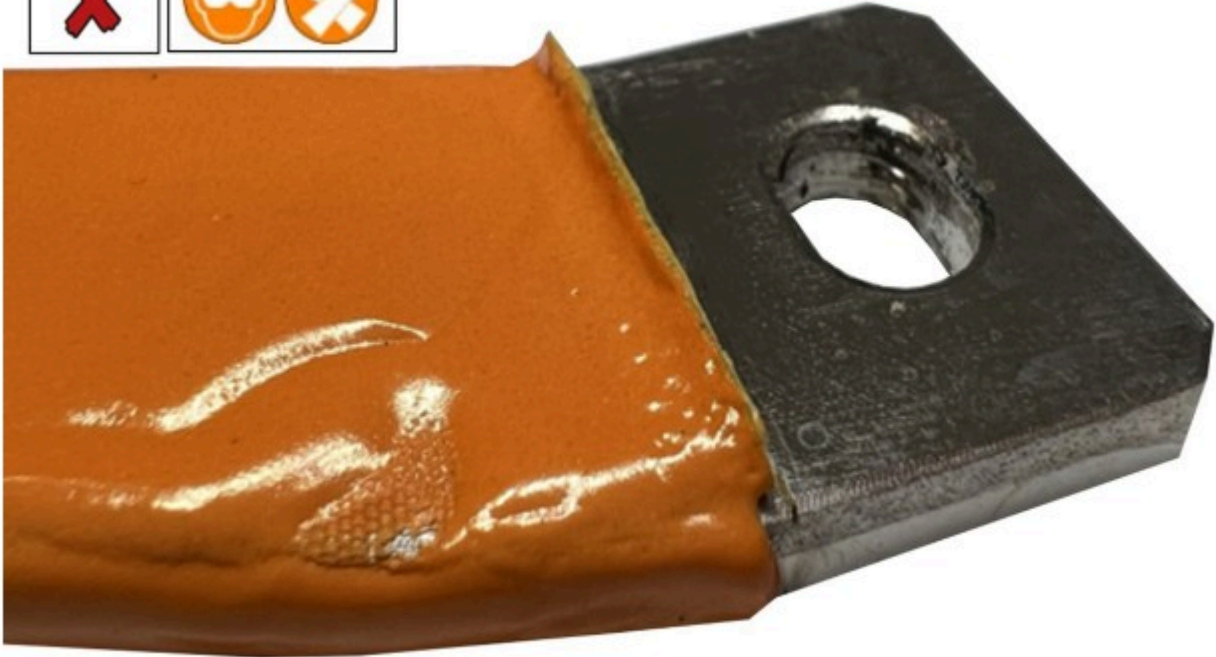
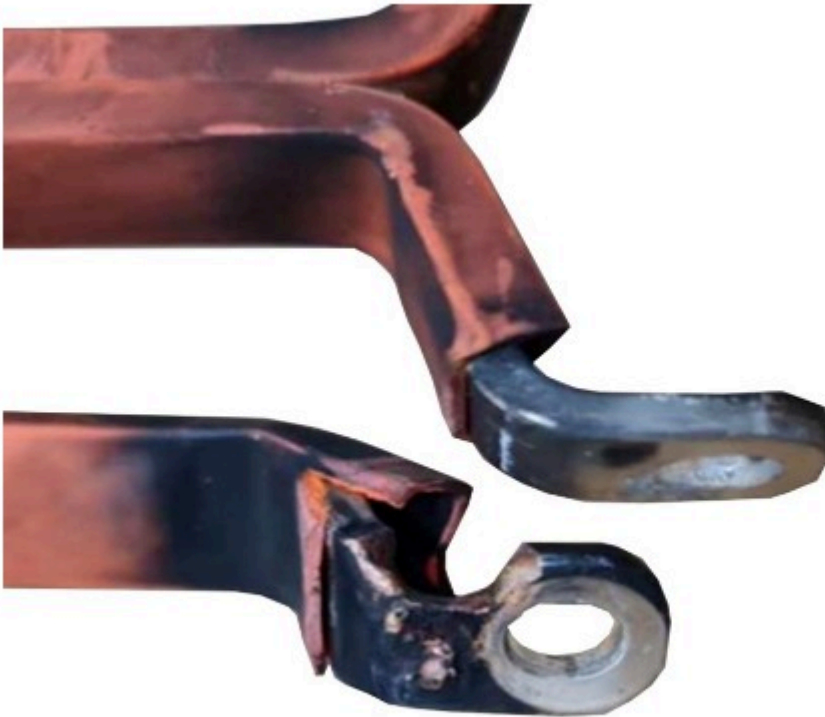
- Make a note of all damage found and the installed position of the damaged busbar within the [HV](#) battery.
- All findings **must** be reported to [TA](#).
- The images marked with a **RED 'X'** show an example of busbar damage caused by overheating, make a note of all damage found.

- Clean the busbar contact areas (**A**) with alcohol based cleaning fluid and a lint free cloth.
- Visually inspect the contact areas (**A**) for signs of damage.
- Visually inspect the protective insulation for damage (**B**).
- If there **ARE** any signs of damage as shown in the images marked with a **RED 'X'**, make a note of the installed position of the busbar in the [HV](#) battery. **Continue to step 16, do not reinstall the busbars..**
- If there **ARE NOT** any signs of damage, **continue to step 16, do not reinstall the busbars..**

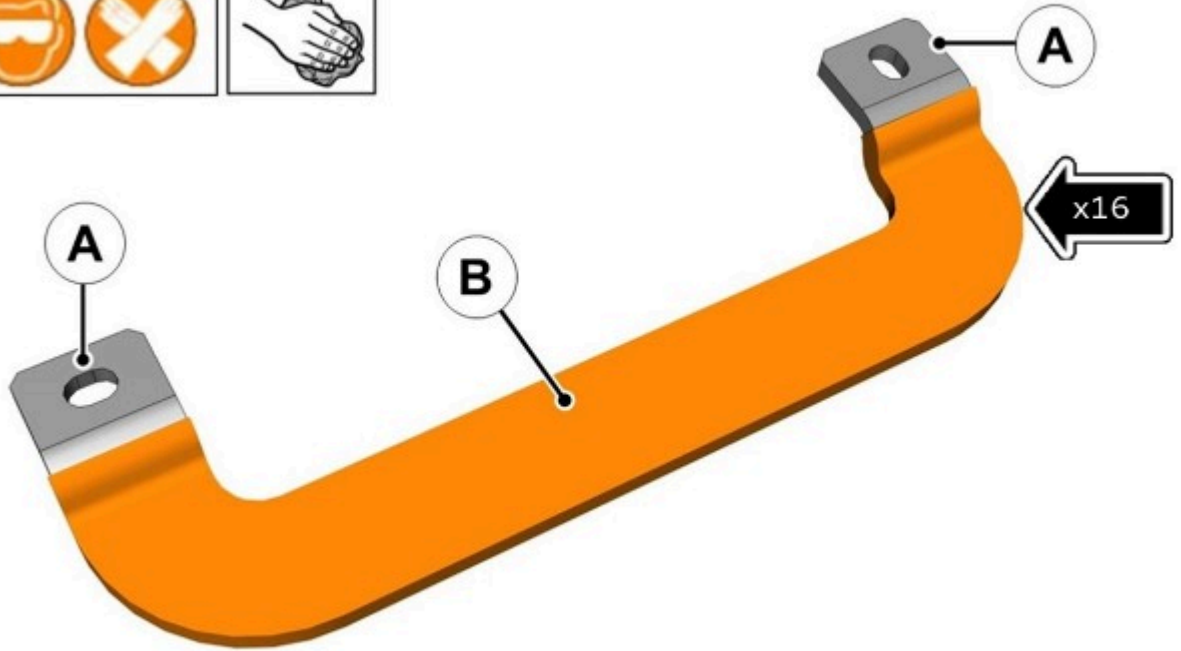
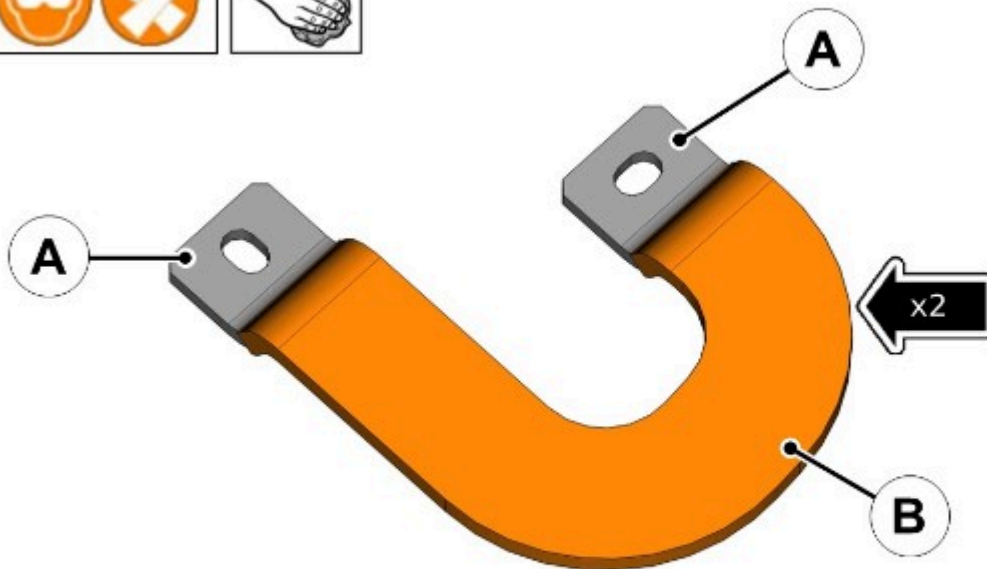
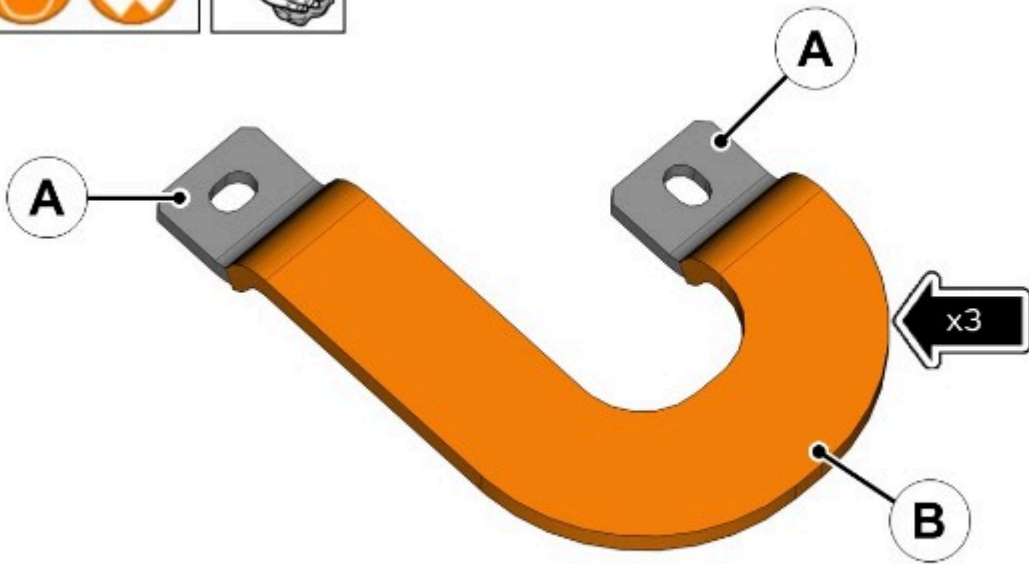
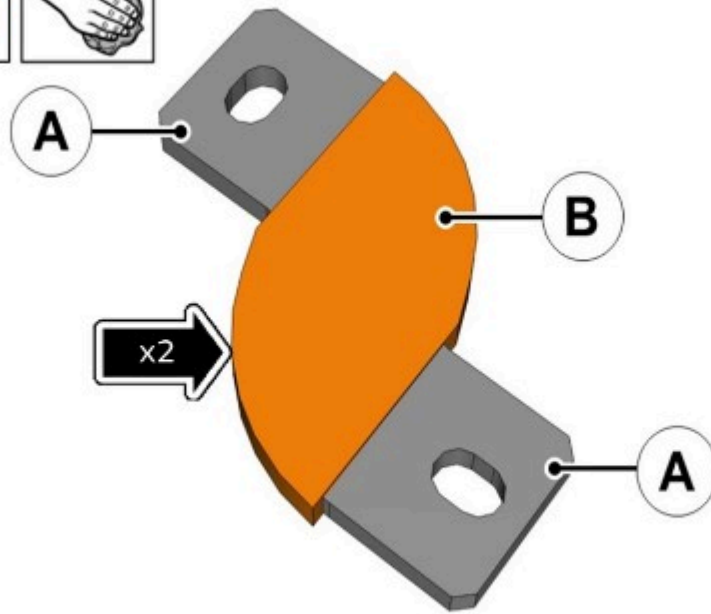
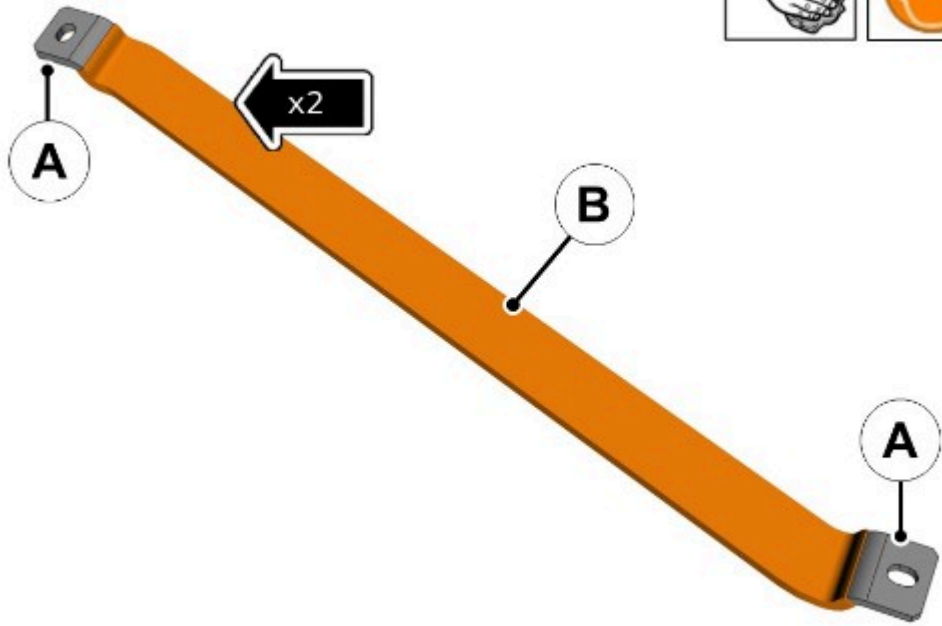
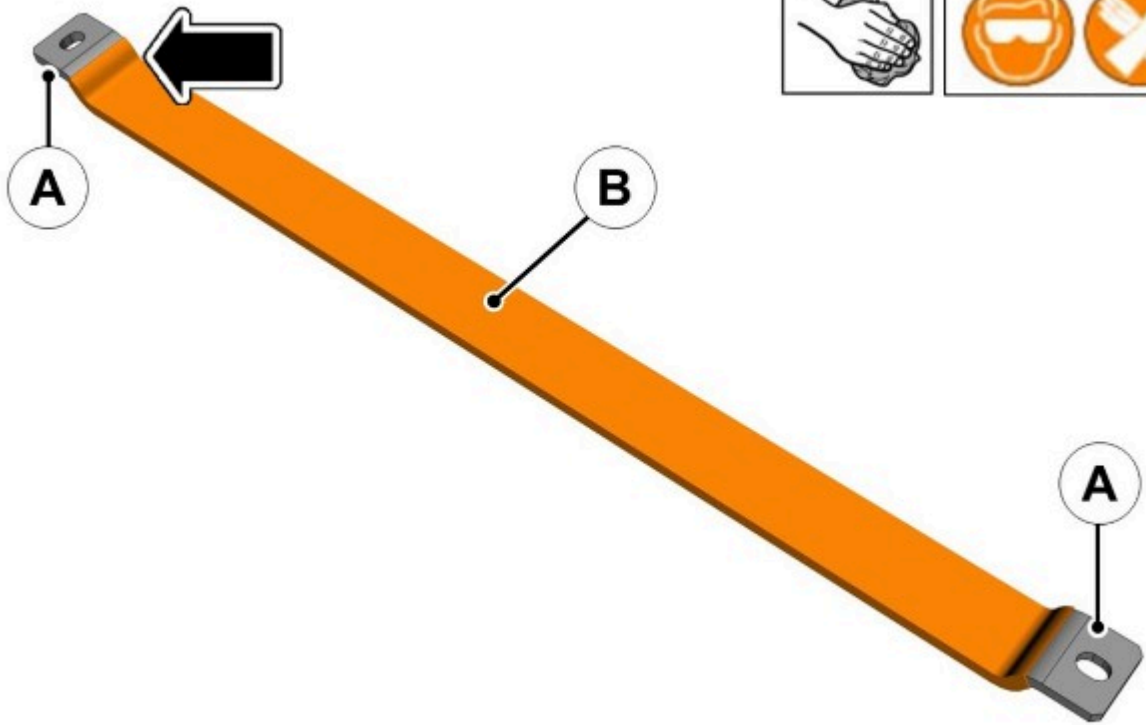
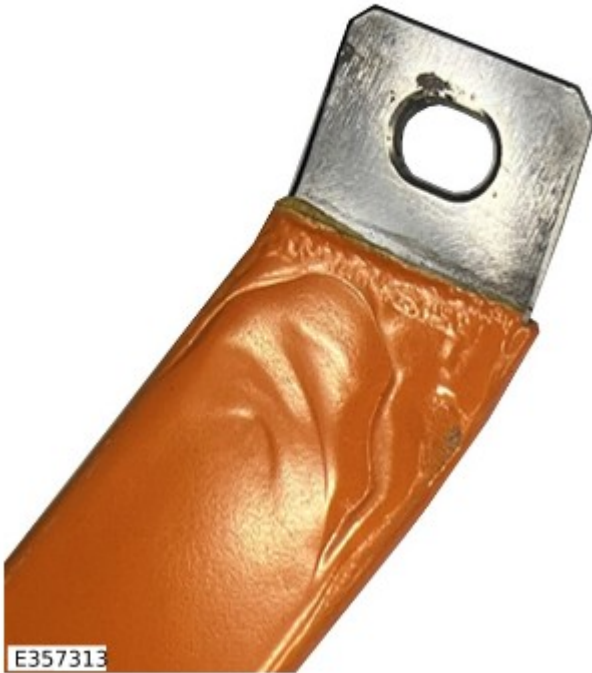
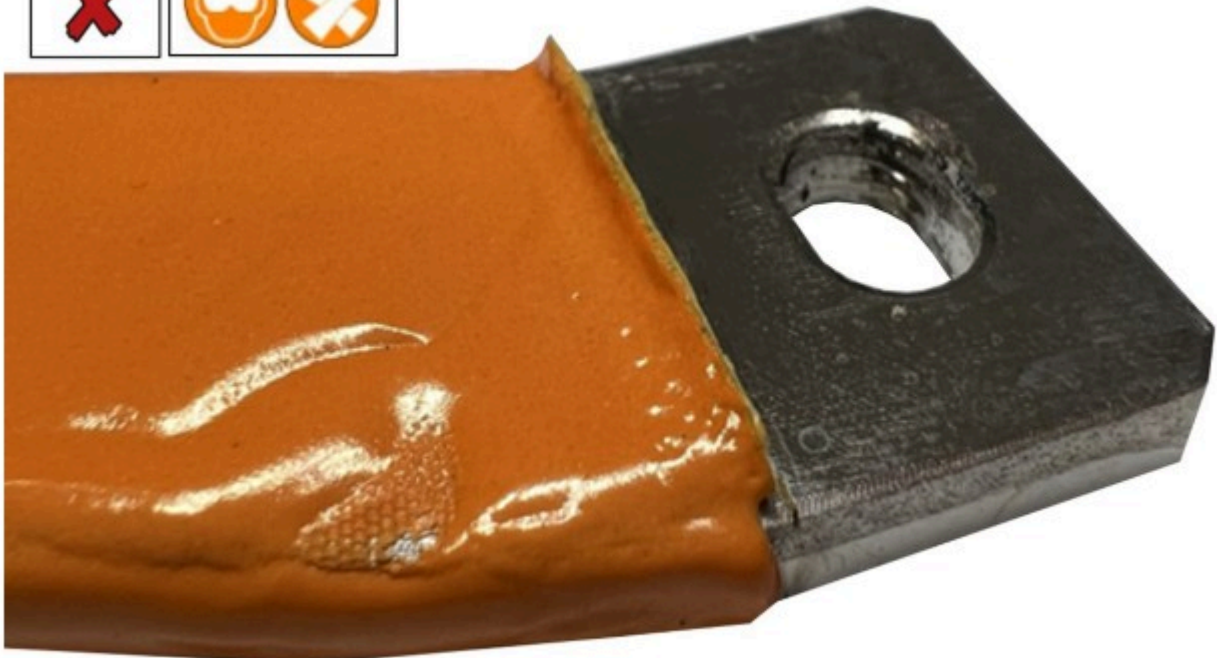
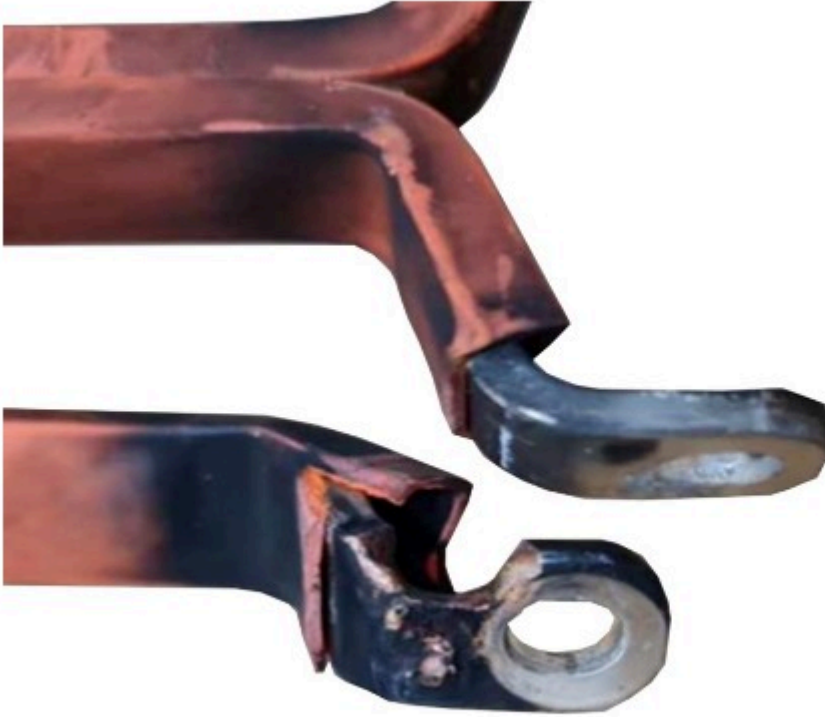
- Make a note of all damage found and the installed position of the damaged busbar within the [HV](#) battery.
- All findings **must** be reported to [TA](#).
- The images marked with a **RED 'X'** show an example of busbar damage caused by overheating, make a note of all damage found.

- Clean the busbar contact areas (**A**) with alcohol based cleaning fluid and a lint free cloth.
- Visually inspect the contact areas (**A**) for signs of damage.
- Visually inspect the protective insulation for damage (**B**).
- If there **ARE** any signs of damage as shown in the images marked with a **RED 'X'**, make a note of the installed position of the busbar in the [HV](#) battery. **Continue to step 18, do not reinstall the busbars.**
- If there **ARE NOT** any signs of damage, **continue to step 18, do not reinstall the busbars.**

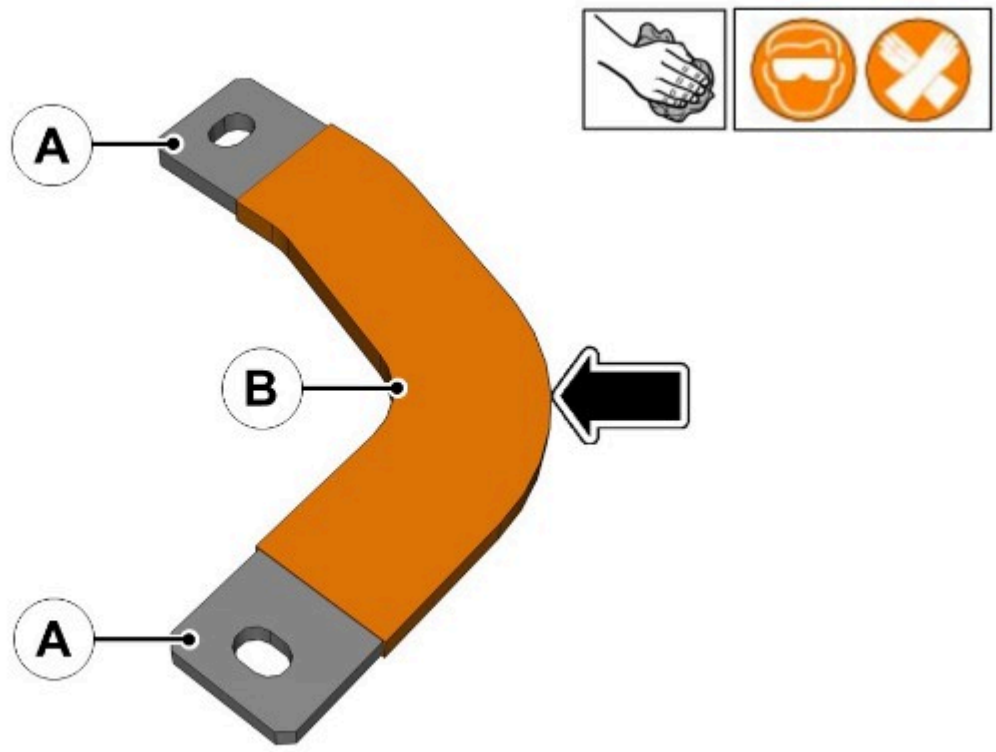
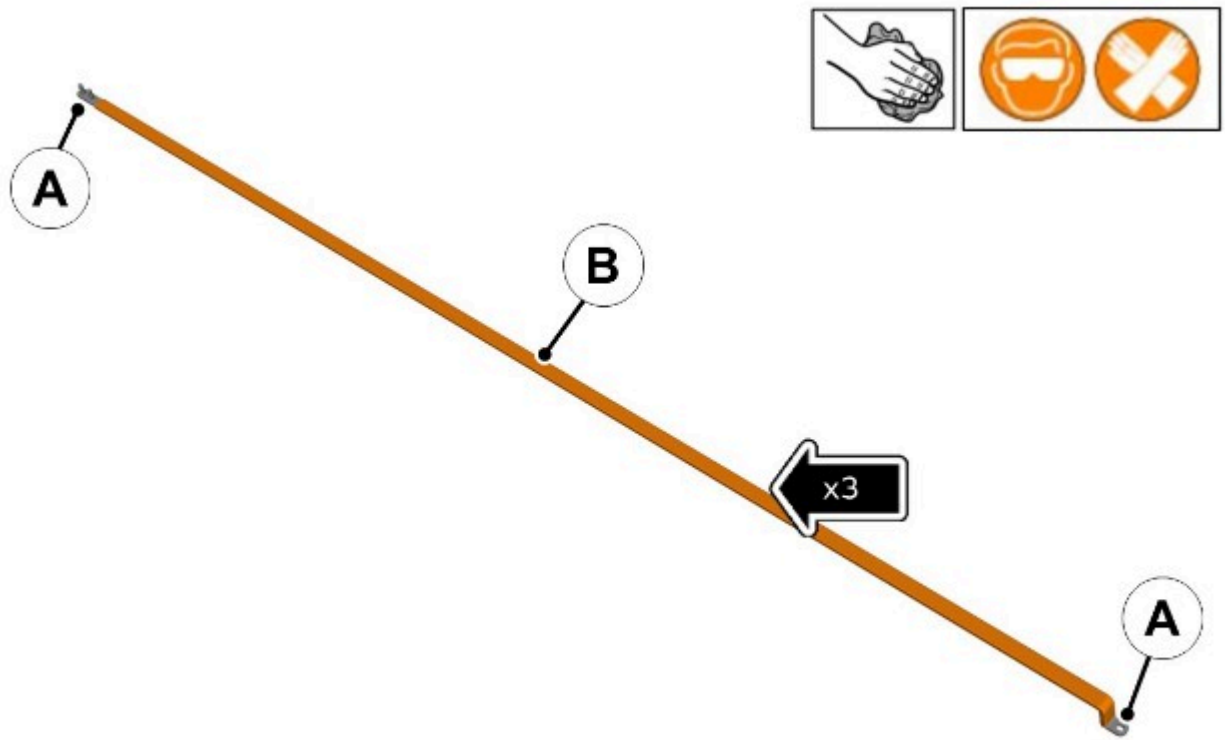
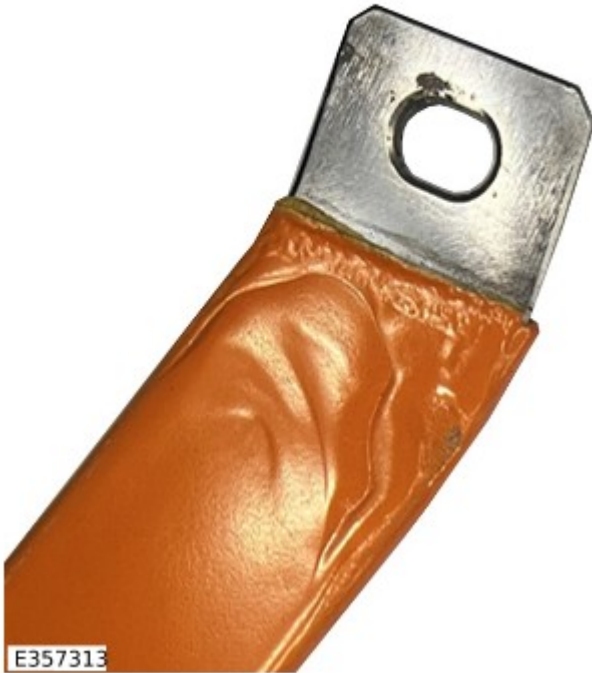
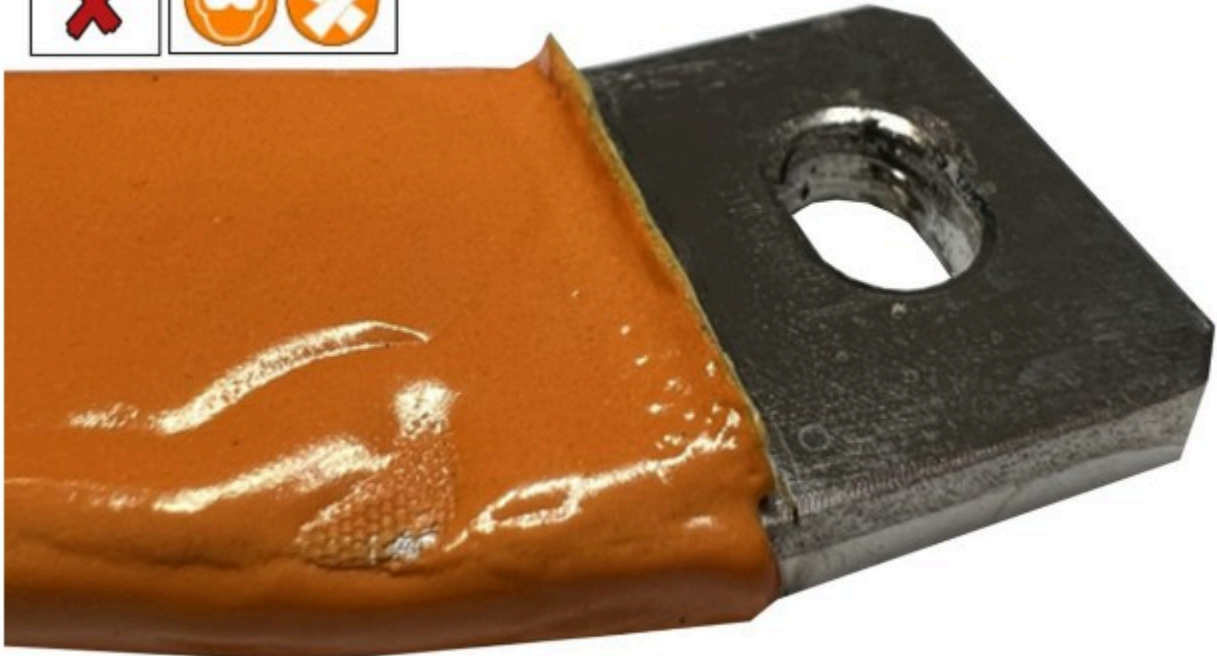
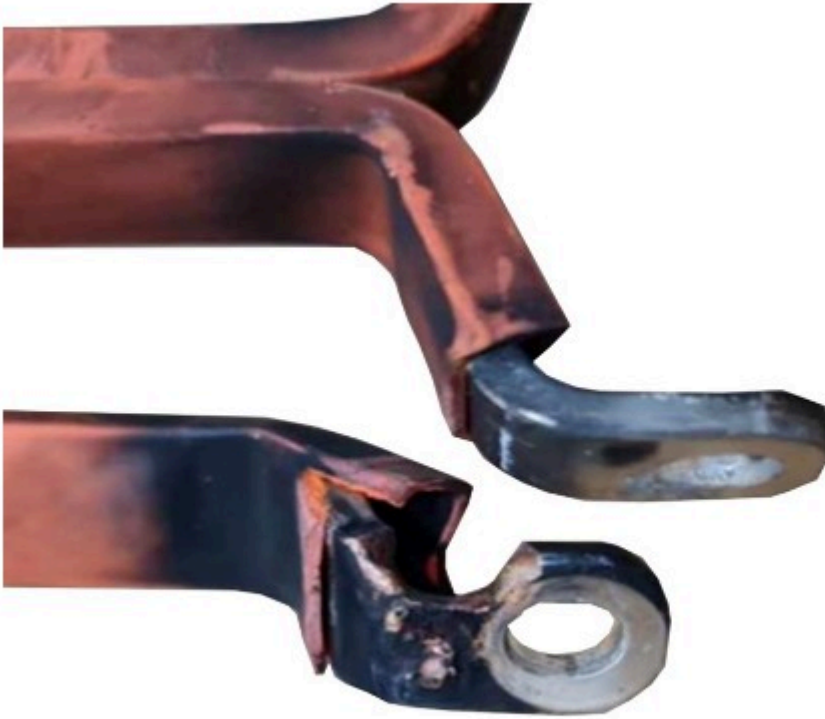
- Make a note of all damage found and the installed position of the damaged busbar within the [HV](#) battery.
- All findings **must** be reported to [TA](#).
- The images marked with a **RED 'X'** show an example of busbar damage caused by overheating, make a note of all damage found.

- Clean the busbar contact areas (**A**) with alcohol based cleaning fluid and a lint free cloth.
- Visually inspect the contact areas (**A**) for signs of damage.
- Visually inspect the protective insulation for damage (**B**).
- If there **ARE** any signs of damage as shown in the images marked with a **RED 'X'**, make a note of the installed position of the busbar in the [HV](#) battery. **Continue to step 19.**
- If there **ARE NOT** any signs of damage, **continue to step 19.**

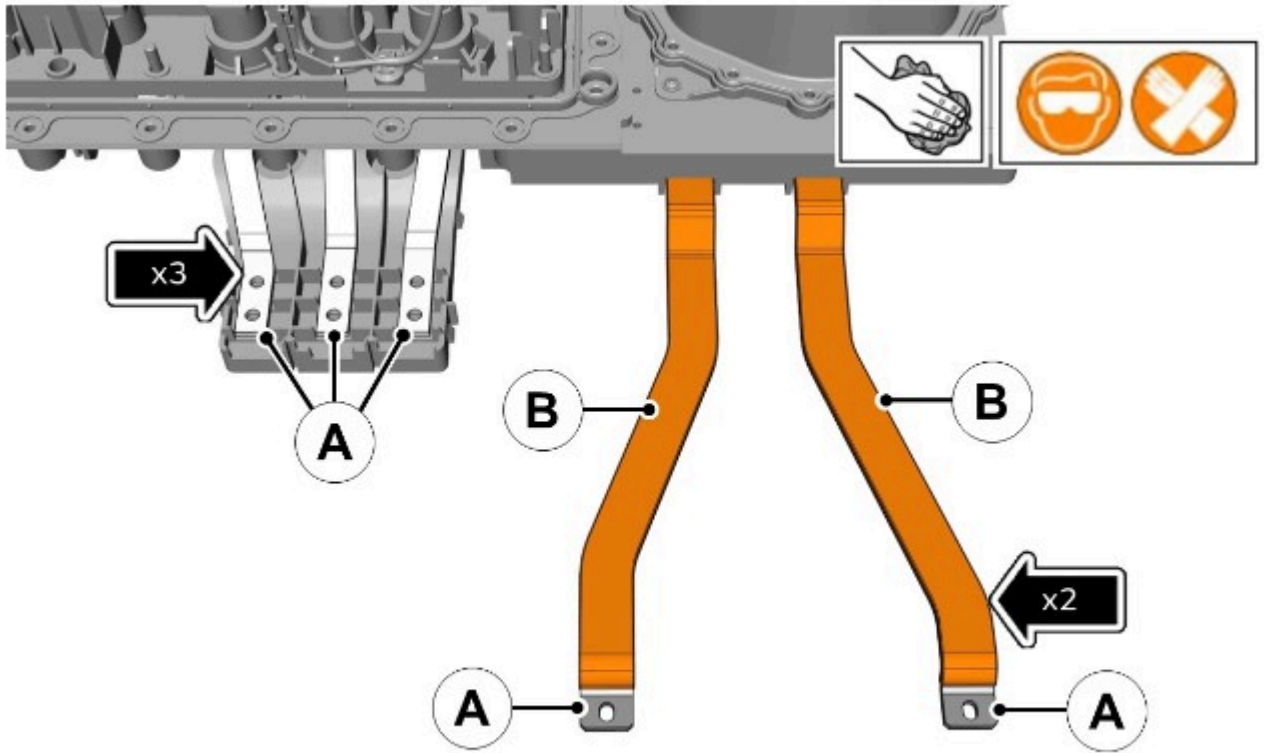
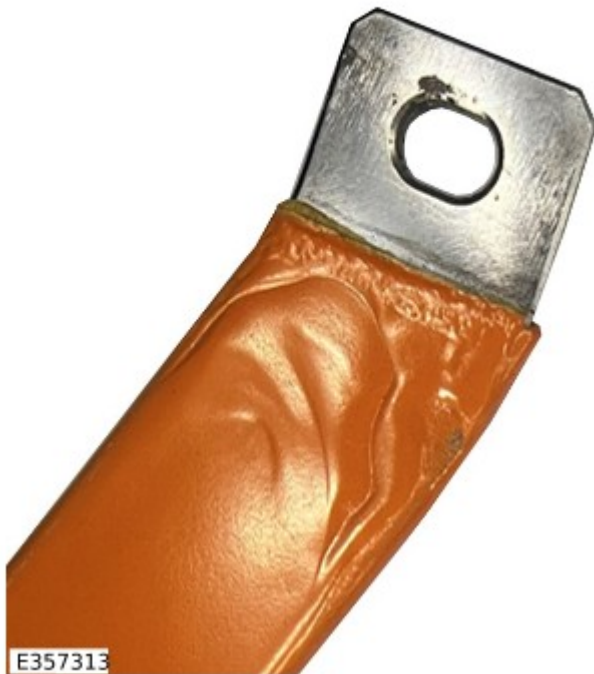
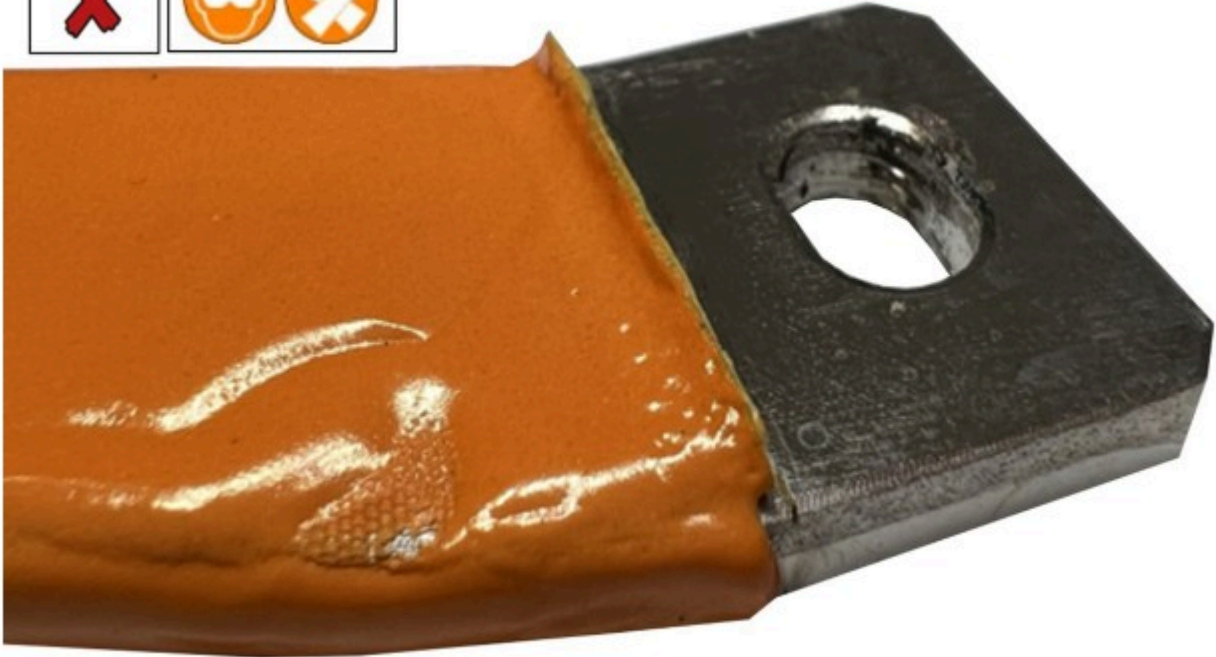
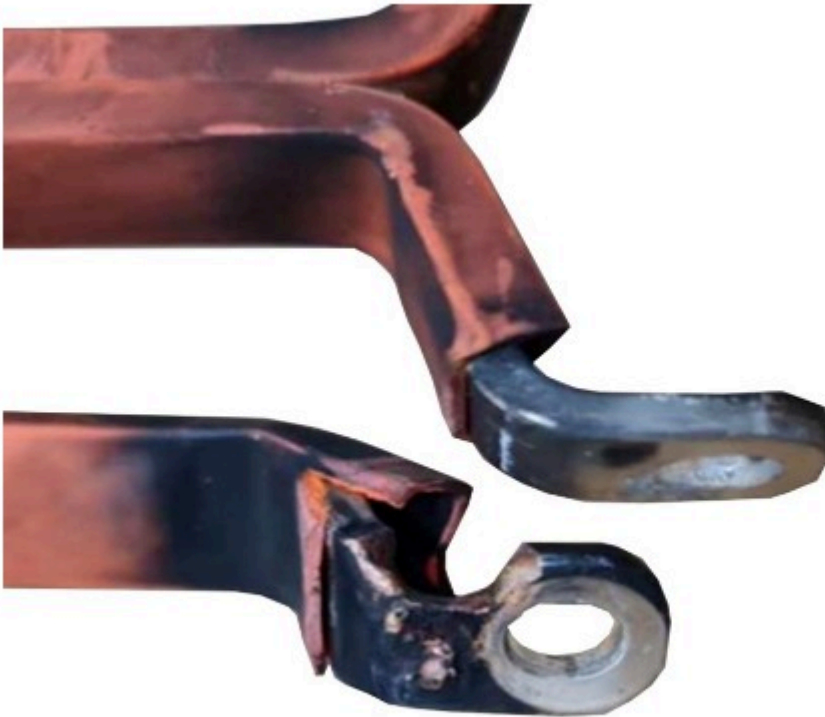
- Make a note of all damage found and the installed position of the damaged busbar within the [HV](#) battery.
- All findings **must** be reported to [TA](#).
- The images marked with a **RED 'X'** show an example of busbar damage caused by overheating, make a note of all damage found.

- Clean the busbar contact areas (**A**) with alcohol based cleaning fluid and a lint free cloth.
- Visually inspect the contact areas (**A**) for signs of damage.
- Visually inspect the protective insulation for damage (**B**).
- If there **ARE** any signs of damage as shown in the images marked with a **RED 'X'**, make a note of the installed position of the busbar in the [HV](#) battery. **Continue to step 20.**
- If there **ARE NOT** any signs of damage, **continue to step 20.**

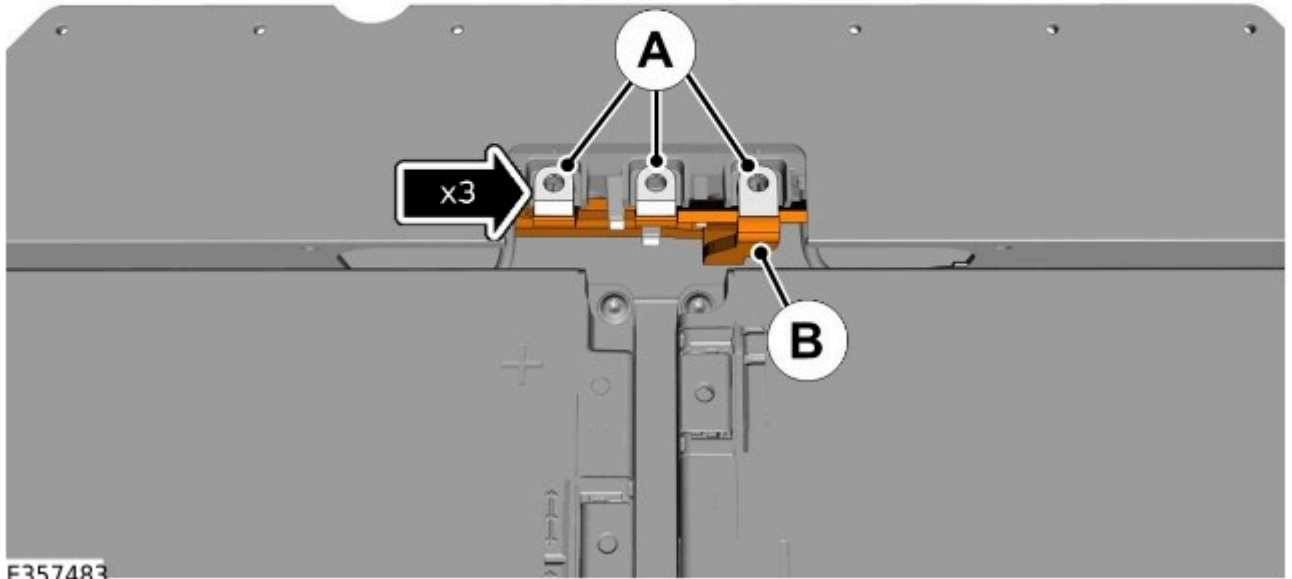
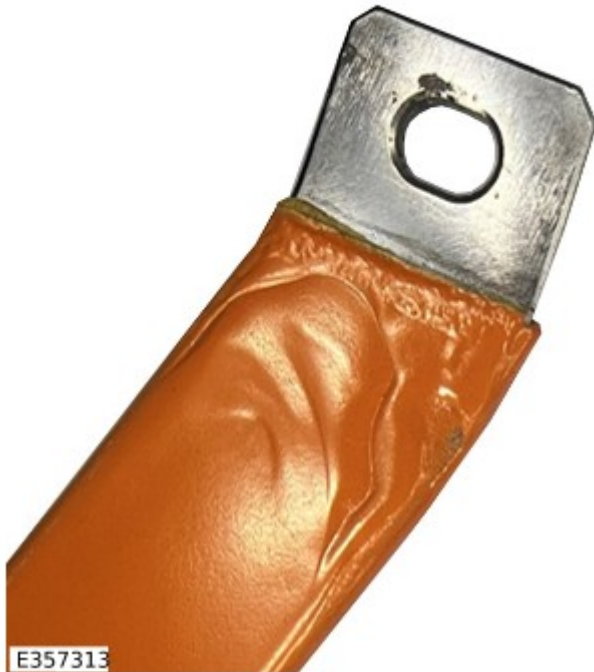
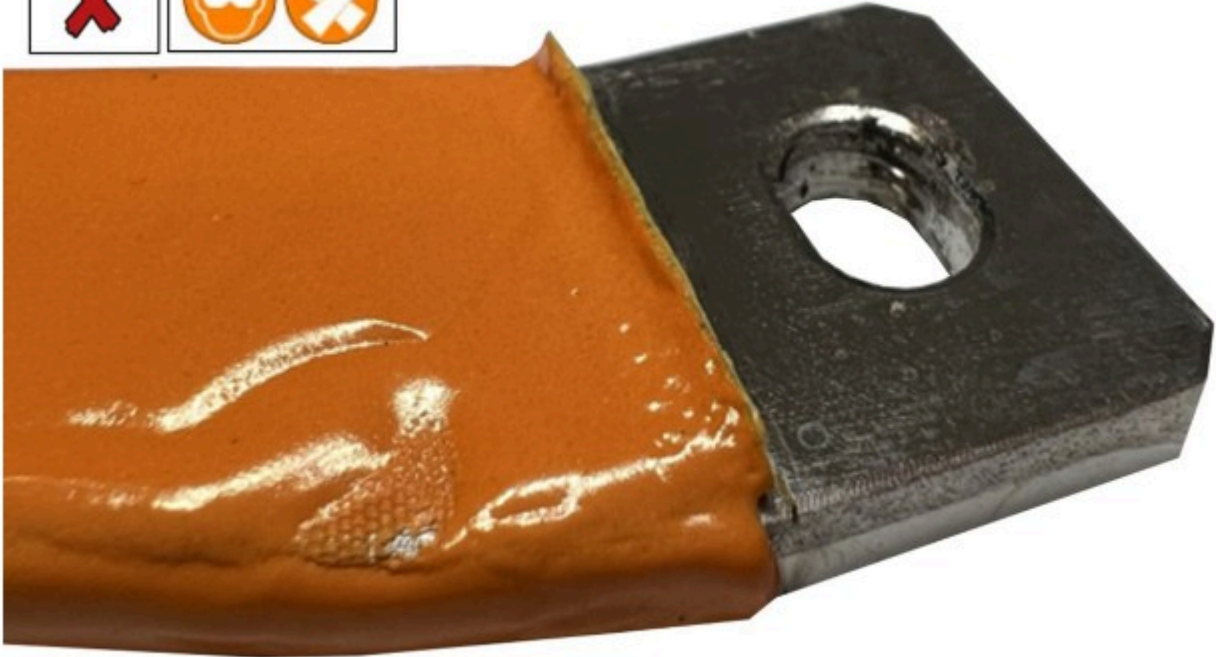
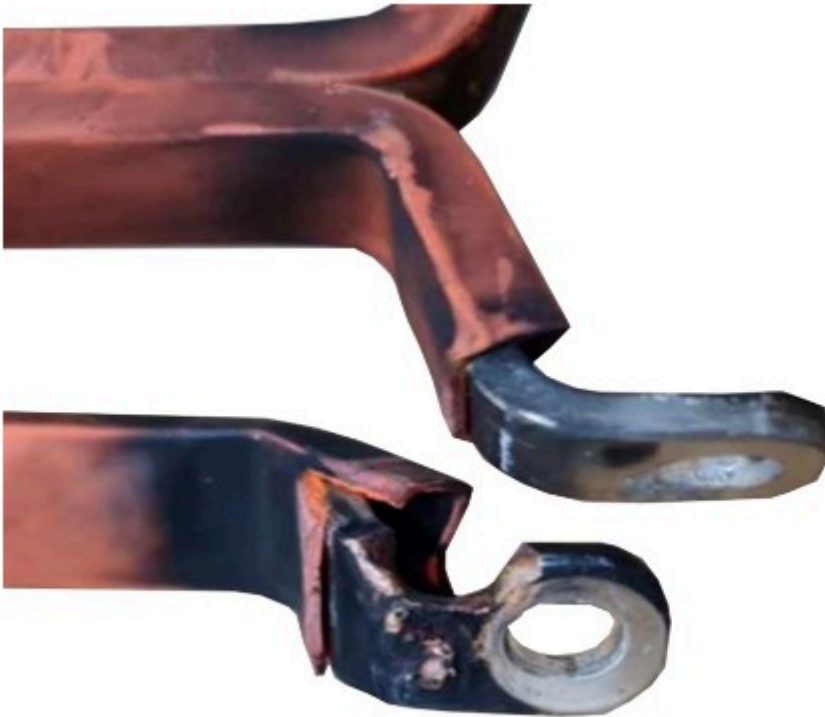
- Make a note of all damage found and the installed position of the damaged busbar within the [HV](#) battery.
- All findings **must** be reported to [TA](#).
- The images marked with a **RED 'X'** show an example of busbar damage caused by overheating, make a note of all damage found.

- Clean the busbar contact areas (**A**) with alcohol based cleaning fluid and a lint free cloth.
- Visually inspect the contact areas (**A**) for signs of damage.
- Visually inspect the protective insulation for damage (**B**).
- If there **ARE** any signs of damage as shown in the images marked with a **RED 'X'**, make a note of the installed position of the busbar in the [HV](#) battery. **Continue to step 22.**
- If there **ARE NOT** any signs of damage, **continue to step 22.**

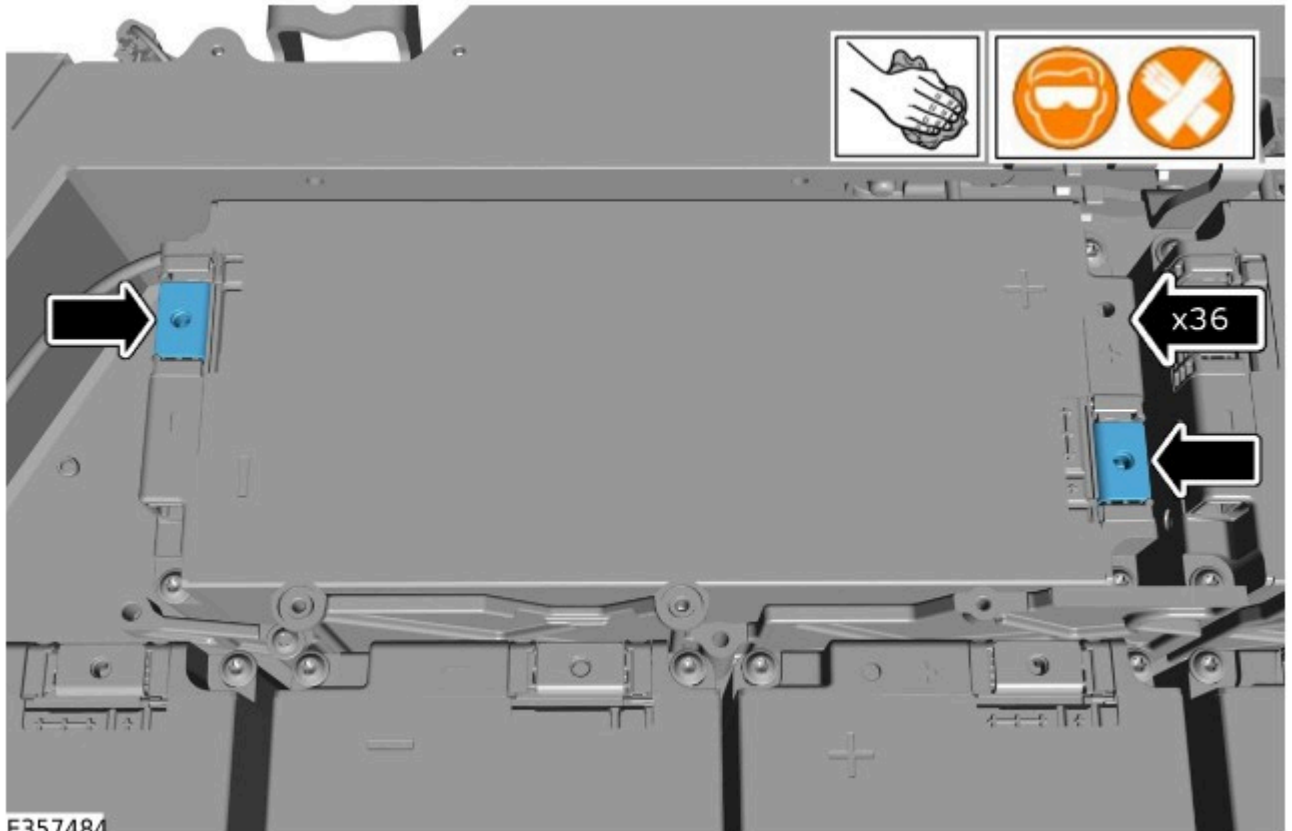
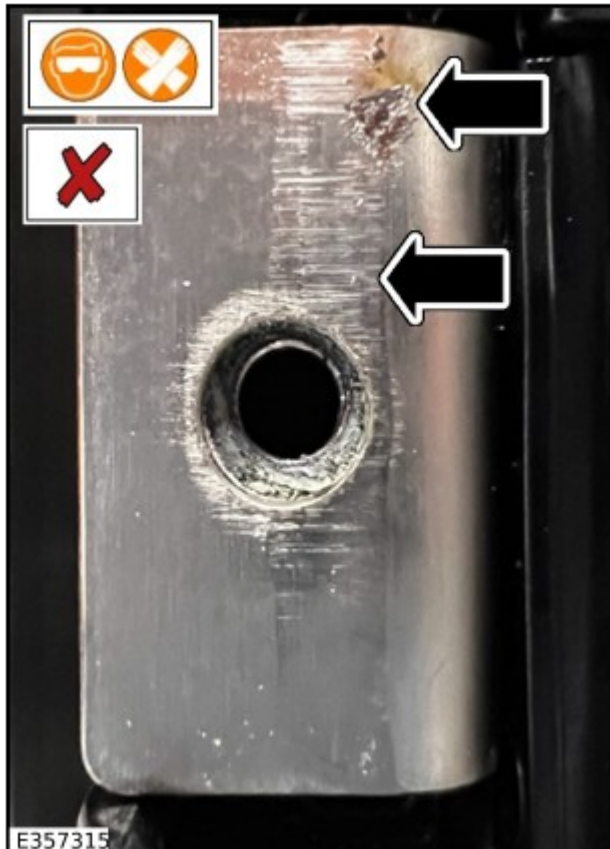
- Each **HV** battery module has 2 contact areas, all contacts areas **must** be thoroughly inspected.
- All findings **must** be reported to **TA**.
- The image marked with a **RED 'X'** show an example of **HV** battery module damage caused by overheating, make a note of all damage found.

- Remove the battery module terminal blanking caps, JLR-415-016, from the module terminals.
- Clean the **HV** battery module contact areas with alcohol based cleaning fluid and a lint free cloth.
- Visually inspect the **HV** battery module contact areas for signs of damage.
- If there **ARE** any signs of damage as shown in the images marked with a **RED 'X'**, make a note of the installed position of the busbar in the **HV** battery. **Continue to step 23.**
- If there **ARE NOT** any signs of damage, **continue to step 23.**
