# SAFETY RELATED RECALL

Global Recall Action  
Number: H468v4

| <b>Subject:</b><br><br><b>High Voltage (HV) Battery Busbar Fixings</b> | Publication No.: H468v4 |

# SERVICE INSTRUCTION - H468V4

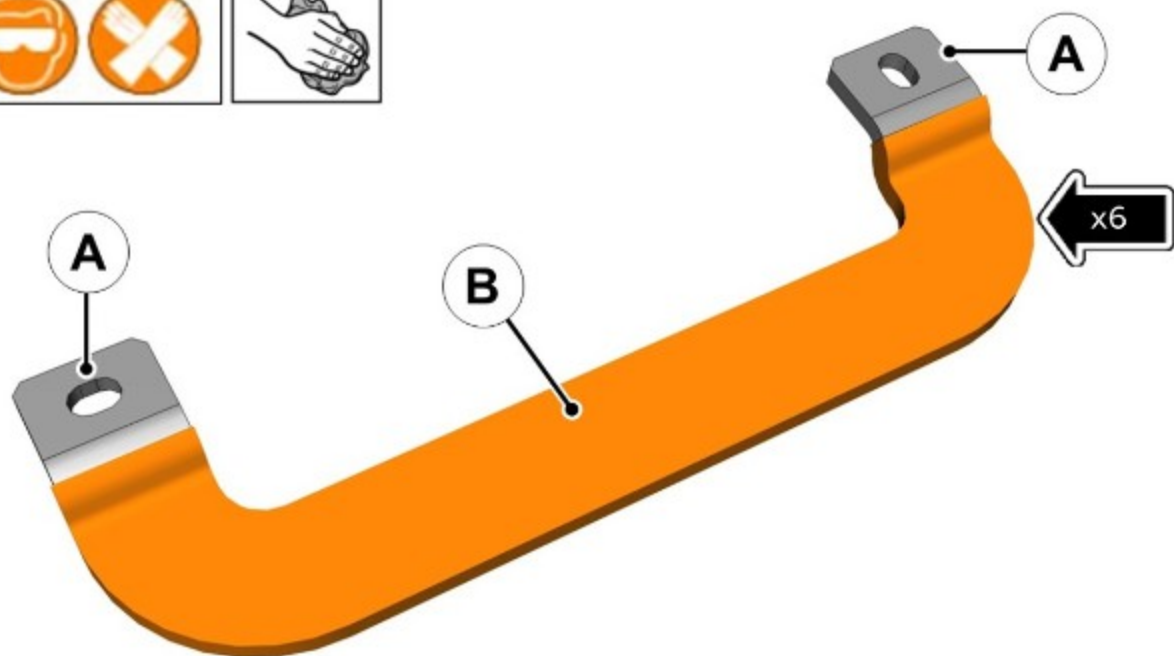
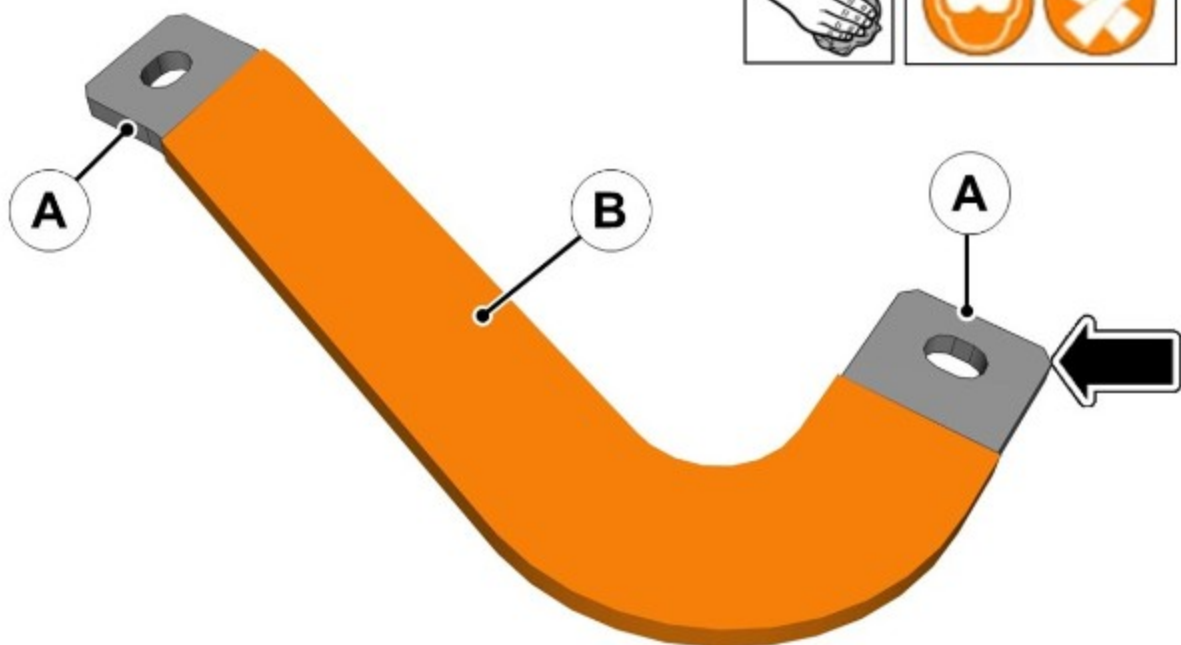
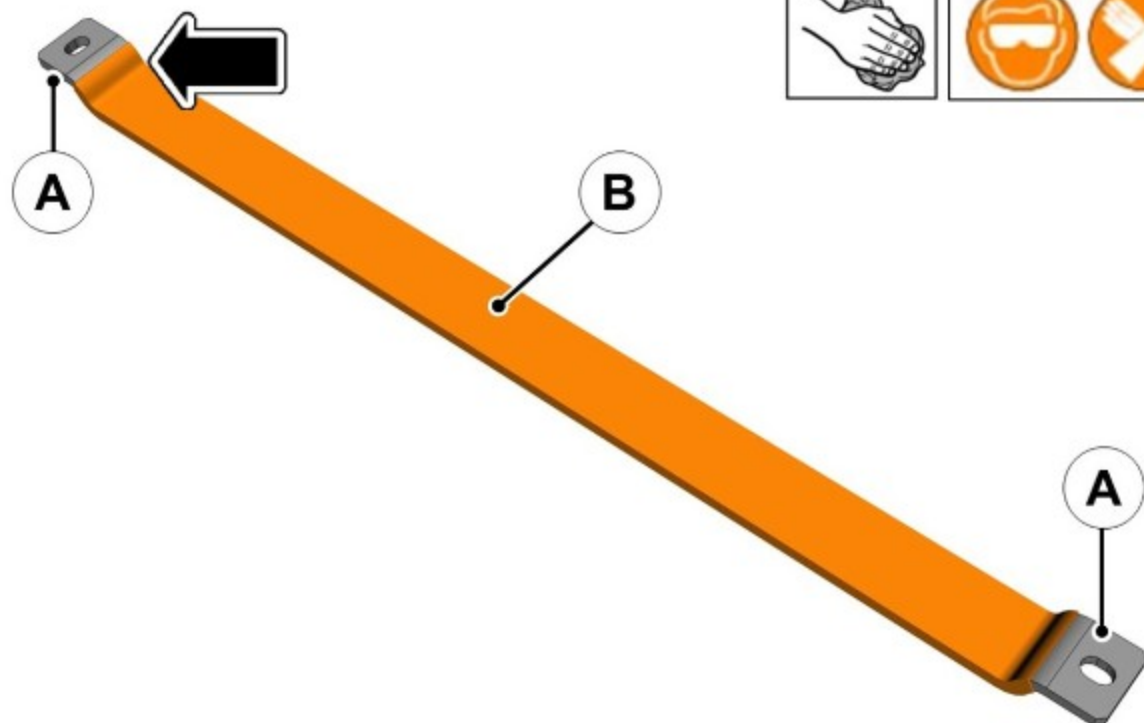
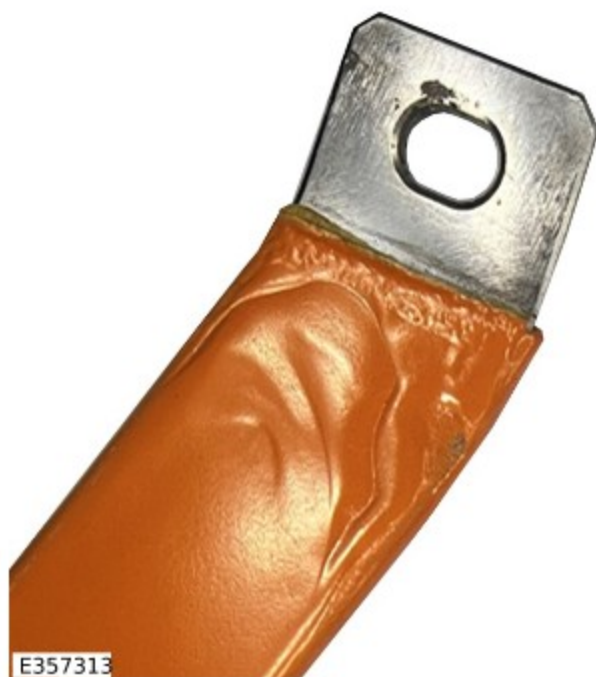
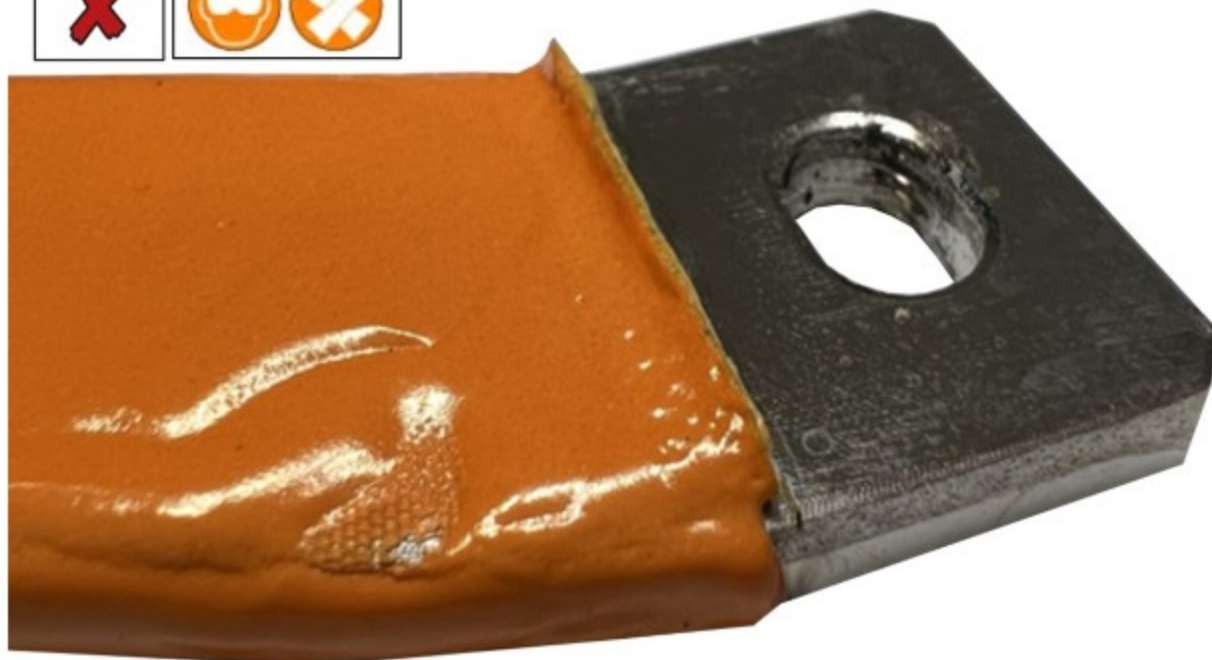
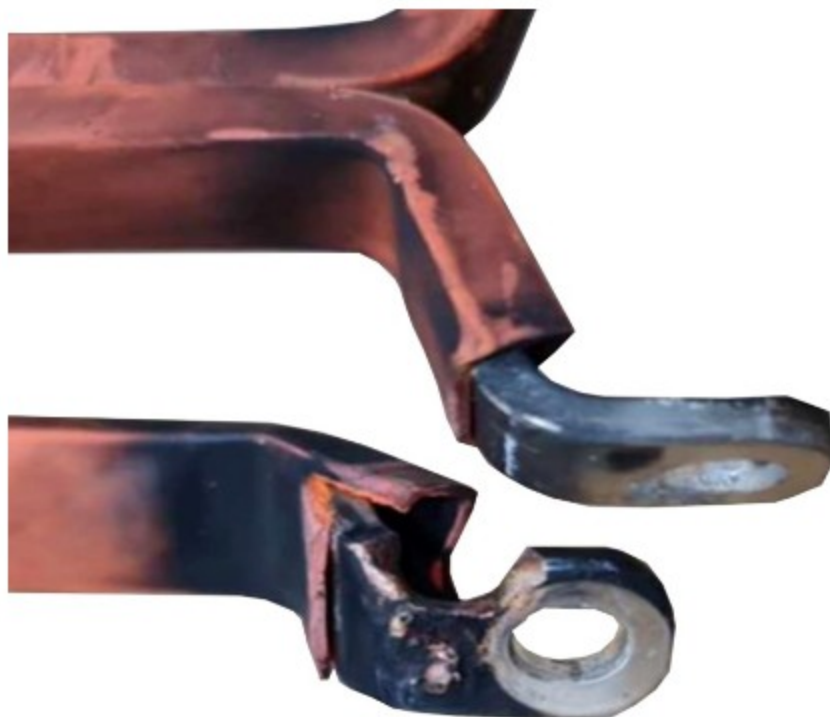
- Make a note of all damage found and the installed position of the damaged busbar within the [HV](#) battery.
- All findings **must** be reported to [TA](#).
- The images marked with a **RED 'X'** show an example of busbar damage caused by overheating, make a note of all damage found.

- Clean the busbar contact areas (**A**) with alcohol based cleaning fluid and a lint free cloth.
- Visually inspect the contact areas (**A**) for signs of damage.
- Visually inspect the protective insulation for damage (**B**).
- If there **ARE** any signs of damage as shown in the images marked with a **RED 'X'**, make a note of the installed position of the busbar in the [HV](#) battery. **Continue to step 16, do not reinstall the busbars..**
- If there **ARE NOT** any signs of damage, **continue to step 16, do not reinstall the busbars..**

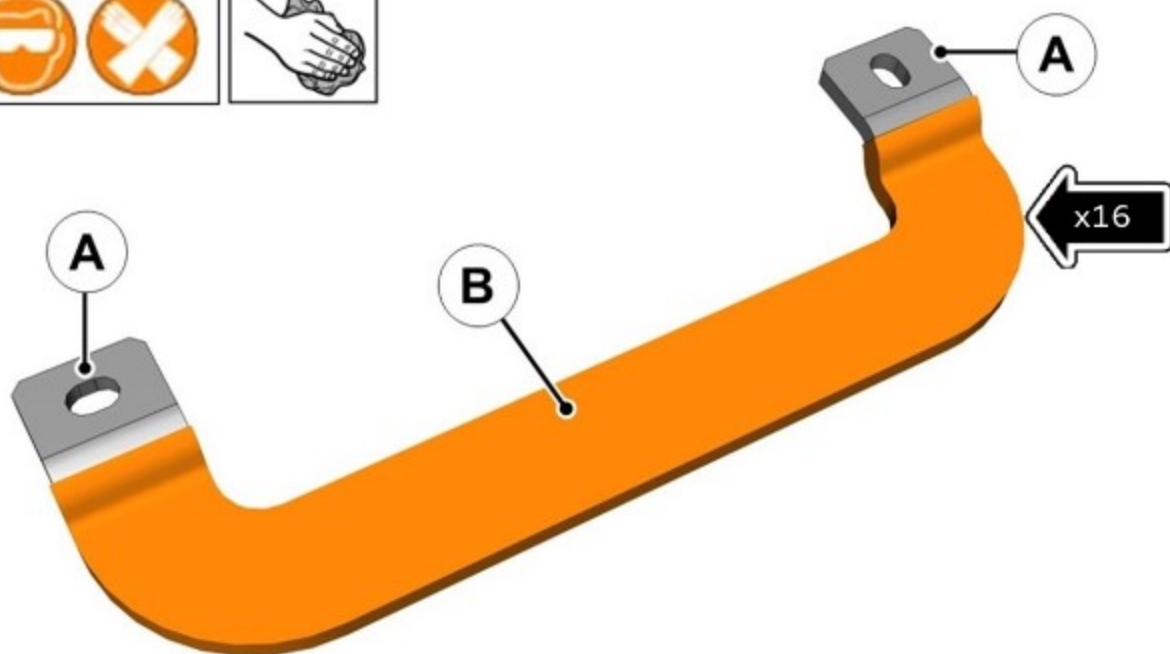
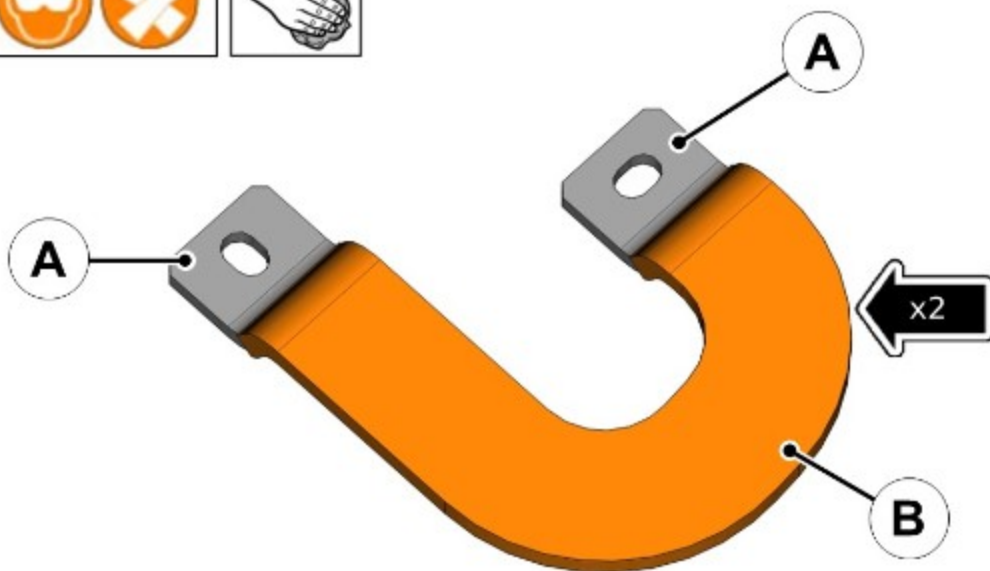
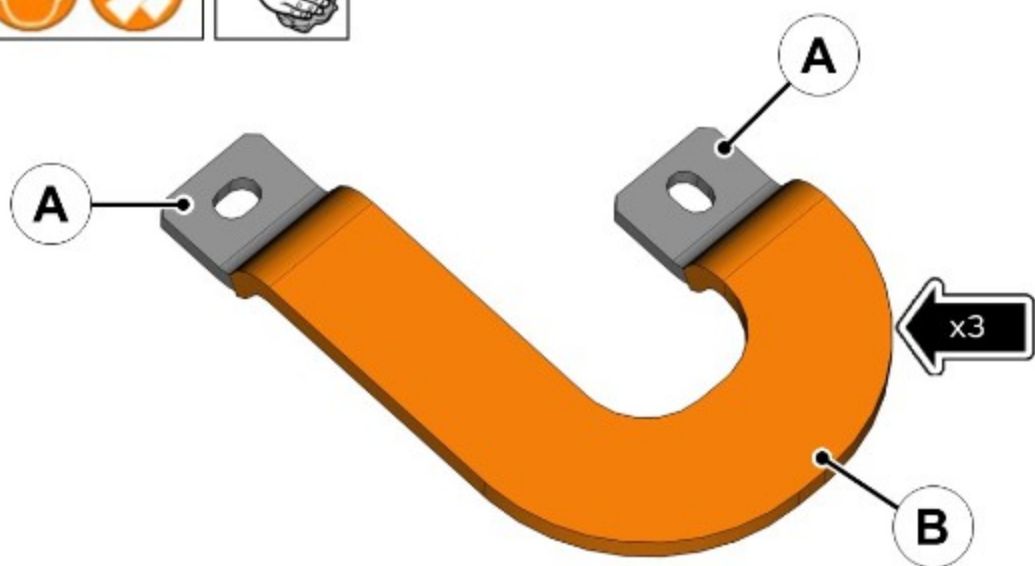
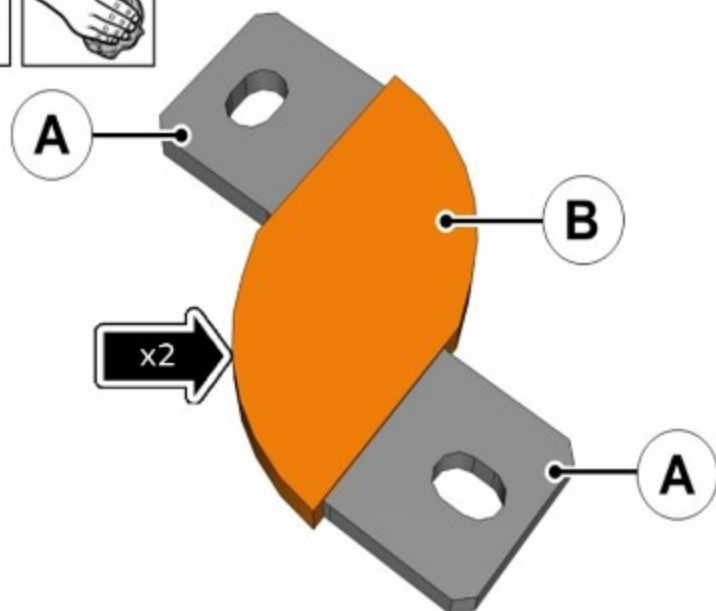
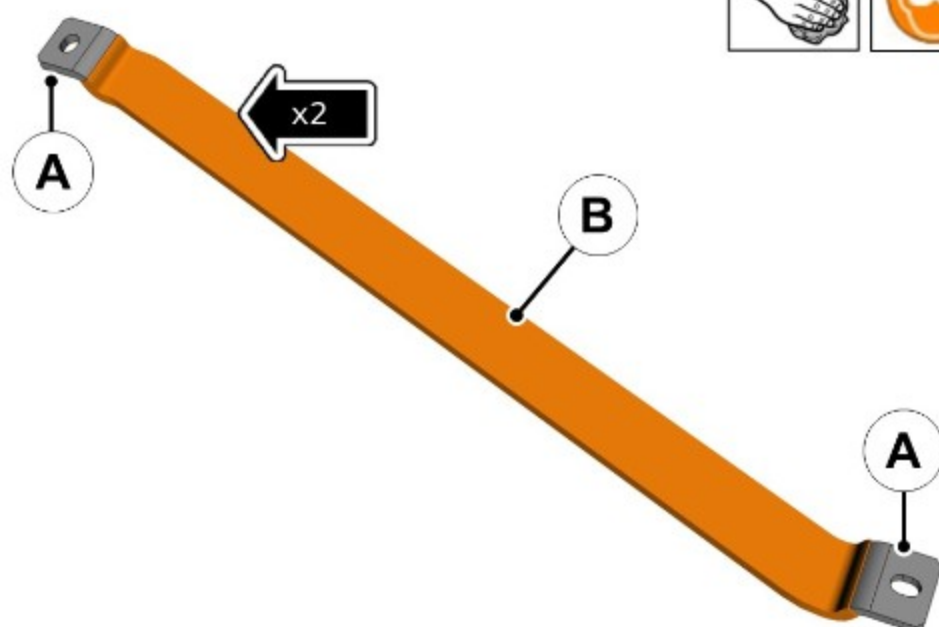
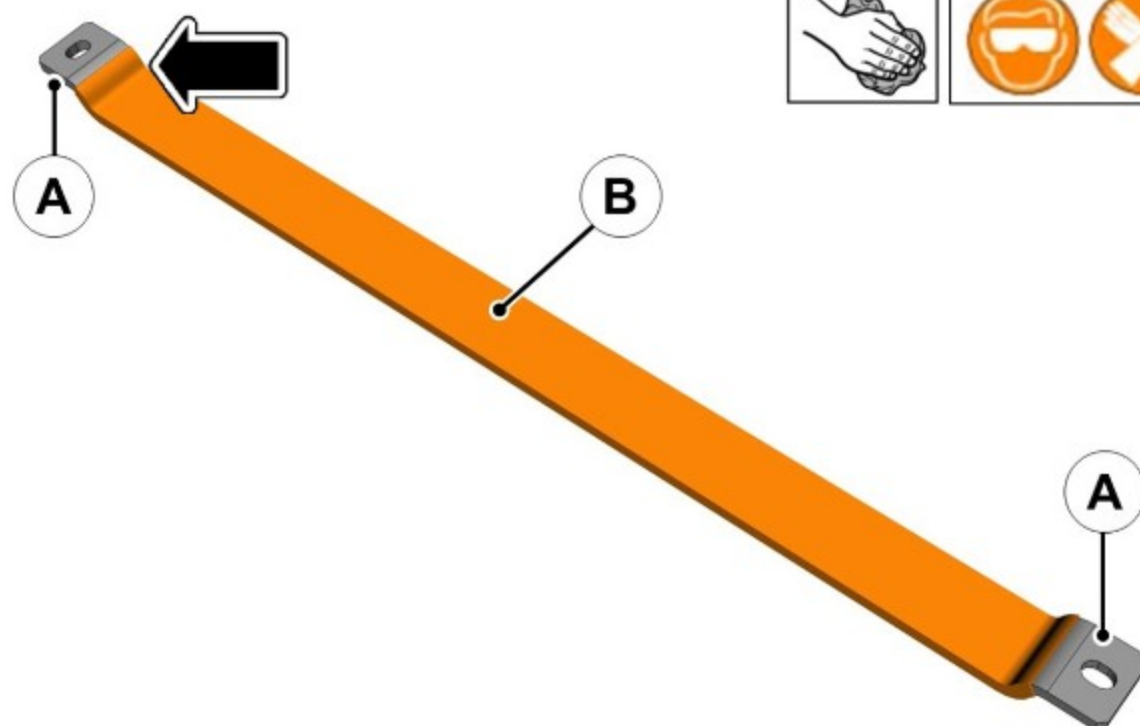
- Make a note of all damage found and the installed position of the damaged busbar within the [HV](#) battery.
- All findings **must** be reported to [TA](#).
- The images marked with a **RED 'X'** show an example of busbar damage caused by overheating, make a note of all damage found.

- Clean the busbar contact areas **(A)** with alcohol based cleaning fluid and a lint free cloth.
- Visually inspect the contact areas **(A)** for signs of damage.
- Visually inspect the protective insulation for damage **(B)**.
- If there **ARE** any signs of damage as shown in the images marked with a **RED 'X'**, make a note of the installed position of the busbar in the [HV](#) battery. **Continue to step 18, do not reinstall the busbars.**
- If there **ARE NOT** any signs of damage, **continue to step 18, do not reinstall the busbars.**

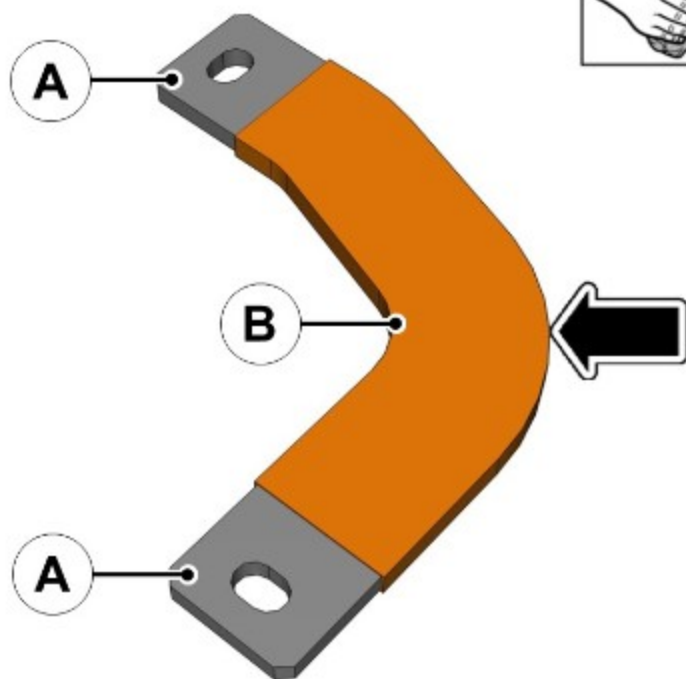
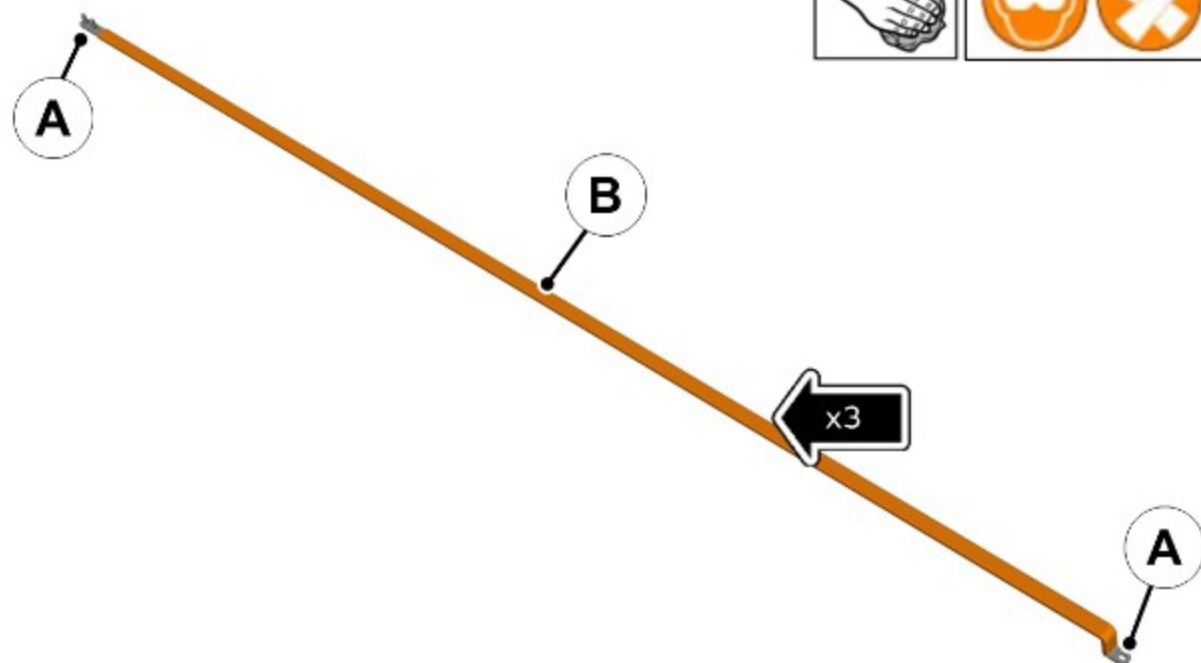
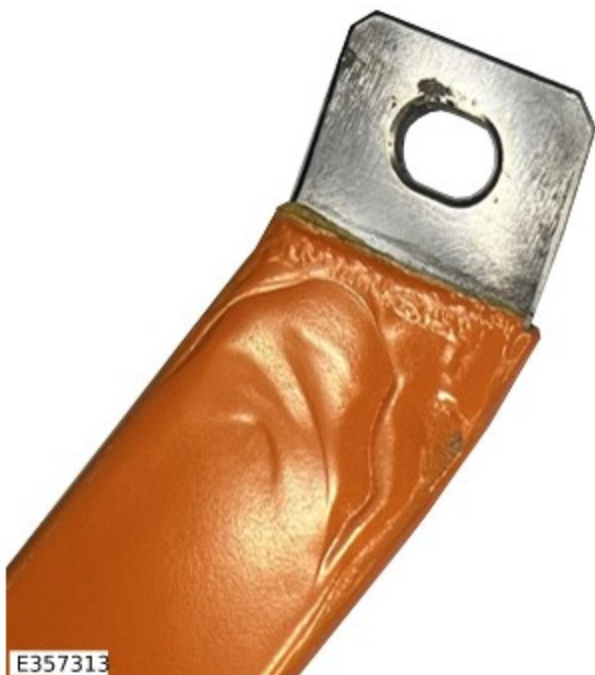
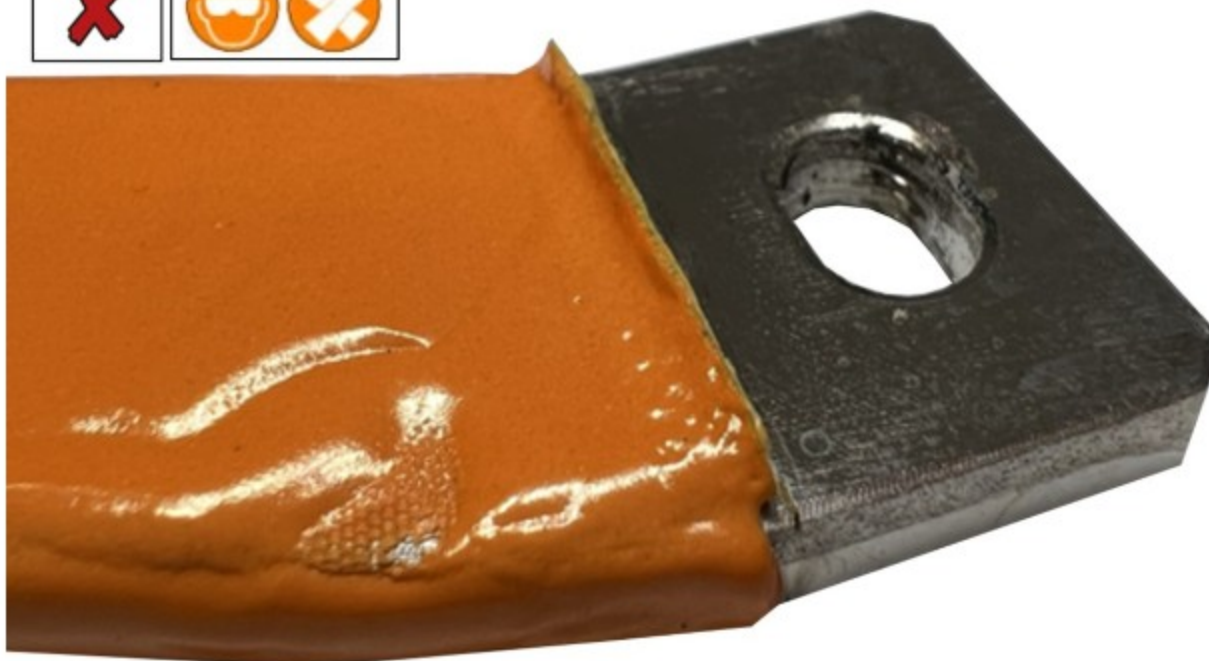
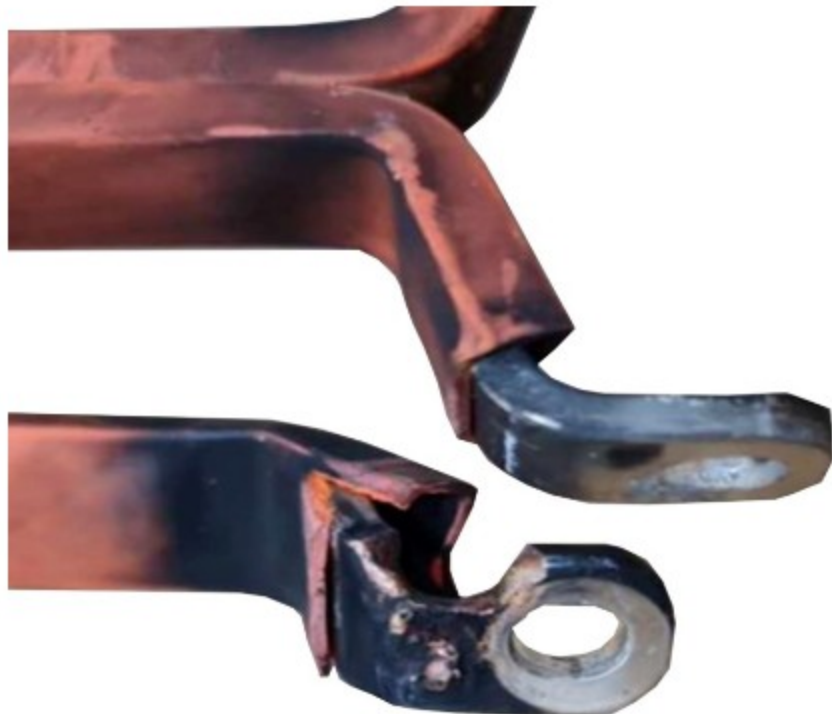
- Make a note of all damage found and the installed position of the damaged busbar within the [HV](#) battery.
- All findings **must** be reported to [TA](#).
- The images marked with a **RED 'X'** show an example of busbar damage caused by overheating, make a note of all damage found.

- Clean the busbar contact areas (**A**) with alcohol based cleaning fluid and a lint free cloth.
- Visually inspect the contact areas (**A**) for signs of damage.
- Visually inspect the protective insulation for damage (**B**).
- If there **ARE** any signs of damage as shown in the images marked with a **RED 'X'**, make a note of the installed position of the busbar in the [HV](#) battery. **Continue to step 19.**
- If there **ARE NOT** any signs of damage, **continue to step 19.**

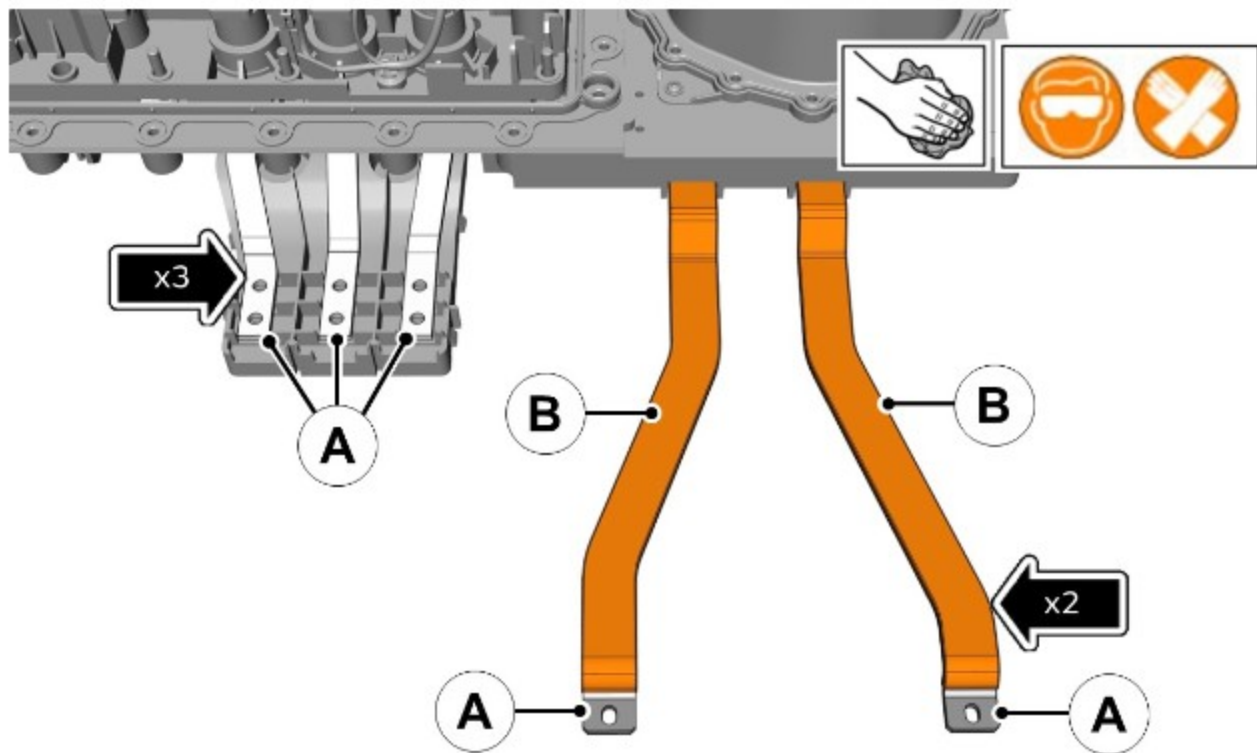
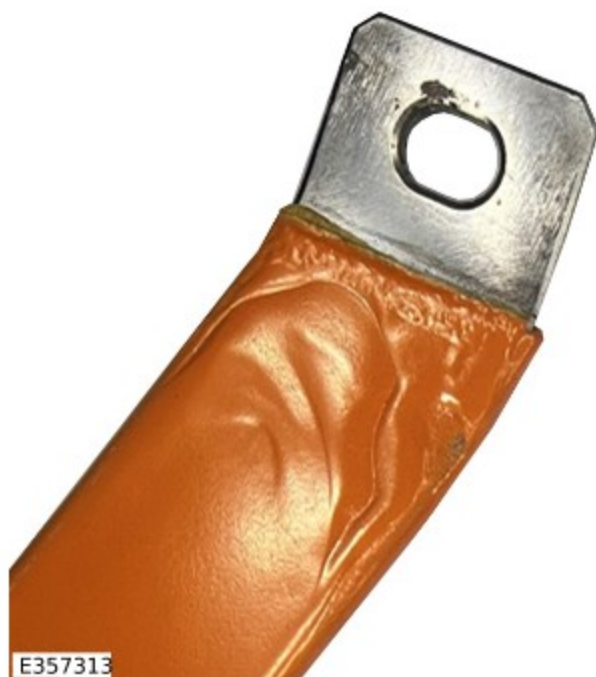
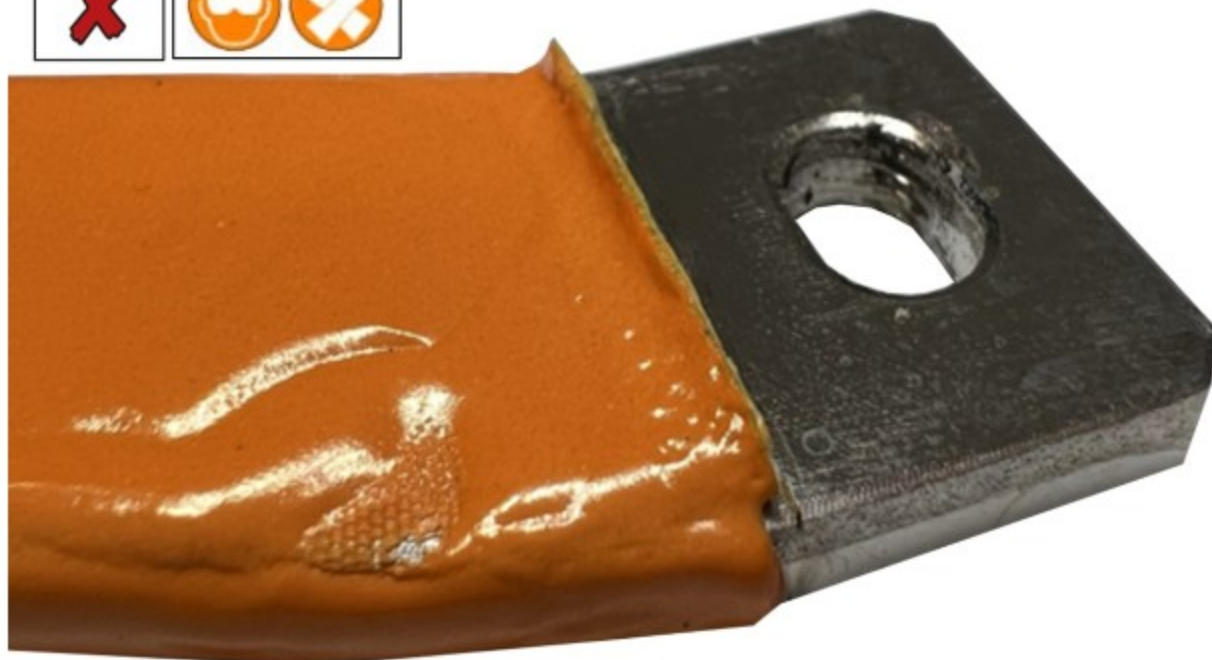
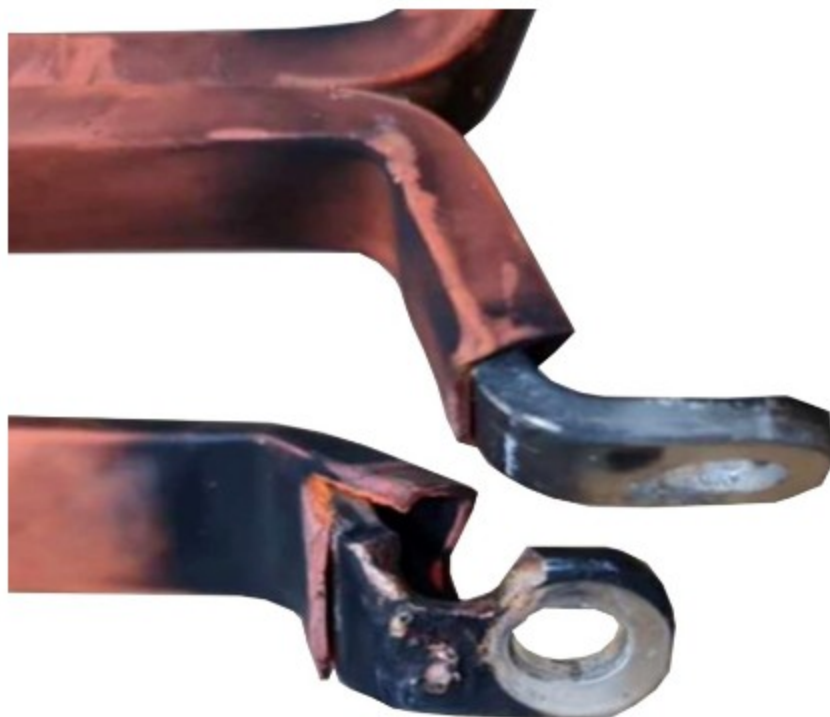
- Make a note of all damage found and the installed position of the damaged busbar within the [HV](#) battery.
- All findings **must** be reported to [TA](#).
- The images marked with a **RED 'X'** show an example of busbar damage caused by overheating, make a note of all damage found.

- Clean the busbar contact areas **(A)** with alcohol based cleaning fluid and a lint free cloth.
- Visually inspect the contact areas **(A)** for signs of damage.
- Visually inspect the protective insulation for damage **(B)**.
- If there **ARE** any signs of damage as shown in the images marked with a **RED 'X'**, make a note of the installed position of the busbar in the [HV](#) battery. **Continue to step 20.**
- If there **ARE NOT** any signs of damage, **continue to step 20.**

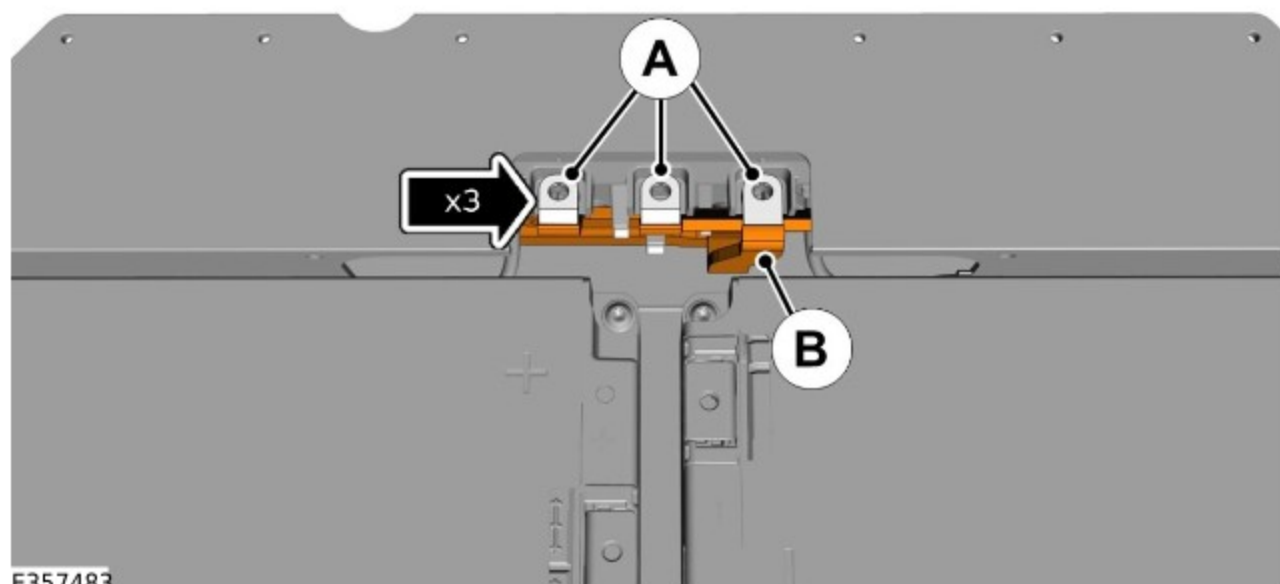
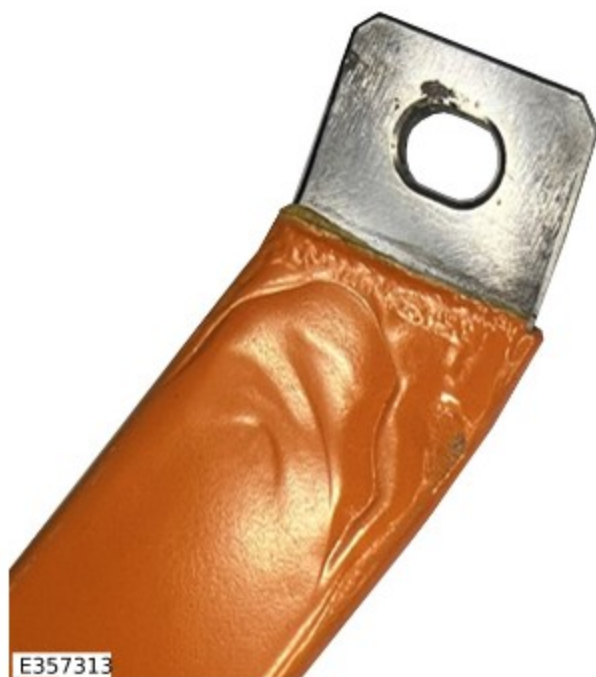
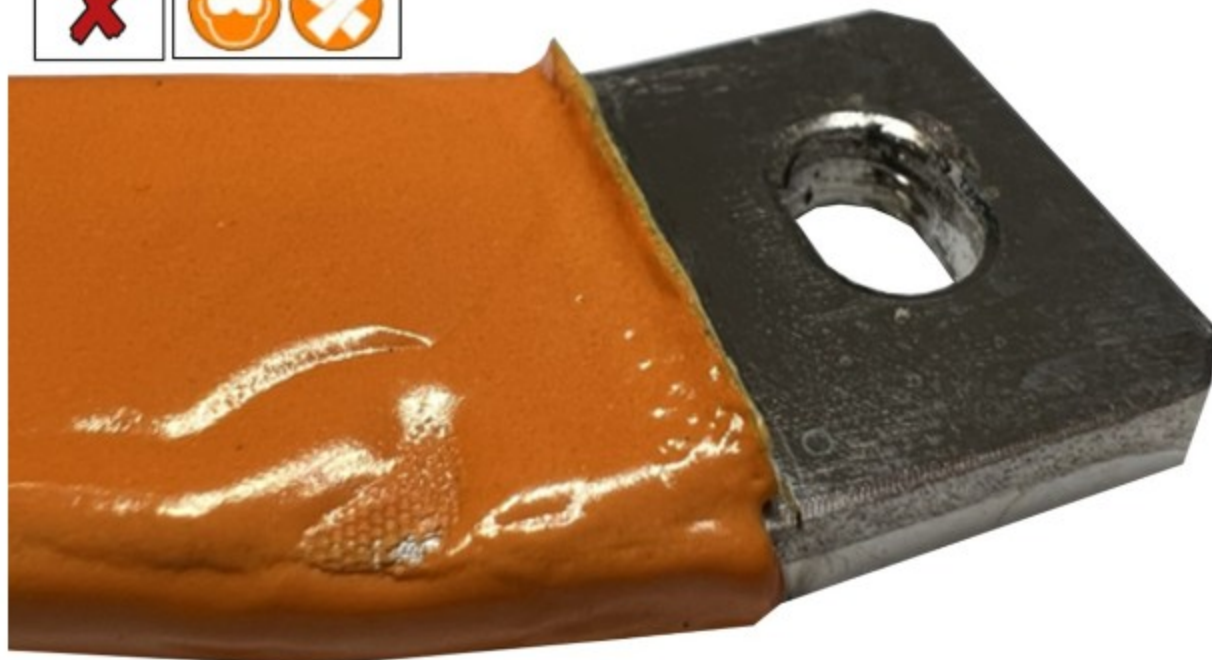
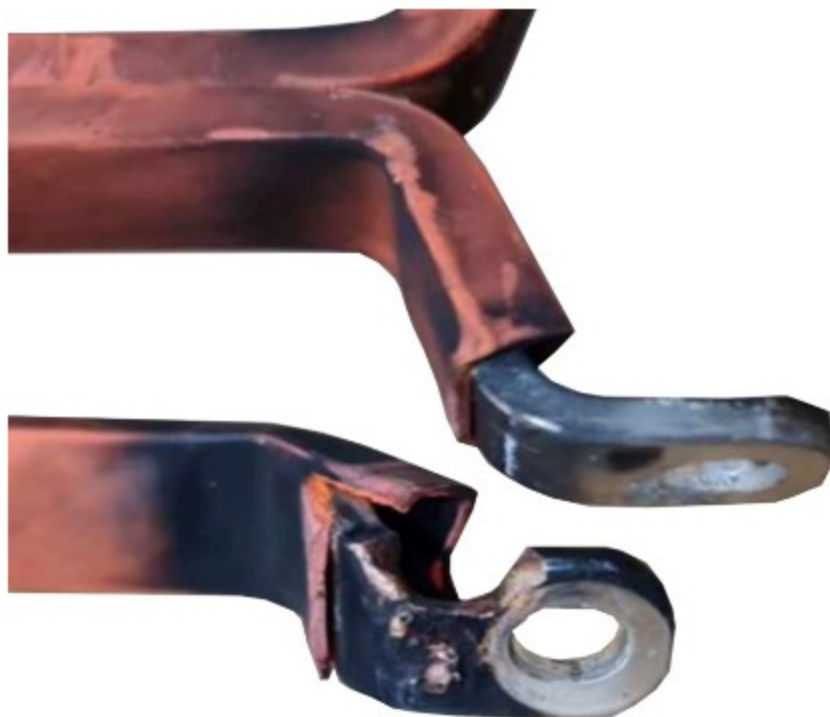
- Make a note of all damage found and the installed position of the damaged busbar within the [H.V.](#) battery.
- All findings **must** be reported to [T.A.](#).
- The images marked with a **RED 'X'** show an example of busbar damage caused by overheating, make a note of all damage found.

- Clean the busbar contact areas **(A)** with alcohol based cleaning fluid and a lint free cloth.
- Visually inspect the contact areas **(A)** for signs of damage.
- Visually inspect the protective insulation for damage **(B)**.
- If there **ARE** any signs of damage as shown in the images marked with a **RED 'X'**, make a note of the installed position of the busbar in the [H.V.](#) battery. **Continue to step 22.**
- If there **ARE NOT** any signs of damage, **continue to step 22.**

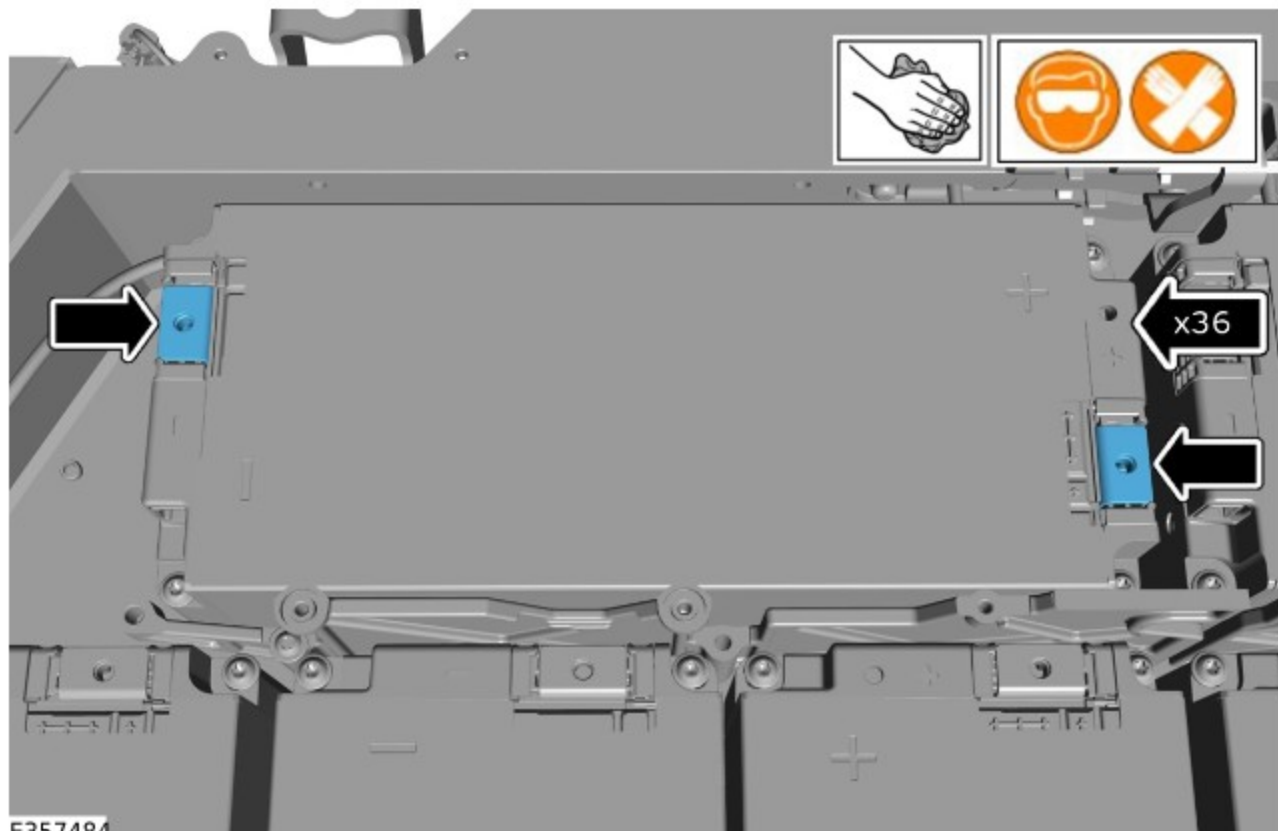
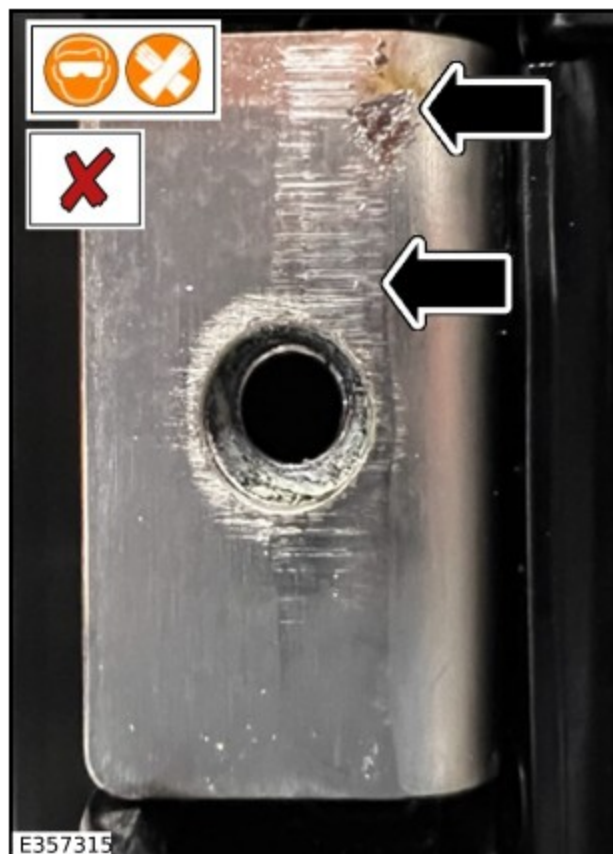
- Each [HV](#) battery module has 2 contact areas, all contacts areas **must** be thoroughly inspected.
- All findings **must** be reported to [TA](#).
- The image marked with a **RED 'X'** show an example of [HV](#) battery module damage caused by overheating, make a note of all damage found.

- Remove the battery module terminal blanking caps, JLR-415-016, from the module terminals.
- Clean the [HV](#) battery module contact areas with alcohol based cleaning fluid and a lint free cloth.
- Visually inspect the [HV](#) battery module contact areas for signs of damage.
- If there **ARE** any signs of damage as shown in the images marked with a **RED 'X'**, make a note of the installed position of the busbar in the [HV](#) battery. **Continue to step 23.**
- If there **ARE NOT** any signs of damage, **continue to step 23.**
