SIB 34 02 24

RECALL 24V-104: INTEGRATED BRAKING SYSTEM

This Service Information Bulletin (Revision 2) replaces SI B34 02 24 **dated August 2024**.

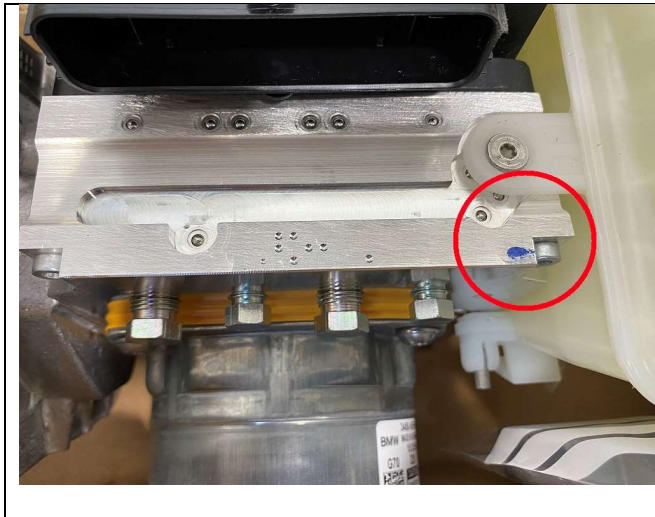
1. Inspect the IB installed in the vehicle for a blue dot as shown in the photo.

Yes, Submit TSARA case, subject line: B34 02 24 Blue dot and await further assistance.

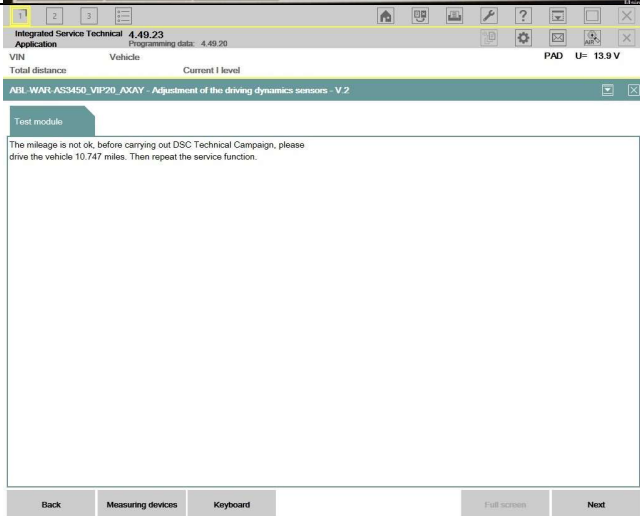
- The test plan results will determine whether the vehicle needs to be driven x number of miles, as shown in the photo, or the mileage is appropriate to proceed with IB replacement.
- **Note:** The vehicle must be driven the minimum given miles but not beyond 0.5 miles above. Anything above or below will result in another required drive.

- Repeat the service function after the vehicle has been driven the given number of miles from the test plan results.
- **Note:** the photo shown is only an example of a vehicle test which requires miles accrued before replacing an IB

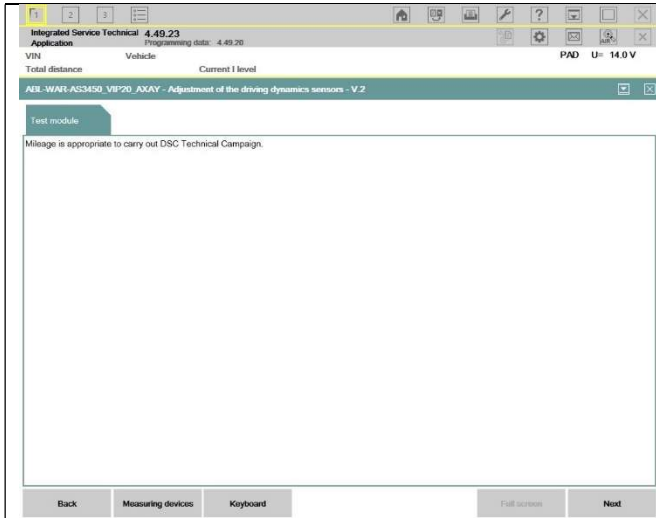
- The test plan results indicate the mileage is appropriate to proceed with IB replacement
- **IMPORTANT: Do not proceed with IB replacement without receiving this message**

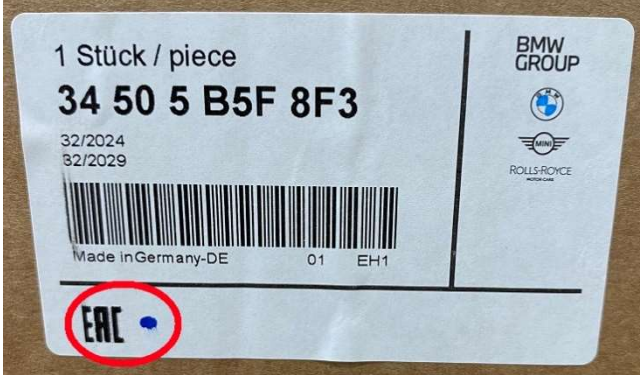
3. Verify the blue dot is located on the part number label as shown in the photo.

Note: Photo shown for location of blue dot on the parts label and does not indicate the part number for all models

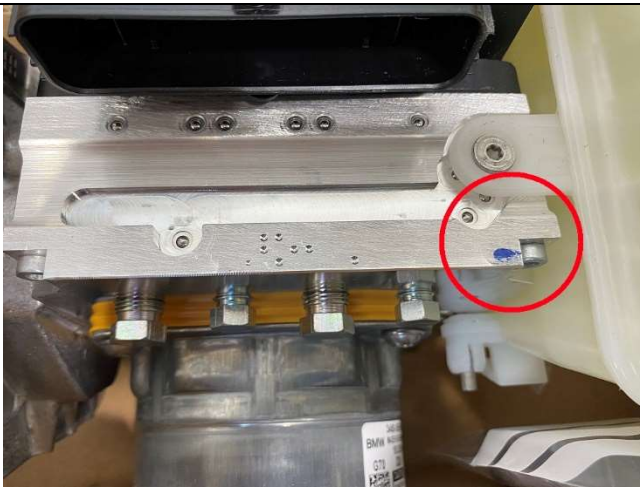
4. Verify the blue dot is located on the on the new component as shown in the photo.

Note: Some models or IB may have an additional blue dot which is on the brake fluid reservoir. Disregard that blue dot. The only blue dot to be verified is shown here.
