SIB 34 02 24

RECALL 24V-104: INTEGRATED BRAKING SYSTEM

2025-10-31

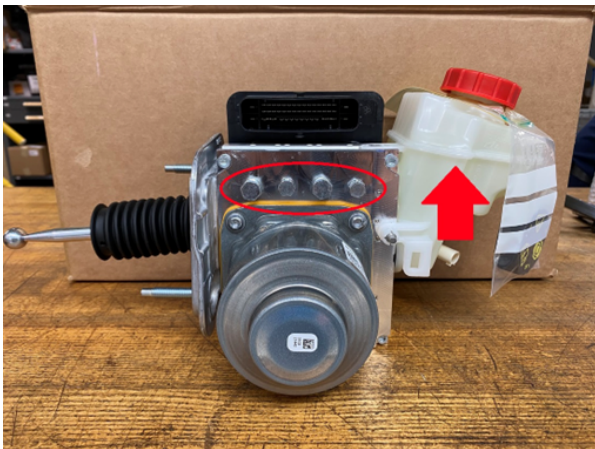
“Wet” IB pre-filled: Brake fluid reservoir is filled (arrow) and brake fluid line ports are plugged with bolts (circled).

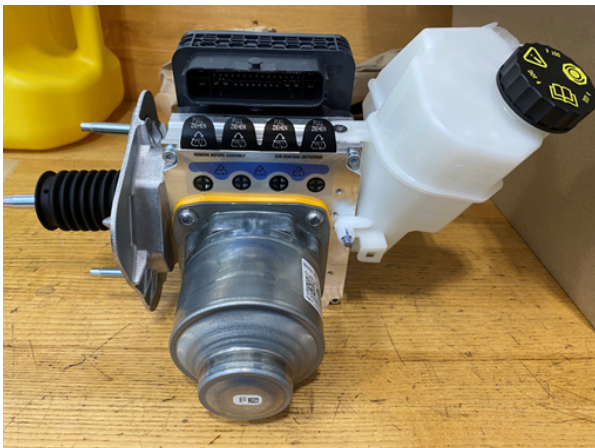
“Dry” IB unfilled: Brake fluid reservoir is empty; brake fluid line ports are sealed with labels.

Note: Additional work is necessary to install these “Dry” units. Refer to the Claim Information section.

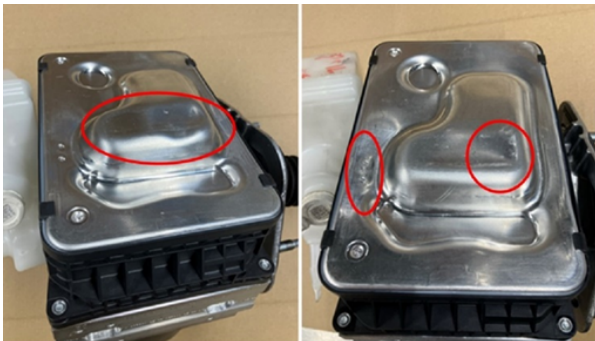
- Prior to installation, the Integrated Brake Modules should be inspected for damage upon arrival. Light scratches are acceptable, but if the aluminum cover is dented or bent, ~~if damage is found~~, please send photos in a Recall IDS Ticket for review prior to entering a claim. If approved, please claim in accordance with the Dealer Services Return and Claims Manual.

Do not install any part which shows visual damage as shown, or has been dropped from any height.
