SIB 34 02 24

**RECALL 24V-104: INTEGRATED BRAKING SYSTEM**

This Service Information Bulletin (Revision 4) replaces SI B34 02 24 **dated September 2024**.

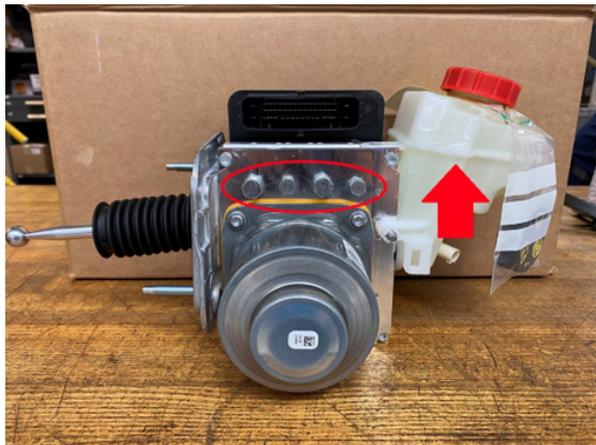
**“Wet” IB pre-filled:** Brake fluid reservoir is filled (arrow) and brake fluid line ports are plugged with bolts (circled).

Replace the IB with either a “wet” pre-filled unit or a “dry” unfilled unit.
