SIM 34 01 24

2025-07-17

RECALL 24V-104: INTEGRATED BRAKING SYSTEM (IB)

This Service Information Bulletin (Revision 12) replaces SI M34 01 24 **dated May 2025**.

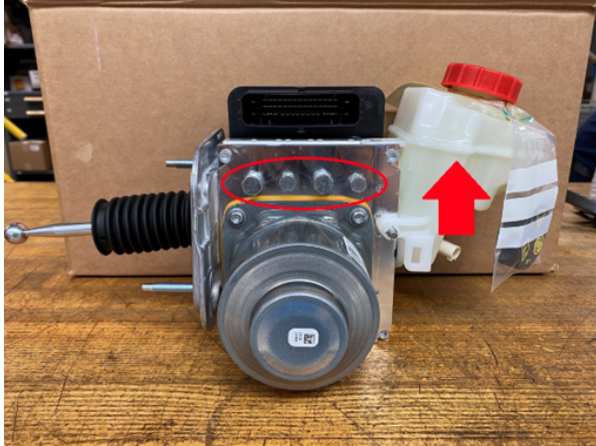
“Wet” IB pre-filled: Brake fluid reservoir is filled (arrow) and brake fluid line ports are plugged with bolts (circled)

5B67B85
5B72715
5B72716
5B6A736

If you have received a “wet” unit, follow the REP34 51 601 Replacing hydraulic unit

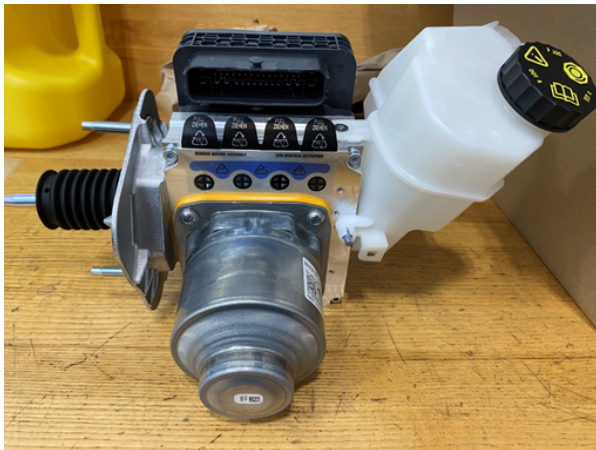
“Dry” IB unfilled: Brake fluid reservoir is empty; brake fluid line ports are sealed with labels.

Part numbers:
5B3C874
5B6C7F1

Note: Additional work is necessary to install these “Dry” units, refer to the Claim Information section.

If you have received a “dry” unit, follow the REP 34 51 602 Replacing the hydraulic unit (not filled).

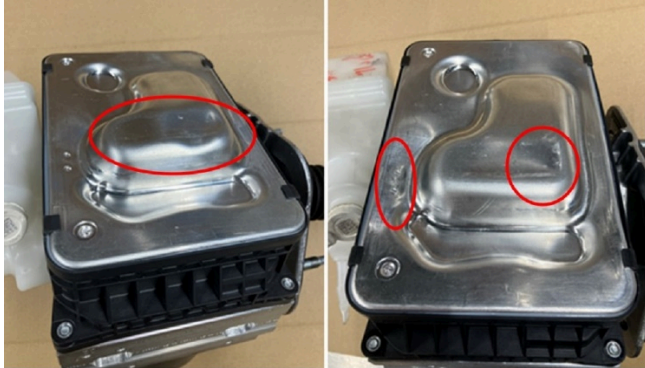
- Prior to installation, the Integrated Brake Modules should be inspected for damage upon arrival. Light scratches are acceptable; but if the aluminum cover is dented or bent, please send photos in a Recall IDS Ticket for review prior to entering a claim. If approved, please claim in accordance with the Dealer Services Return and Claims Manual.
- For further information regarding IB parts updates follow the link [Integrated Brake System Recall's Flowpage](#)

Do not install any part which shows visual damage as shown, or has been dropped from any height.

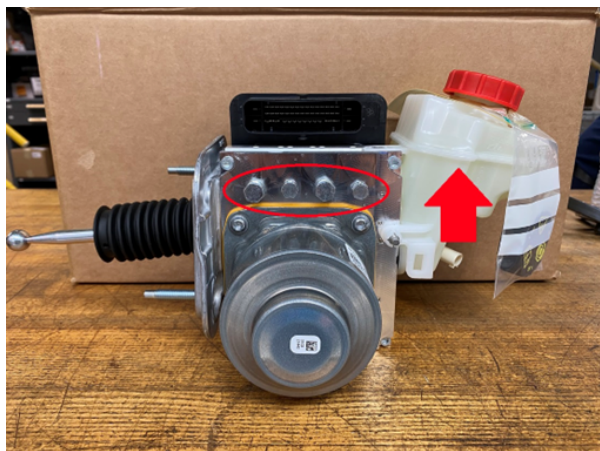
“Wet” IB pre-filled: Brake fluid reservoir is filled (arrow) and brake fluid line ports are plugged with bolts (circled).

5B67B85
5B6E463
5B6E465
5B6E467
5B69D61
5B69D63
5B69D65
5B72715
5B72716
5B6F947
5B6F943

If you have received a “**wet**” unit, follow the REP34 51 601 Replacing hydraulic unit

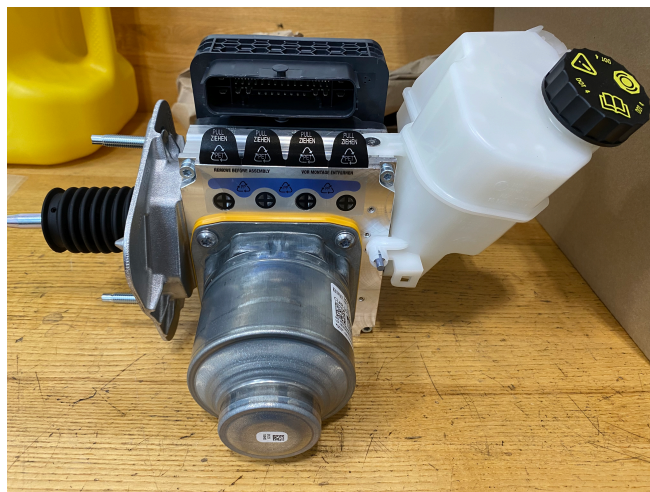
“Dry” IB unfilled: Brake fluid reservoir is empty; brake fluid line ports are sealed with labels.

If you have received a “dry” unit, follow the REP 34 51 602 Replacing the hydraulic unit (not filled).

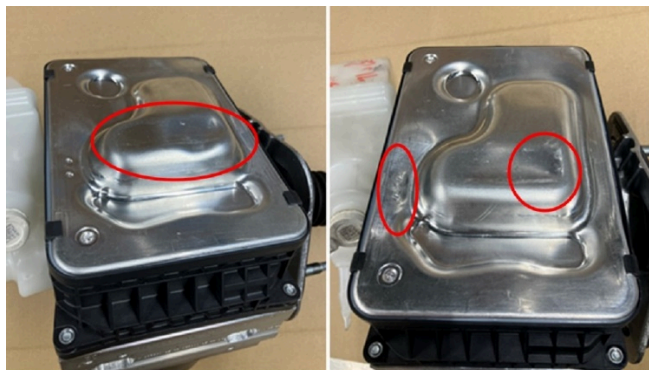
- Prior to installation, the Integrated Brake Modules should be inspected for damage upon arrival. Light scratches are acceptable, but if the aluminum cover is dented or bent, please send photos in a Recall IDS Ticket for review prior to entering a claim. If approved, please claim in accordance with the Dealer Services Return and Claims Manual.

Do not install any part which shows visual damage as shown, or has been dropped from any height.
