SIB 34 02 24

2025-08-13

RECALL 24V-104: INTEGRATED BRAKING SYSTEM

This Service Information Bulletin (Revision 14) replaces SI B34 02 24 **dated July 2025**.

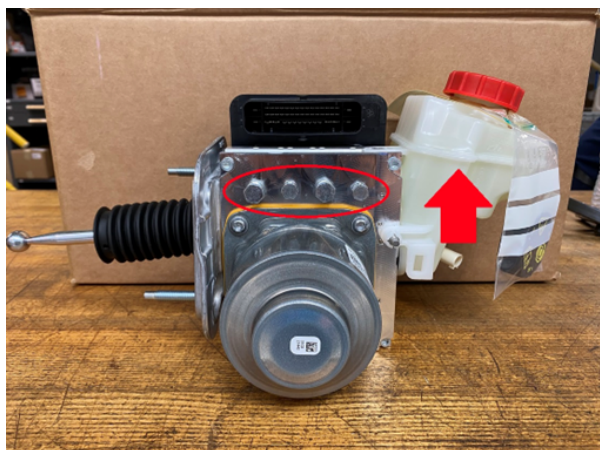
“Wet” IB pre-filled: Brake fluid reservoir is filled (arrow) and brake fluid line ports are plugged with bolts (circled).

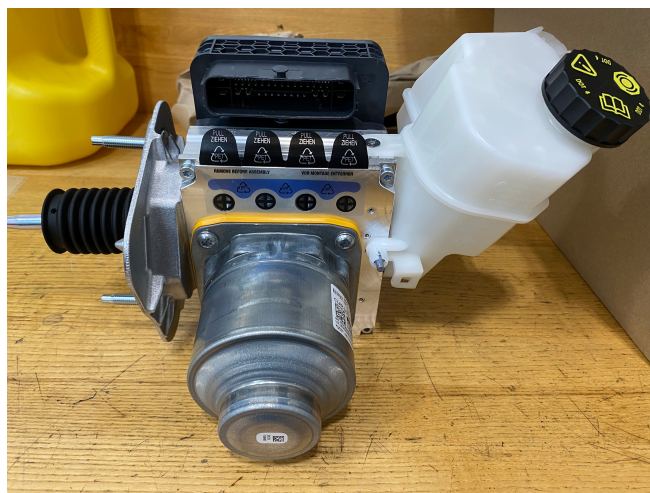
“Dry” IB unfilled: Brake fluid reservoir is empty; brake fluid line ports are sealed with labels.

Note: Additional work is necessary to install these “Dry” units. Refer to the Claim Information section.

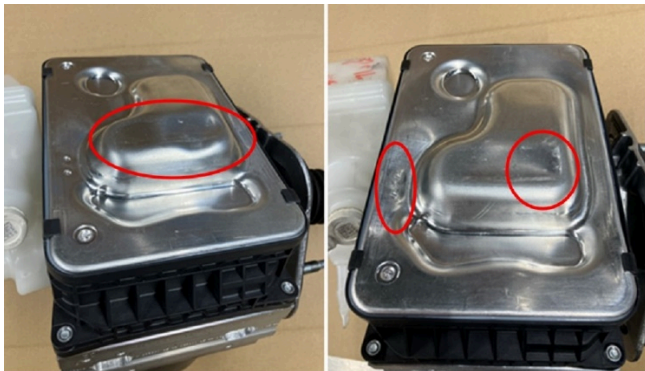
- Prior to installation, the Integrated Brake Modules should be inspected for damage upon arrival. Light scratches are acceptable, but if the aluminum cover is dented or bent, please send photos in a Recall IDS Ticket for review prior to entering a claim. If approved, please claim in accordance with the Dealer Services Return and Claims Manual.

Do not install any part which shows visual damage as shown, or has been dropped from any height.

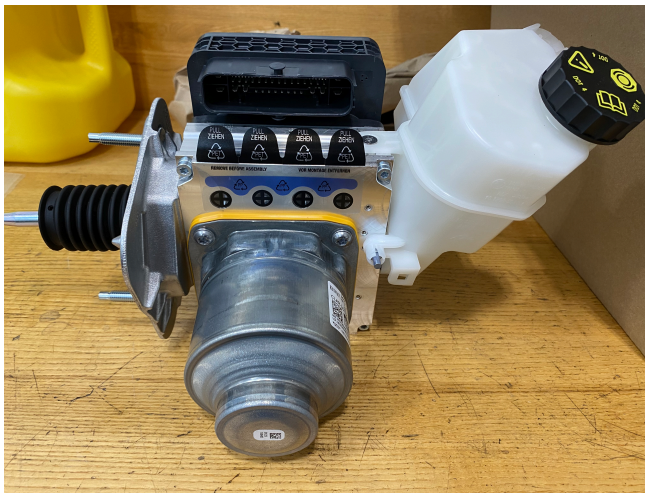
“Dry” IB unfilled: Brake fluid reservoir is empty; brake fluid line ports are sealed with labels.
