SIB 34 02 24

RECALL 24V-104: INTEGRATED BRAKING SYSTEM

This Service Information Bulletin (Revision 9) replaces SI B34 02 24 **dated February 2025**.

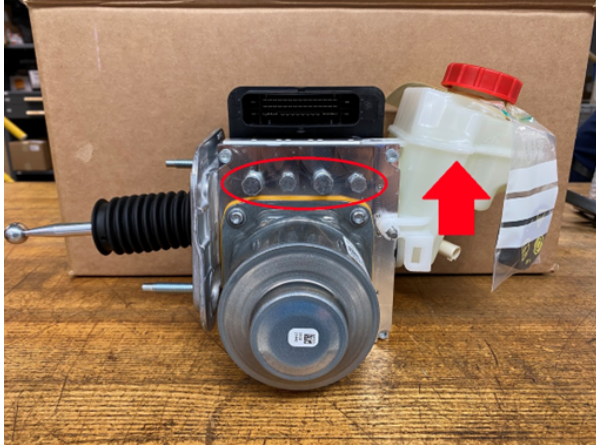
“Wet” IB pre-filled: Brake fluid reservoir is filled (arrow) and brake fluid line ports are plugged with bolts (circled).

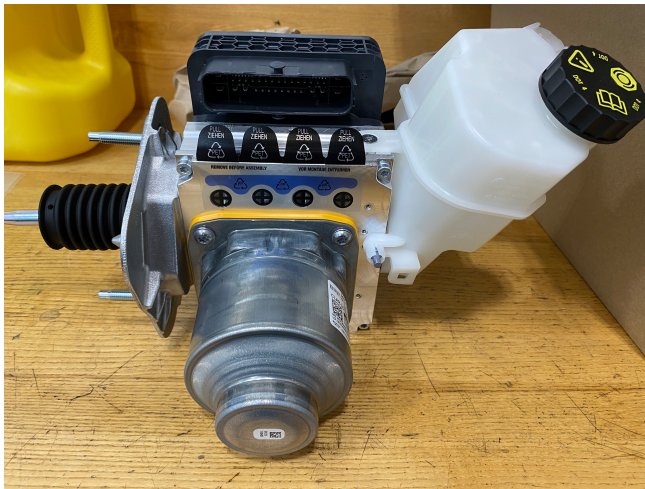
“Dry” IB unfilled: Brake fluid reservoir is empty; brake fluid line ports are sealed with labels.

Note: Additional work is necessary to install these “Dry” units. Refer to the Claim Information section.
