Subject: **Update - BMW Integrated Brake Recall - Software Now Available**

SIB 34 02 24

RECALL 24V-104: INTEGRATED BRAKING SYSTEM

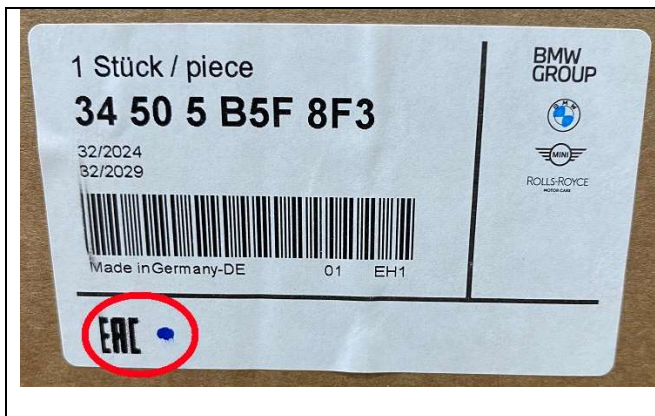
5. Verify the blue dot is located on the part number label as shown in the photo.

**Note:** Photo shown for location of blue dot on the parts label and does not indicate the part number for all models

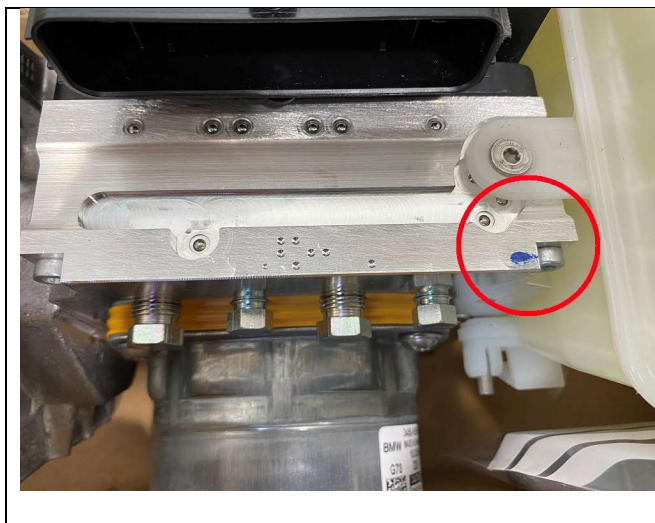
6. Verify the blue mark is located on the new component as shown in the photo.

**Note:** Some IB's may have an additional blue dot on the brake fluid reservoir. Disregard that blue dot. The only blue mark to be verified is shown here.

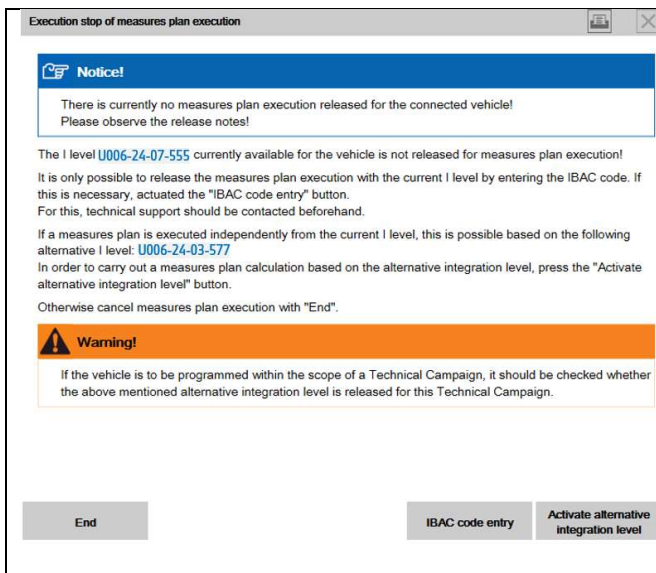
**WARNING:** For U10 and U11 vehicles do not proceed with programming of the vehicle if this warning message appears. Contact technical service via TSARA for further instructions.

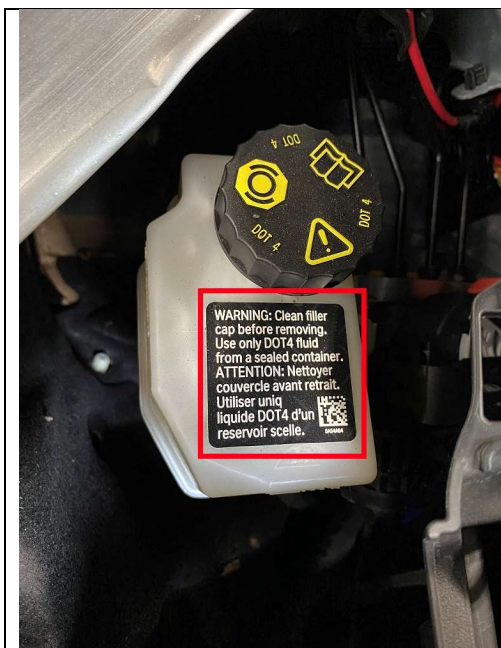
9. For G60 and G70, install the brake fluid label to the reservoir

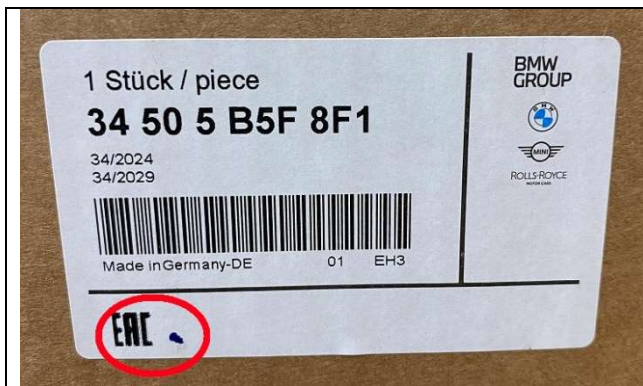
5. Verify the blue dot is located on the part number label as shown in the photo.

**Note:** Photo shown for location of blue dot on the parts label and does not indicate the part number for all models

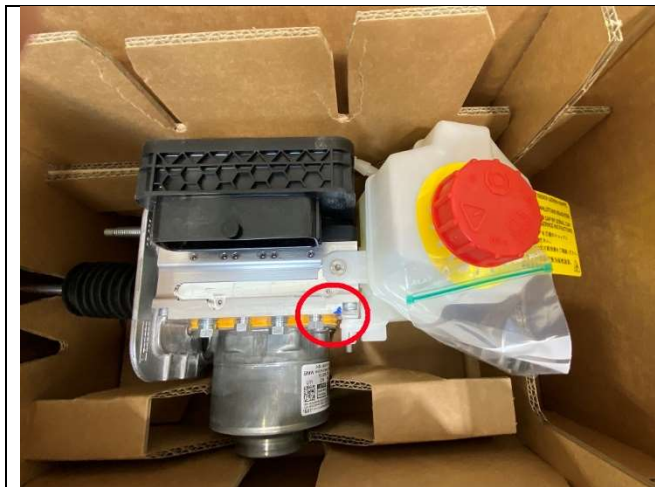
6. Verify the blue mark is located on the new component as shown in the photo.

**Note:** Some IB's may have an additional blue dot on the brake fluid reservoir. Disregard that blue dot. The only blue mark to be verified is shown here.

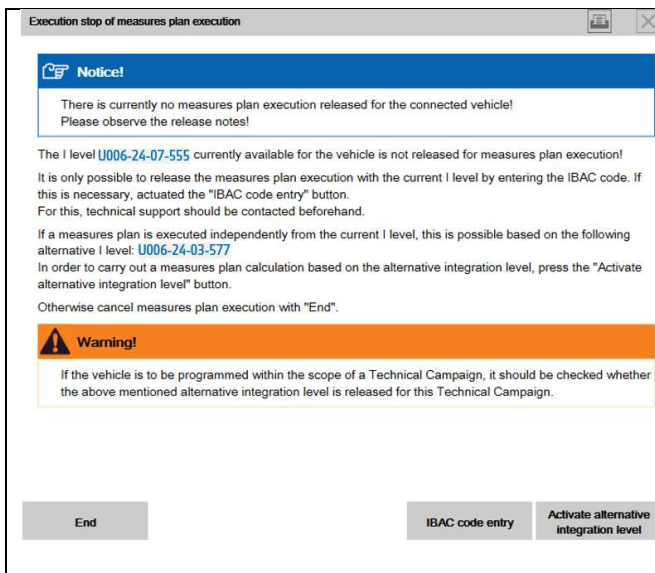
**WARNING: For U25 vehicles do not proceed with programming of the vehicle if this warning message appears. Contact technical service via TSARA for further instructions.**
