SIM 34 01 24

RECALL 24V-104: INTEGRATED BRAKING SYSTEM (IB)

This Service Information Bulletin (Revision 7) replaces SI M34 01 24 **dated November 2024**.

BMW AG is amending Voluntary Safety Recall (effective August 8, 2024) to add certain Model Year 2023 - 2025 MINI vehicles.

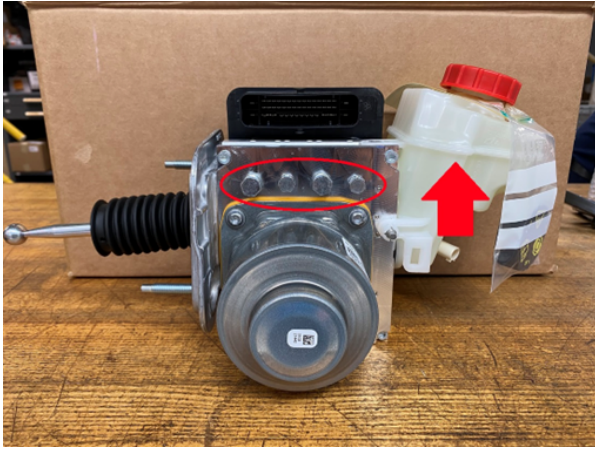
“Wet” IB pre-filled: Brake fluid reservoir is filled (arrow) and brake fluid line ports are plugged with bolts (circled)

Replace the IB with either a “wet” pre-filled unit or a “dry” unfilled unit.

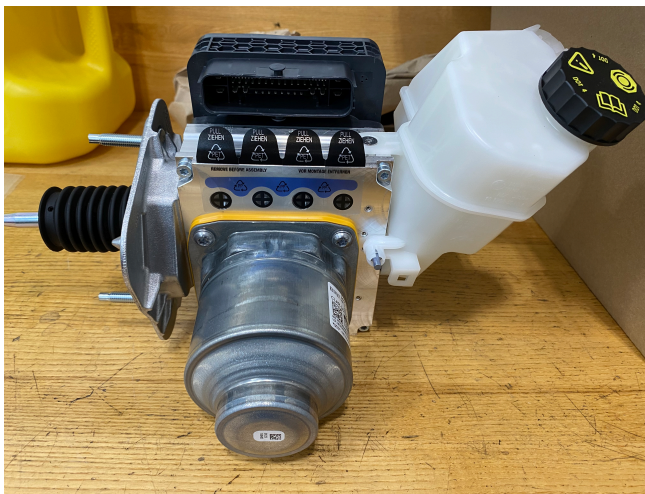
“Dry” IB unfilled: Brake fluid reservoir is empty; brake fluid line ports are sealed with labels.

Note: Additional work is necessary to install these “Dry” units, refer to the Claim Information section.

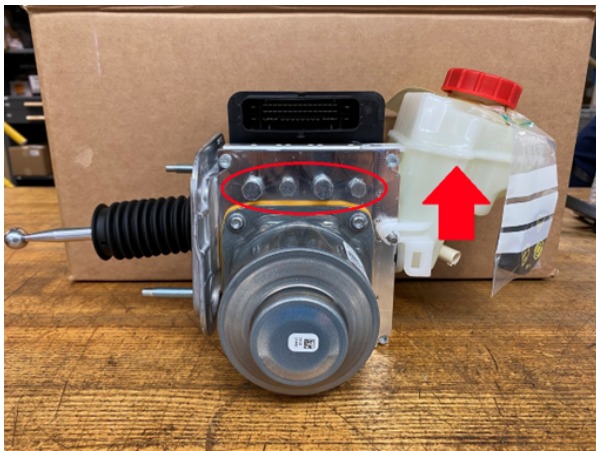
“Wet” IB pre-filled: Brake fluid reservoir is filled (arrow) and brake fluid line ports are plugged with bolts (circled).

Replace the IB with either a “wet” pre-filled unit or a “dry” unfilled unit.

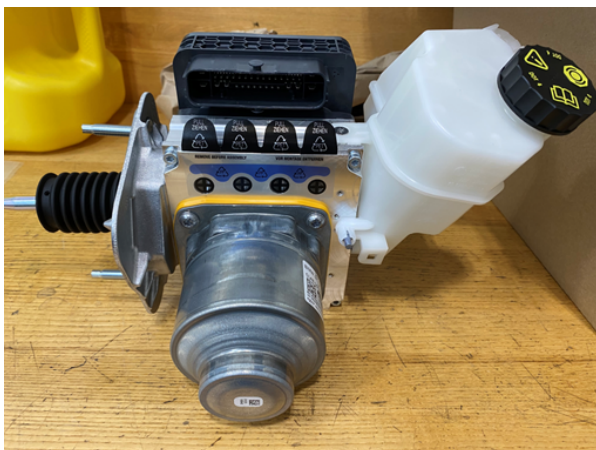
“Dry” IB unfilled: Brake fluid reservoir is empty; brake fluid line ports are sealed with labels.
