SIB 34 02 24

RECALL 24V-104: INTEGRATED BRAKING SYSTEM

2026-05-06

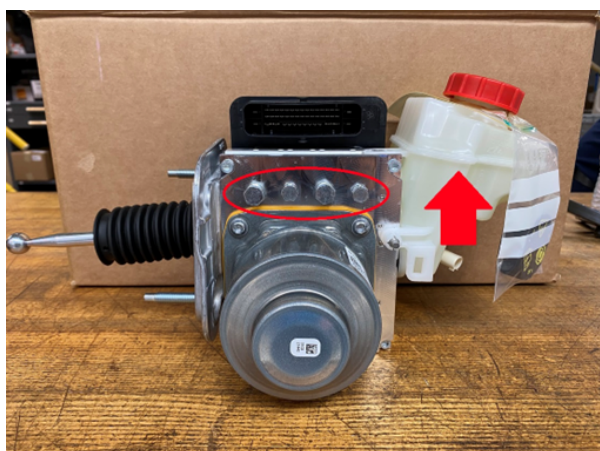
“Wet” IB pre-filled: Brake fluid reservoir is filled (arrow) and brake fluid line ports are plugged with bolts (circled).

Replace the IB with a “wet” pre-filled unit.

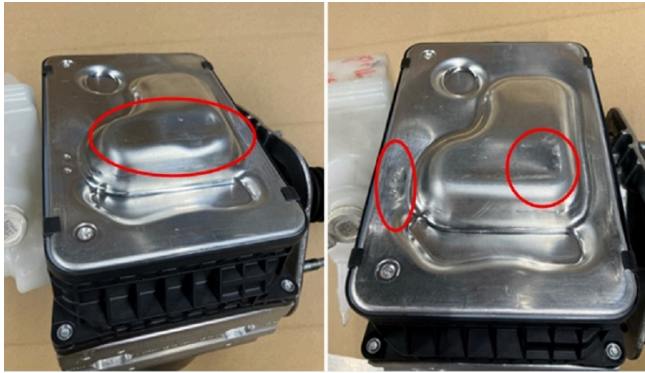
- Prior to installation, the Integrated Brake Modules should be inspected for damage upon arrival. Light scratches are acceptable, but if the aluminum cover is dented or bent, If damage is found, please send photos in a Recall IDS Ticket for review prior to entering a claim. If approved, please claim in accordance with the Dealer Services Return and Claims Manual.

Do not install any part which shows visual damage as shown or has been dropped from any height.

If you have received a “**wet**” unit, follow the REP34 51 601 Replacing hydraulic unit.

If you have received a “dry” unit, **do not install**, follow TEC848 Power Brake Return.

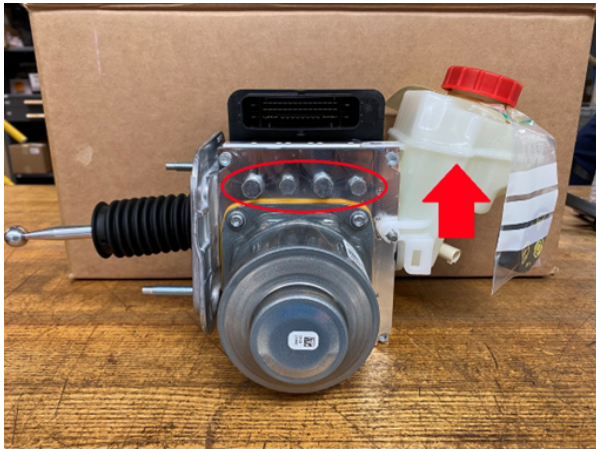
“Wet” IB pre-filled: Brake fluid reservoir is filled (arrow) and brake fluid line ports are plugged with bolts (circled)

Replace the IB with a “wet” pre-filled unit.

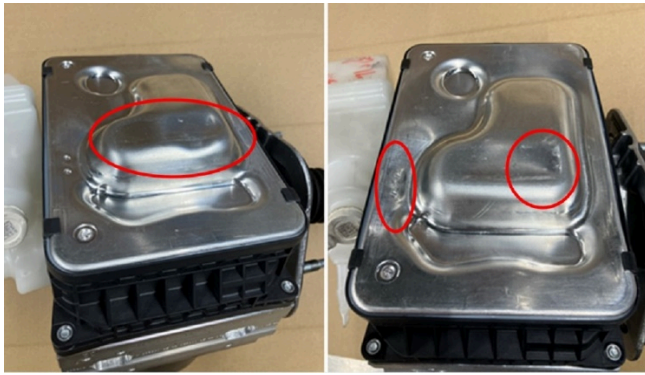
- Prior to installation, the Integrated Brake Modules should be inspected for damage upon arrival. Light scratches are acceptable; but if the aluminum cover is dented or bent, please send photos in a Recall IDS Ticket for review prior to entering a claim. If approved, please claim in accordance with the Dealer Services Return and Claims Manual.

Do not install any part which shows visual damage as shown or has been dropped from any height.

If you have received a “wet” unit, follow the REP34 51 601 Replacing hydraulic unit
