SIB 34 04 23

## RECALL 24V-104: INTEGRATED BRAKE SYSTEM (IB)

This Service Information Bulletin (Revision 7) replaces SI B34 04 23 **dated May 2024**.

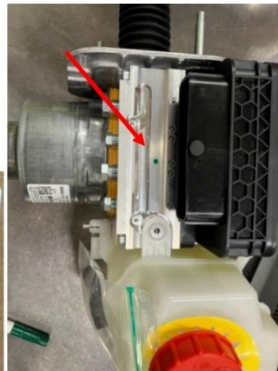
The following process only applies to service parts from production “Made in Germany DE” as shown in the red box on the parts label.

Inspection procedure applies to the service parts **without** a green dot on the label and IB.

**Note:** Label photo is example showing manufacturing location and may not reflect the part number you received.

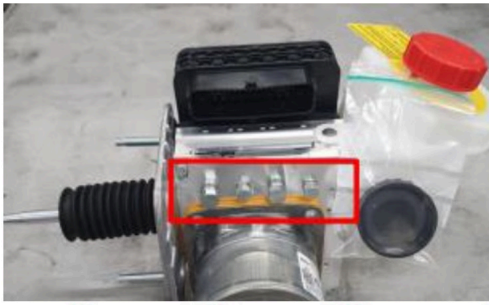
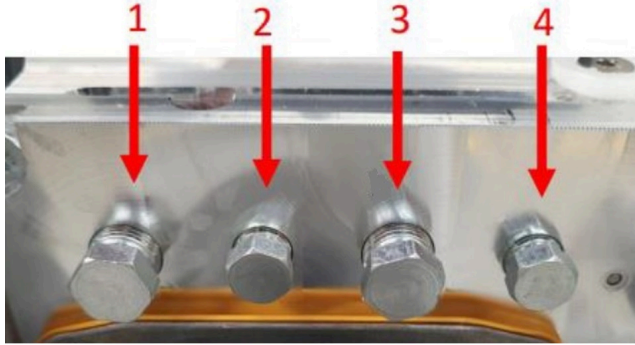
### Replacement Part WITH a Green Dot

When the part has a “green dot” on the label and on the part itself, as indicated by the red arrows shown in the pictures, the part has already been checked and is OK for use.

**Note: Green dots must be in the designated areas as indicated by the arrows in the photos. Green dots in any other area must be ignored.**

If there is no “green dot,” proceed to the next step.

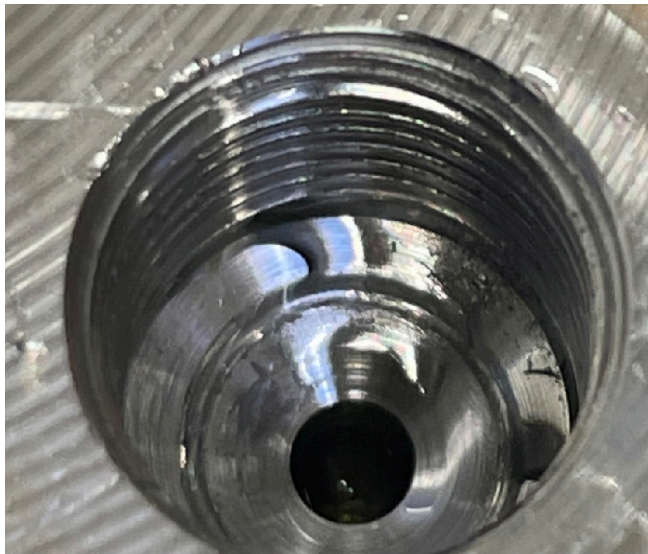
1. Place the IB on a solid surface.
2. Set a torque wrench to the first mounted blind plug and open it with the defined torque.

Defined torque  
 2a) M10 (plug #2 and #4) max 40 Nm.  
 2b) M12 (plug #1 and #3) max 20 Nm.

3. Using the defined torque wrench setting, remove the remaining plugs (2,3,4).

**Note:** If one plug is opening with a torque value higher than indicated, the part is not OK

4. The part is OK if the plugs open with a lower torque than the defined values.

5. Higher torque, Damage threads:

No = Continue to step 6  
 Yes = Proceed to Parts Claim Information below to re-order

6. Inspect and clean the IB bores and brake line connections.

7. Install the IB as per REP34 51 601 "Replacing hydraulic unit".

**Note:** The wheel circuit connections must be properly torqued and inspected for leaks as per the repair instructions.

**Note:** When removing the brake pedal, be particularly careful as not to damage the retaining lugs on the holding clip.

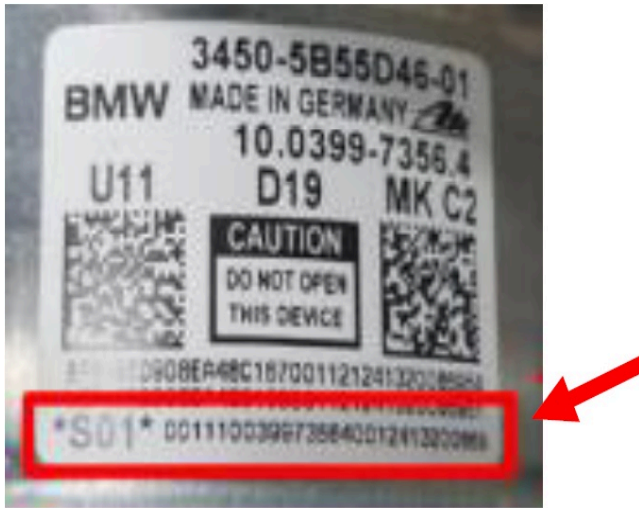
For parts that are not OK, torque higher than indicated value, thread damage or metallic particles inside:

- All plugs must be installed and tightened to 10 Nm to avoid leakage in the return process
- Claim the not OK part via the normal parts claim procedure using YR26
- Put TECIBS and the serial number in the comments field
- Claim the part failure with description defined tripping torque exceeded or optical damage or contamination has been detected in the connection
- If the part was found to have good torque values but optical contaminations (thread area), please attach photos of the damage/contamination and identify which hole this defect was found
- Re-open the Recall IDS Ticket with the Claim number and a replacement part will be ordered for you
