## SIB 34 02 24

### RECALL 24V-104: INTEGRATED BRAKING SYSTEM

2026-01-09

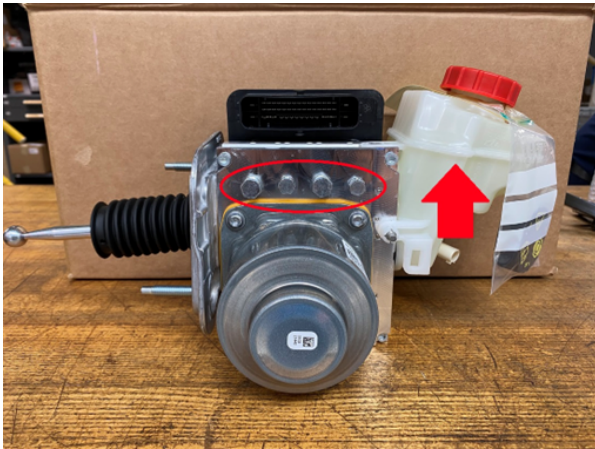
**“Wet” IB pre-filled:** Brake fluid reservoir is filled (arrow) and brake fluid line ports are plugged with bolts (circled).

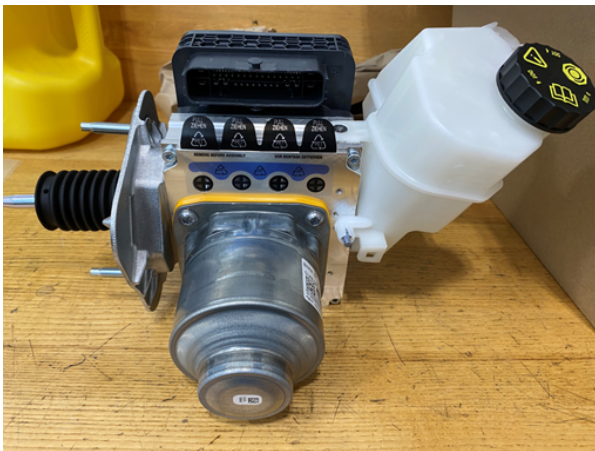
**“Dry” IB unfilled:** Brake fluid reservoir is empty; brake fluid line ports are sealed with labels.

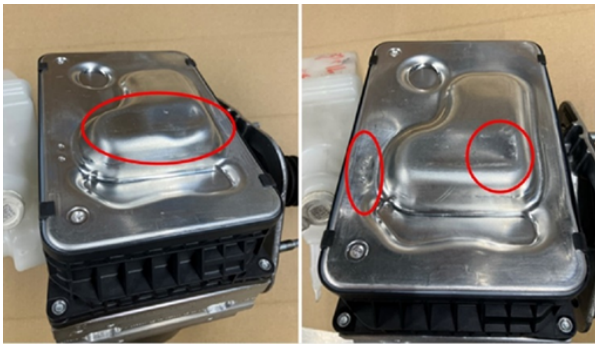
Do not install any part which shows visual damage as shown, or has been dropped from any height.

- Prior to installation, the Integrated Brake Modules should be inspected for damage upon arrival. Light scratches are acceptable, but if the aluminum cover is dented or bent, ~~if damage is found~~, please send photos in a Recall IDS Ticket for review prior to entering a claim. If approved, please claim in accordance with the Dealer Services Return and Claims Manual.

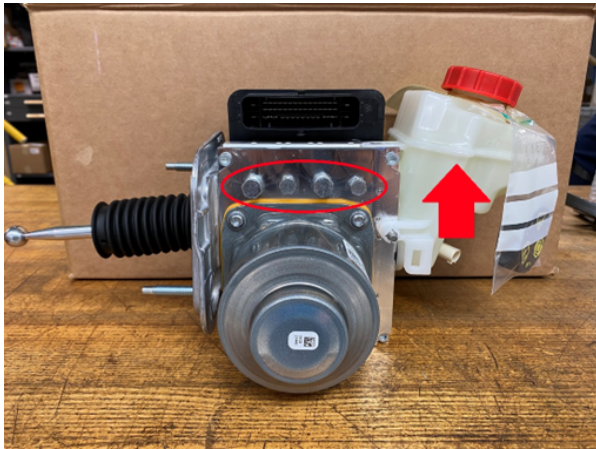
**“Wet” IB pre-filled:** Brake fluid reservoir is filled (arrow) and brake fluid line ports are plugged with bolts (circled)

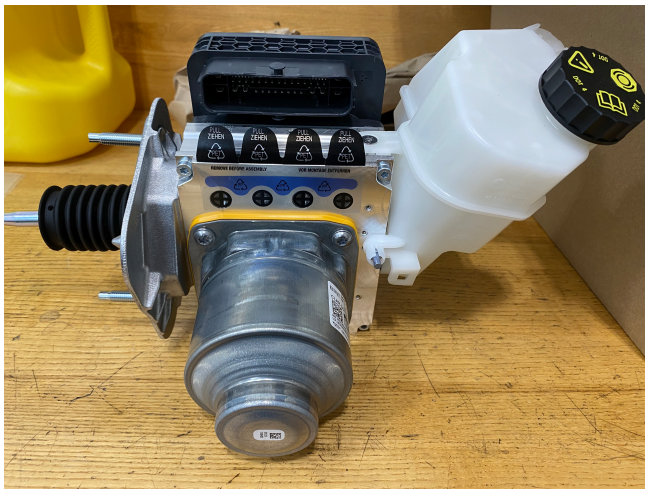
**“Dry” IB unfilled:** Brake fluid reservoir is empty; brake fluid line ports are sealed with labels.

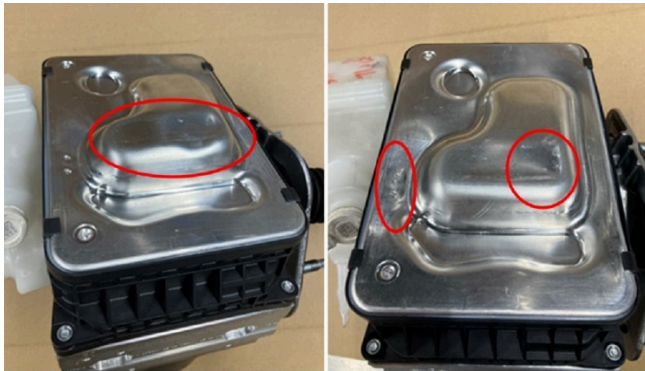
Do not install any part which shows visual damage as shown, or has been dropped from any height.
